Job #: 20180927 Kings Wharf Condition Survey  
King's Wharf  
Dockyard .

Soffit Photos Nov 14, 2017

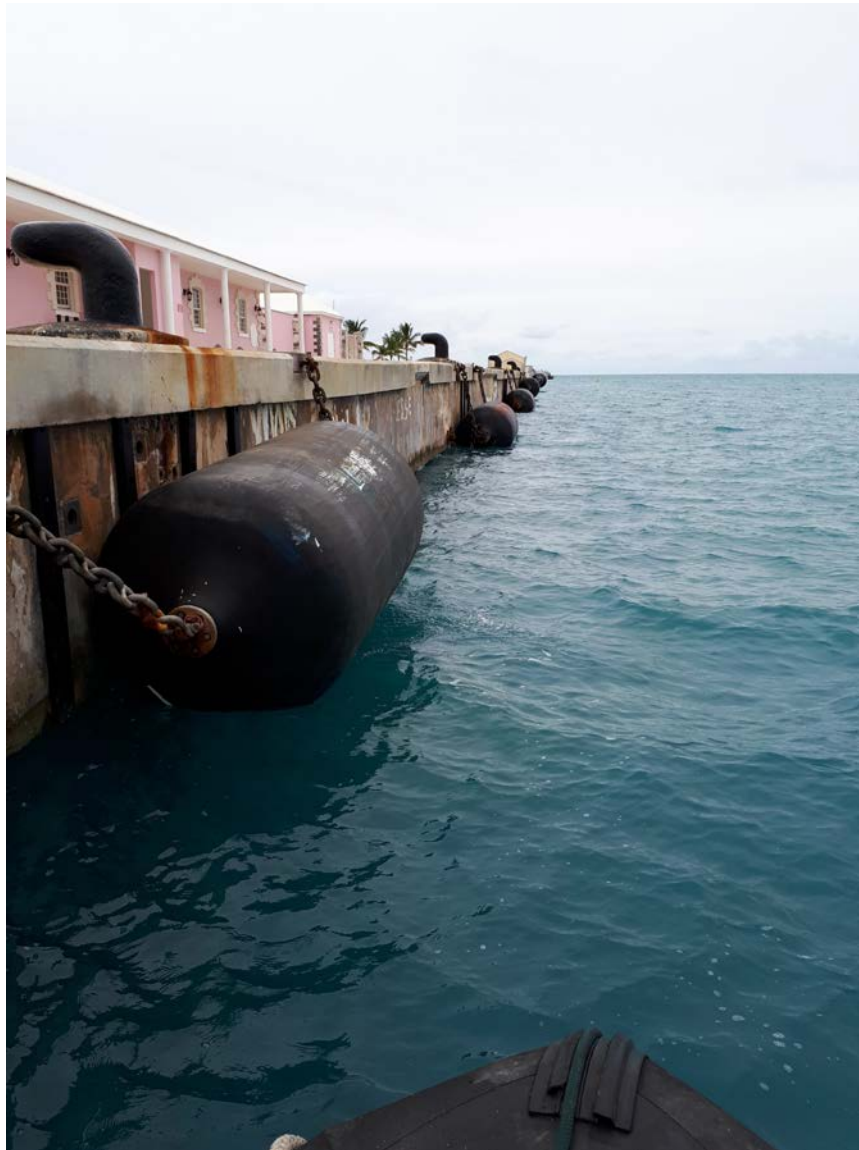
Description  
Typical fender

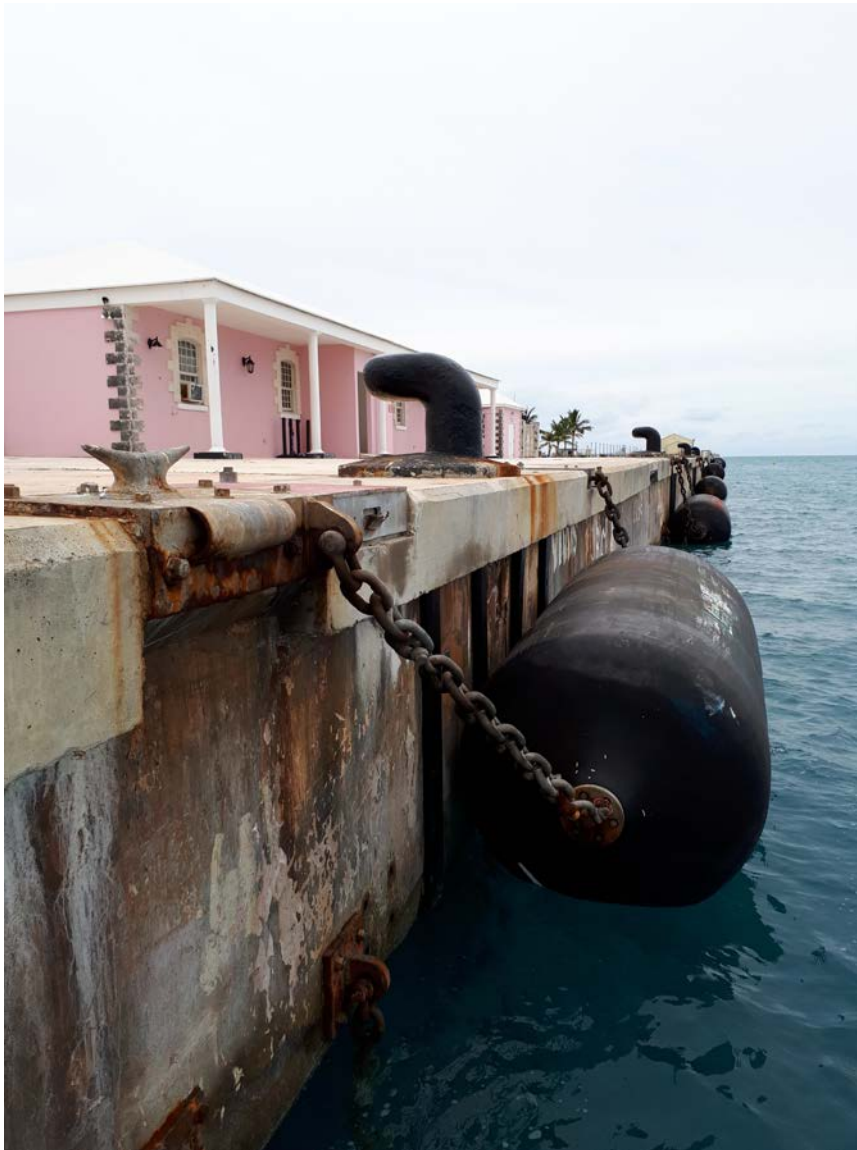
Description  
Typical fender and bollard

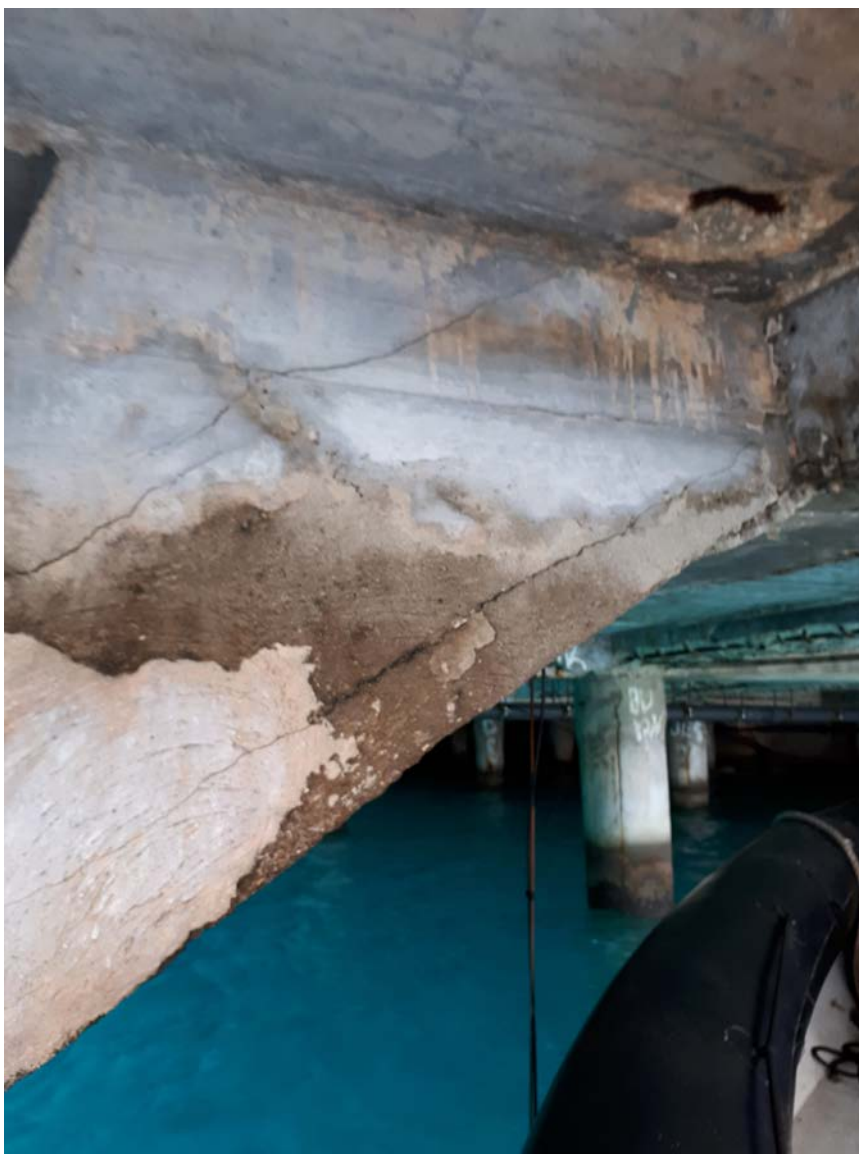
Description  
Front wall strut

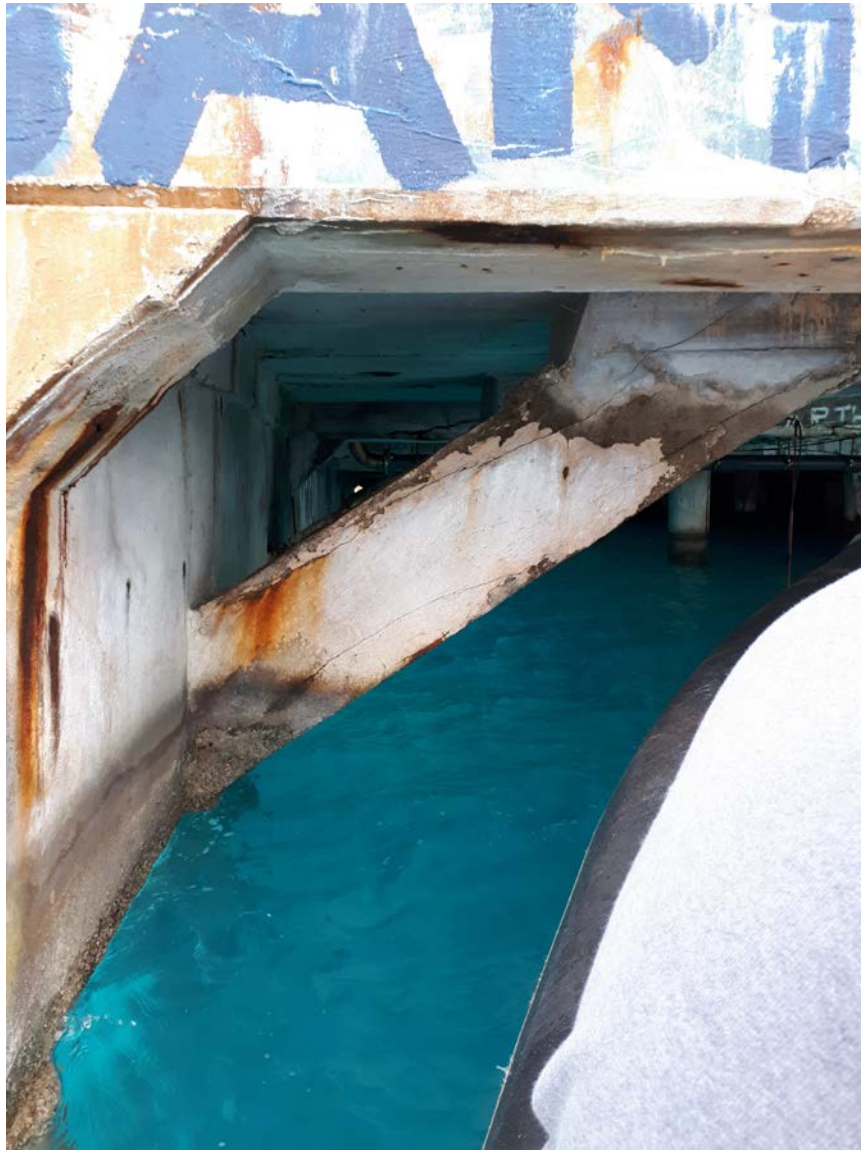
Description  
Line A strut

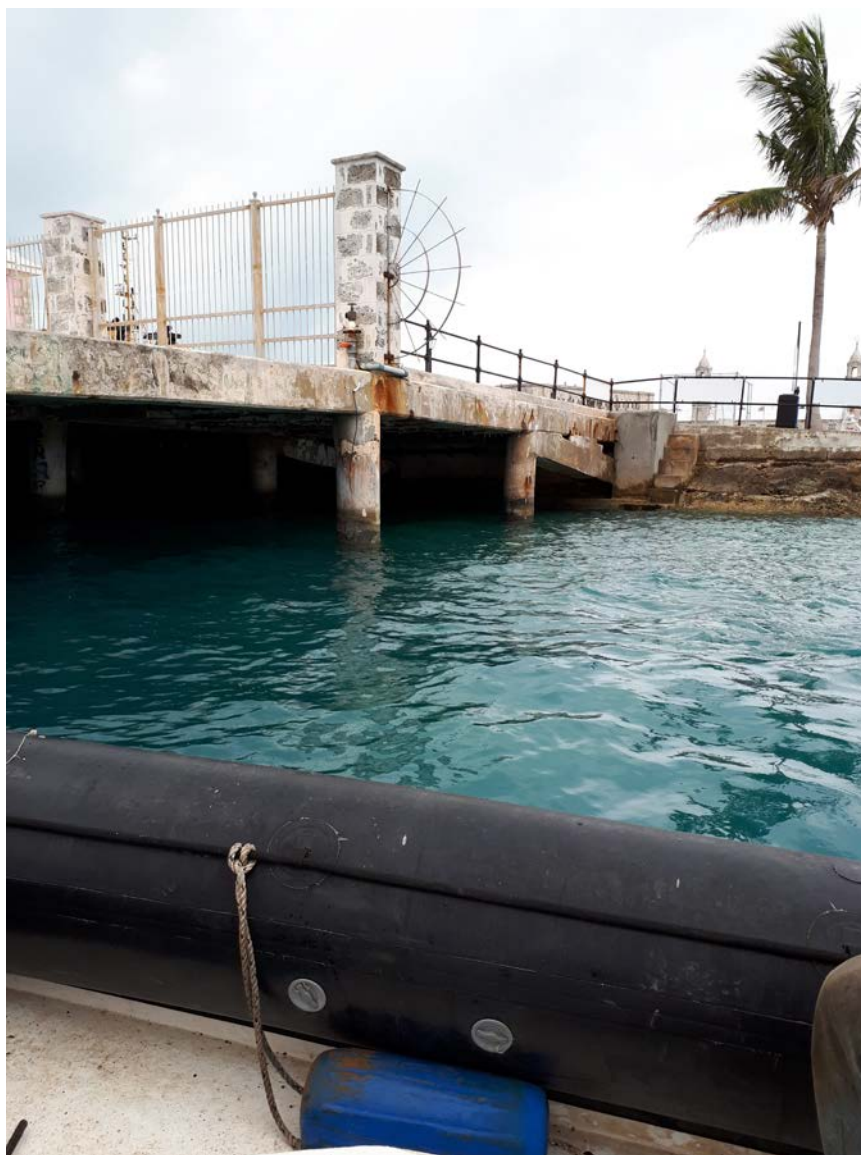
Description  
NW corner

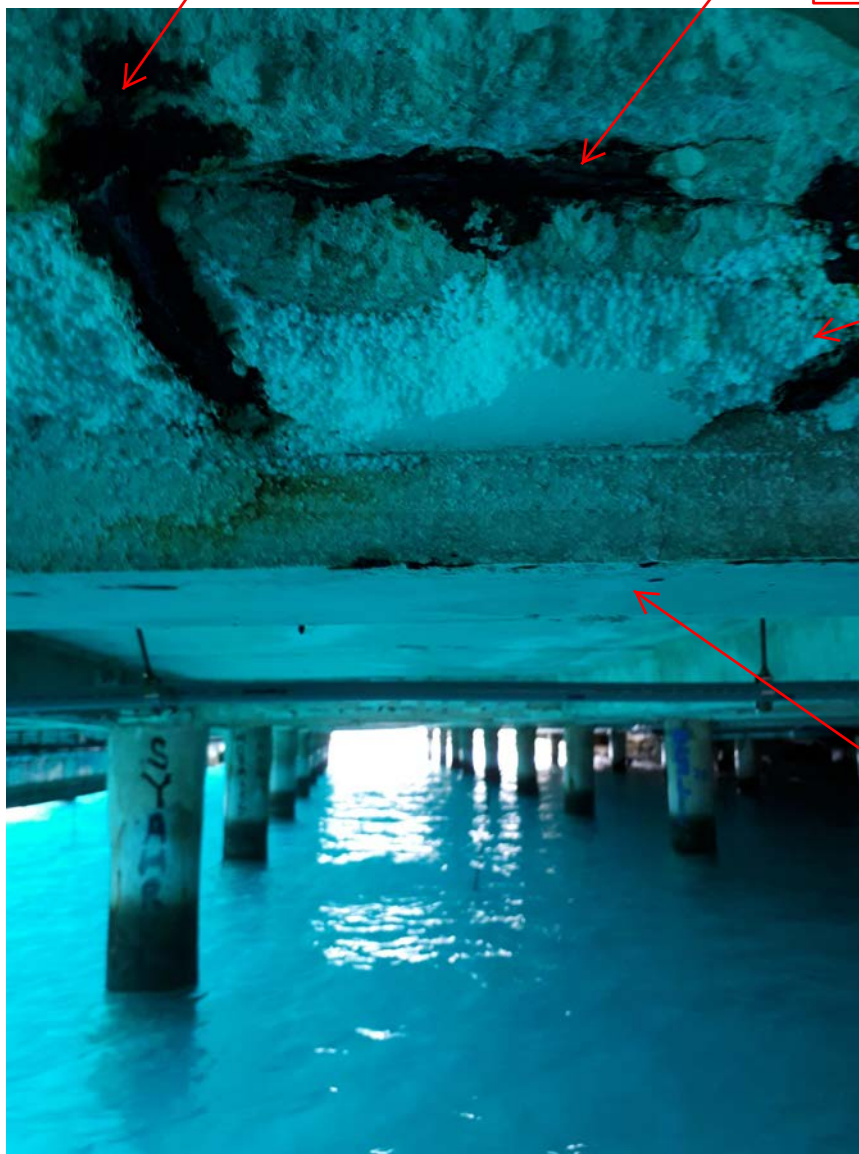
Description  
Styrofoam left in the  
formwork

Bottom flange of  
HP14x73 steel  
beam

Styrofoam left in  
form work

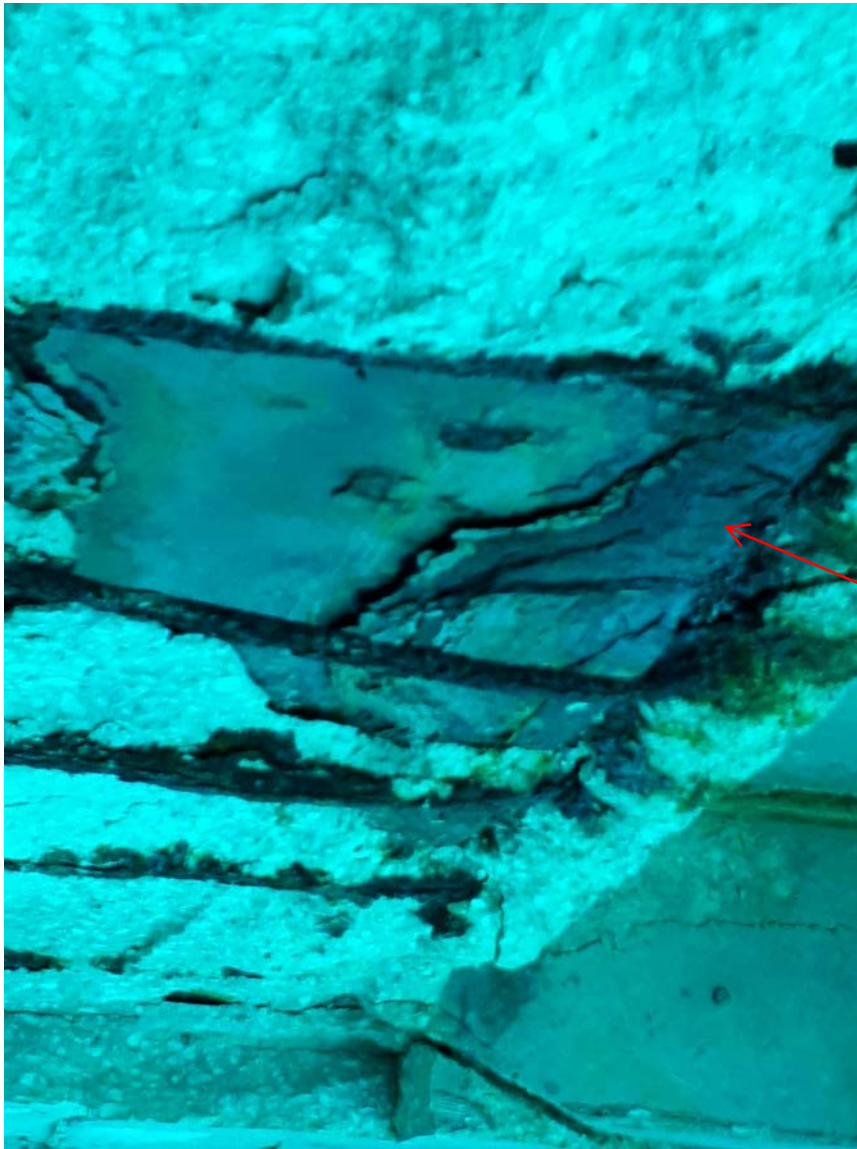
Description  
Typical corroded beam  
lower flange

Rust pack on  
bottom flange of  
HP14x73 steel  
beam

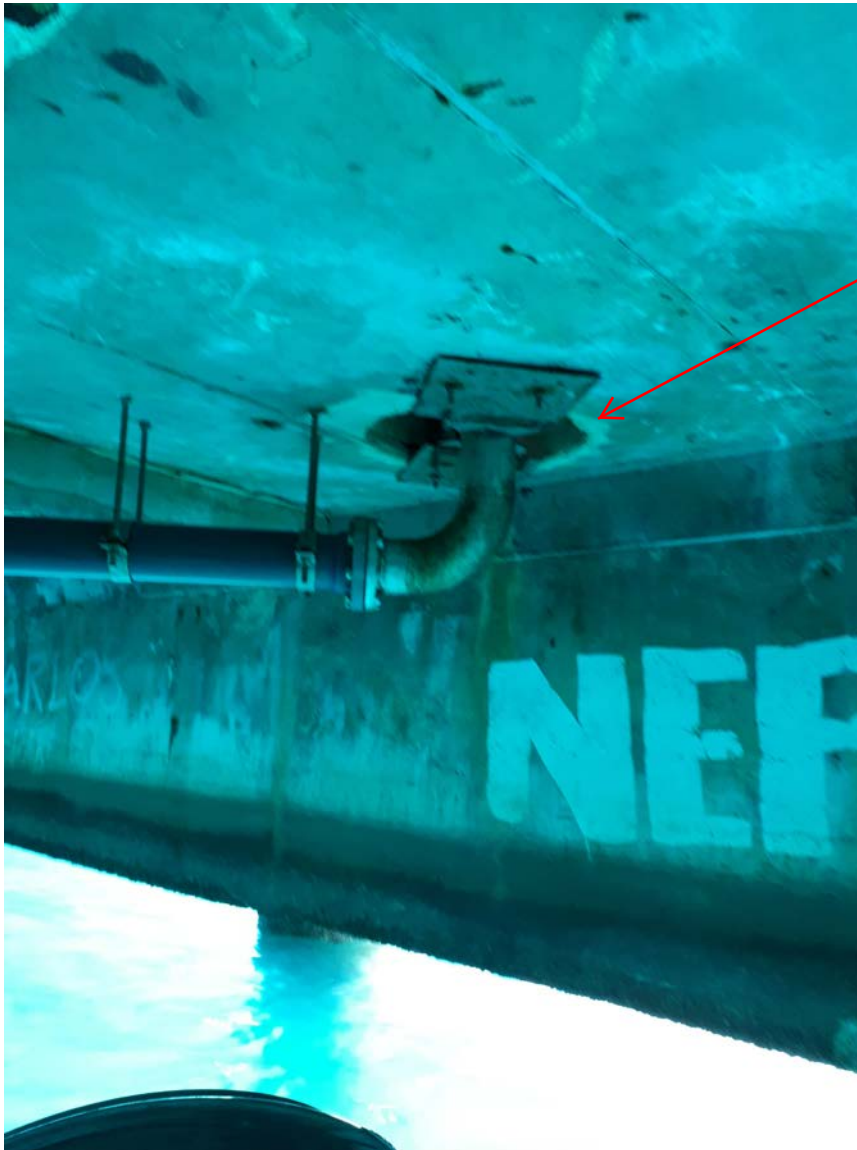
Description  
Sewer connection for Ship

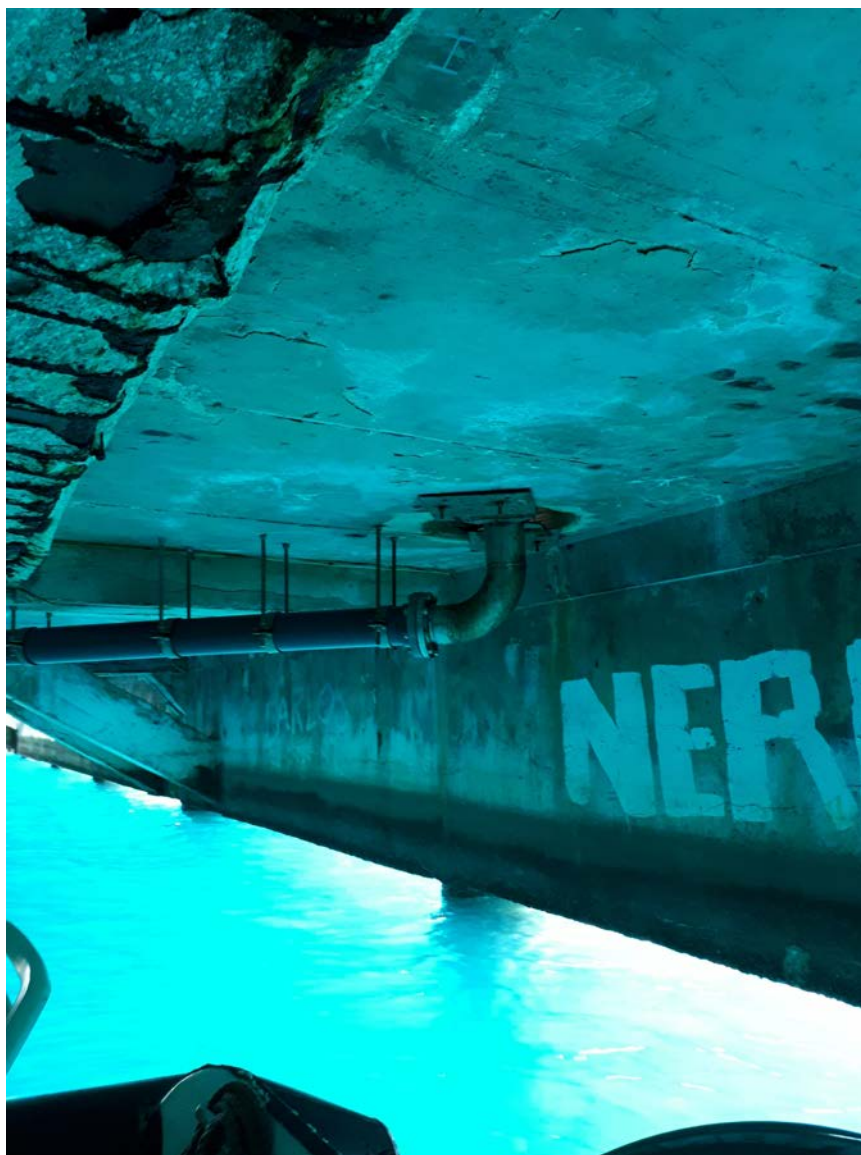
Description  
Sewer connection for Ship

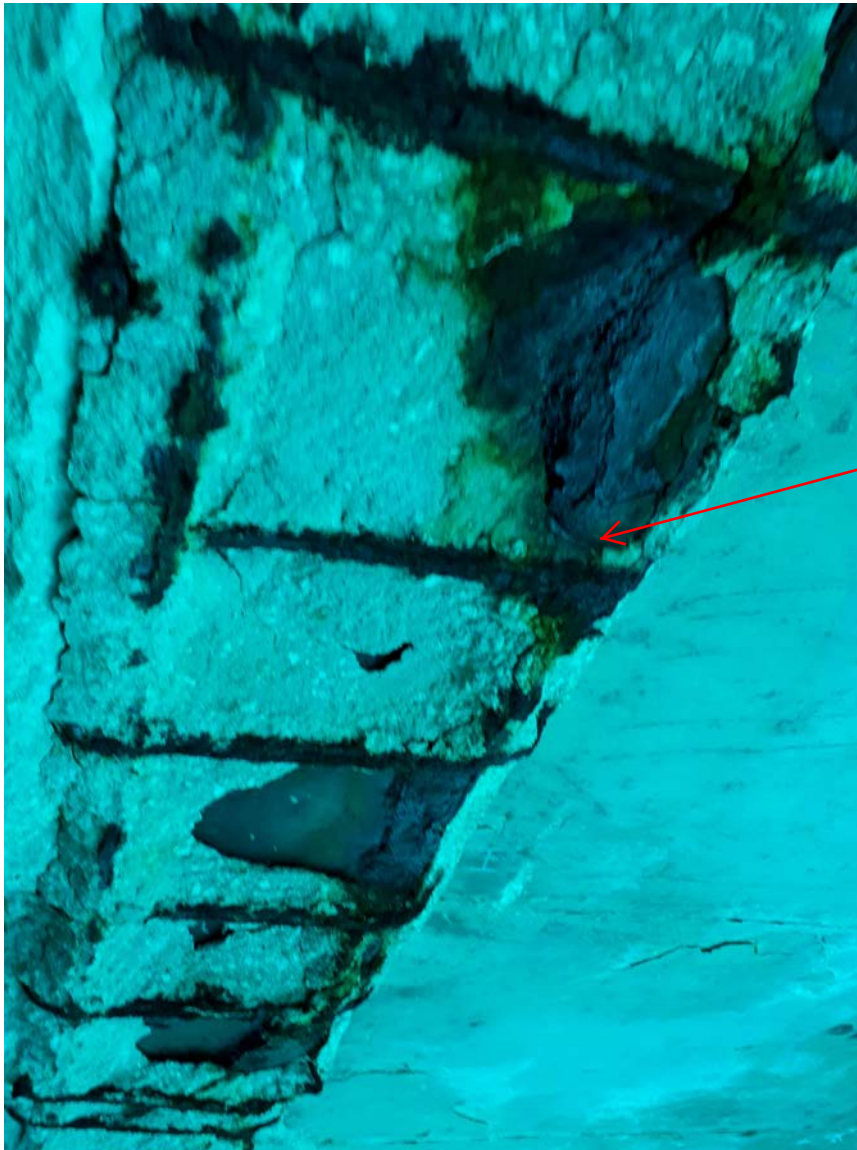
Description  
Steel beam corrosion

Typical concrete  
encase beam

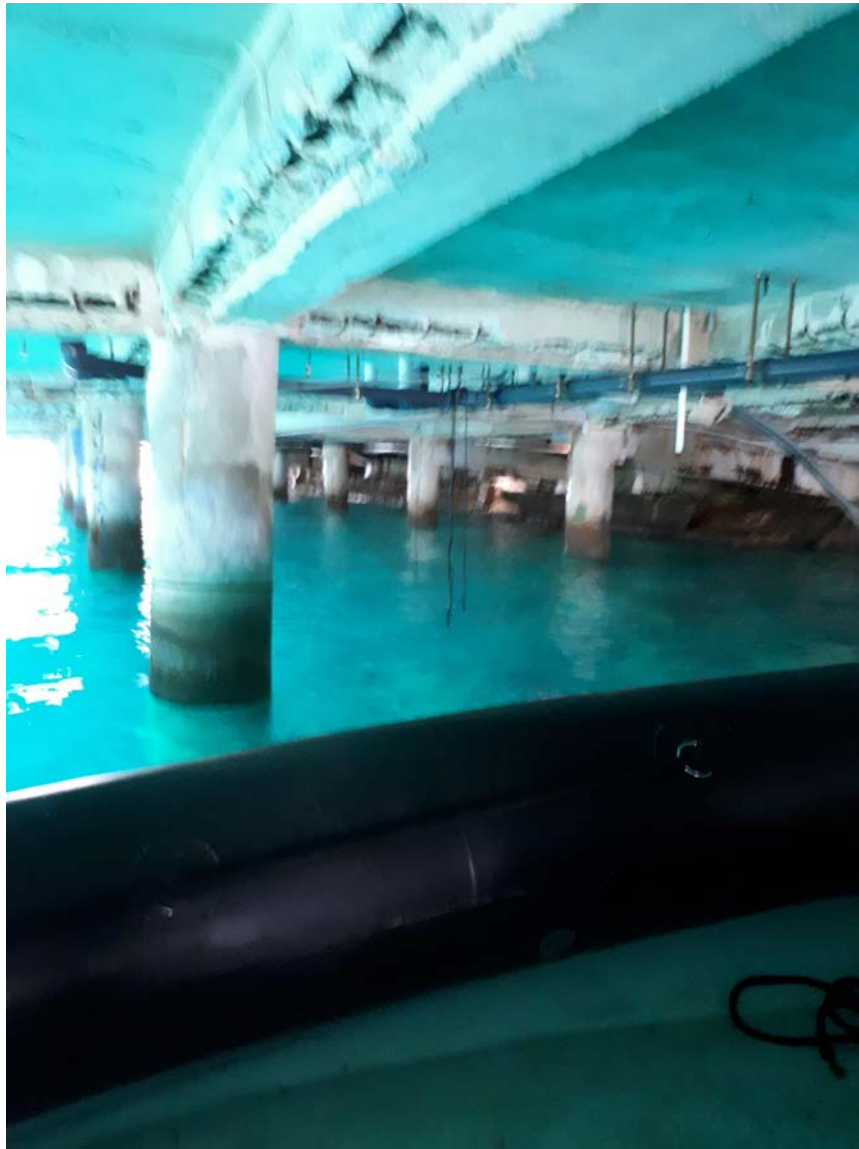
Description  
View of u/s wharf

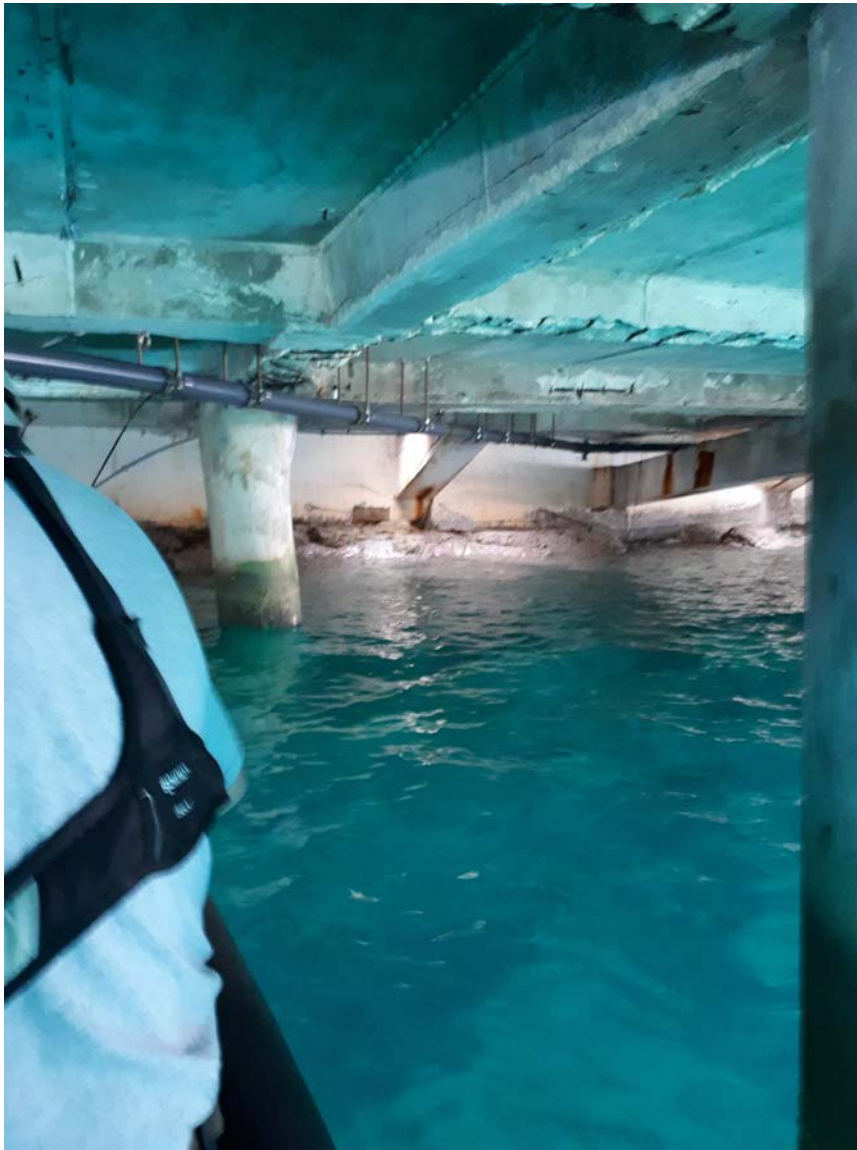
Description  
Sewer line from building  
towards road.

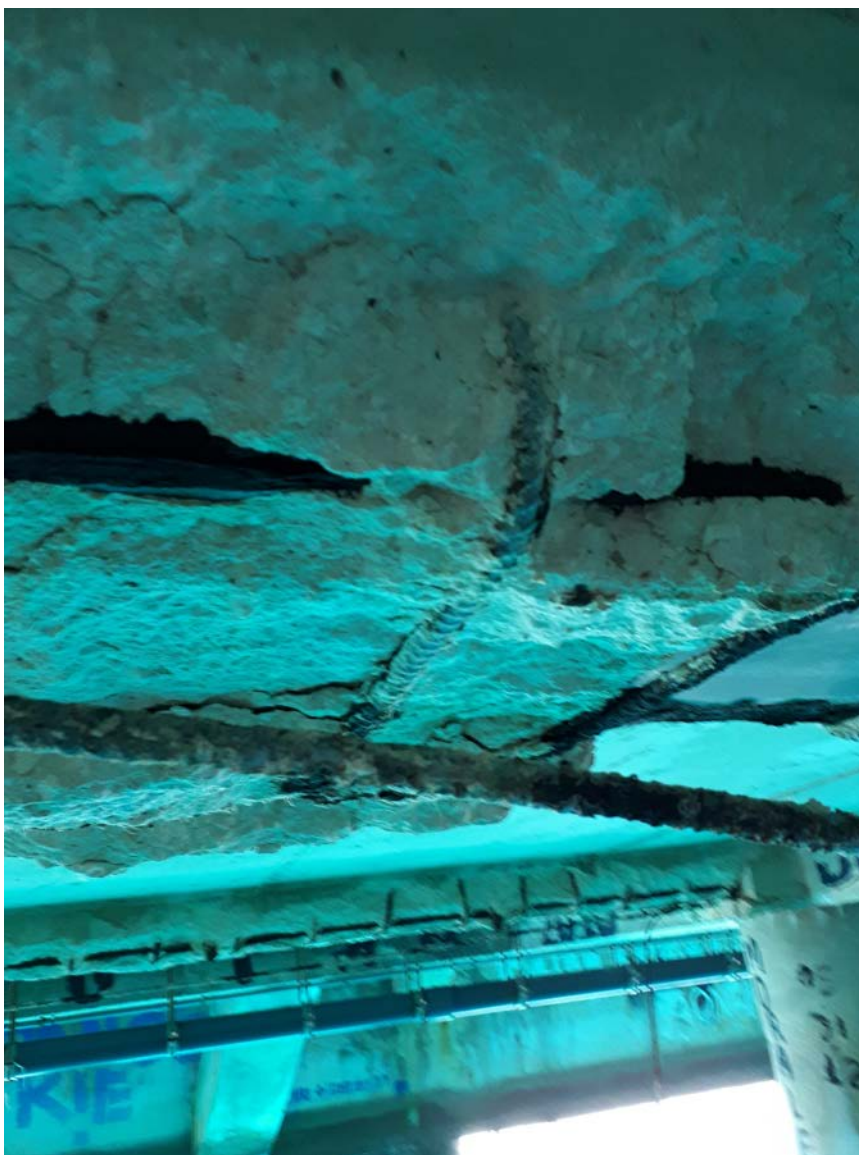
Description  
Galvanized rebar

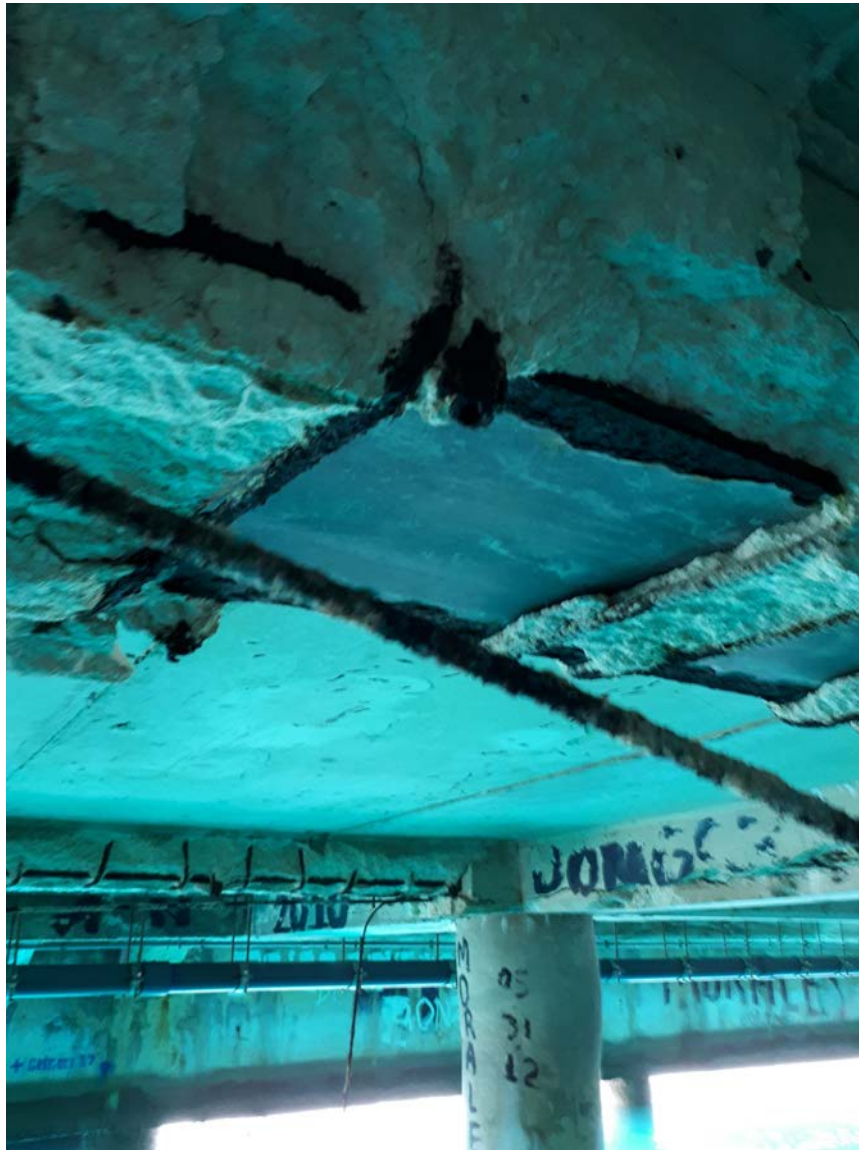
Description  
Bottom flange of beam  
showing galvanizing

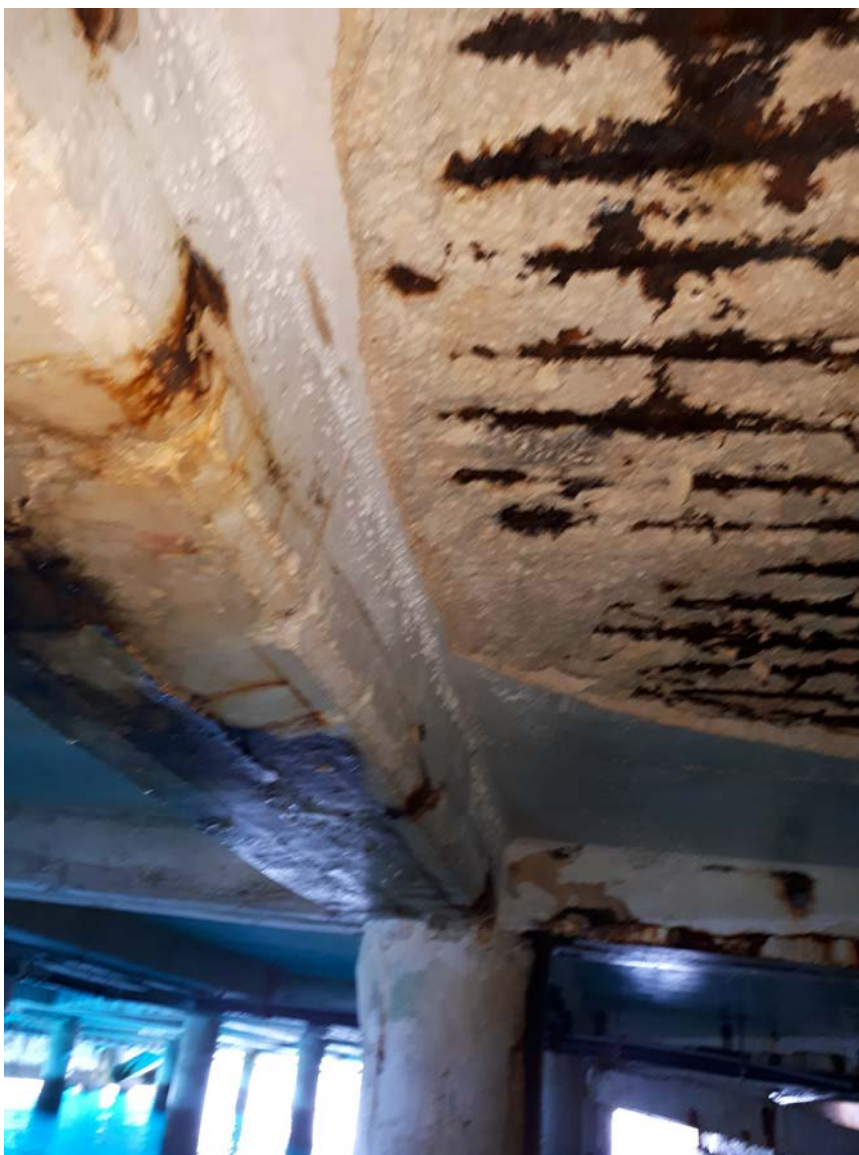
Description  
Delamed u/s deck

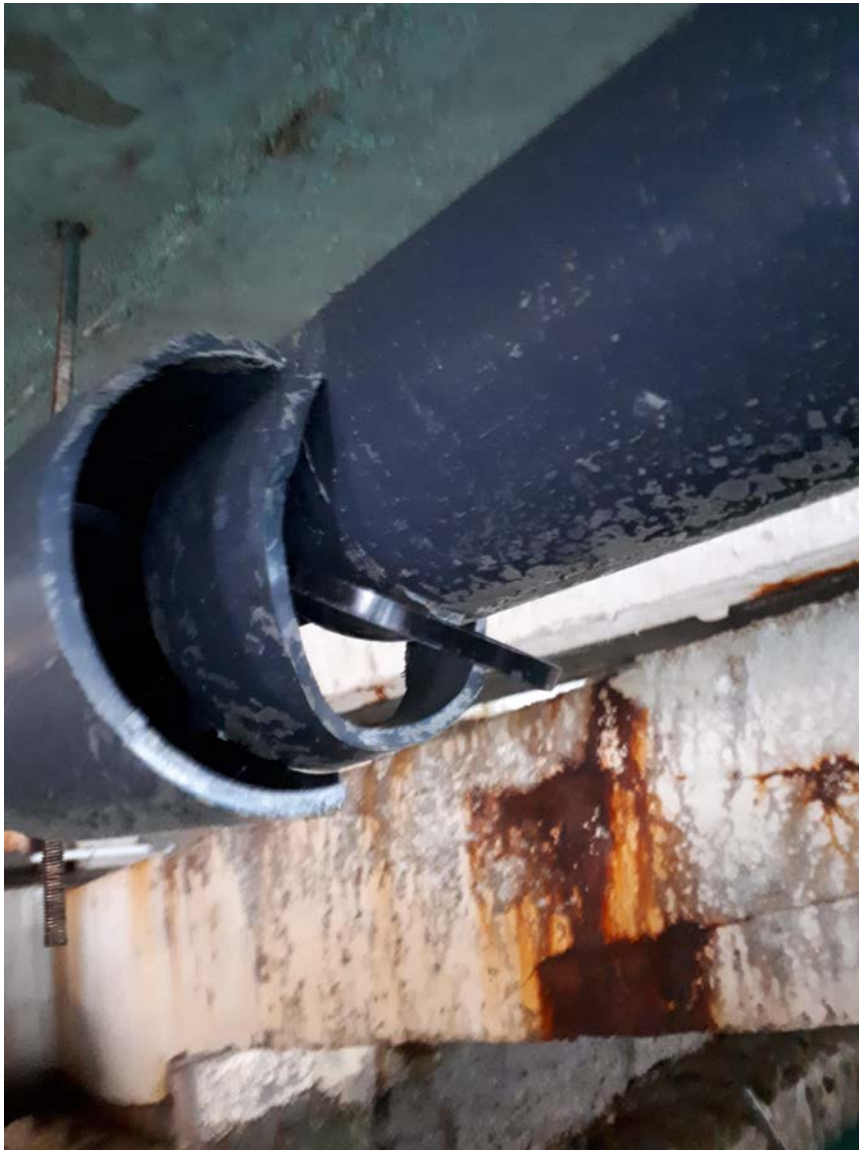
Description  
Broken sewage line

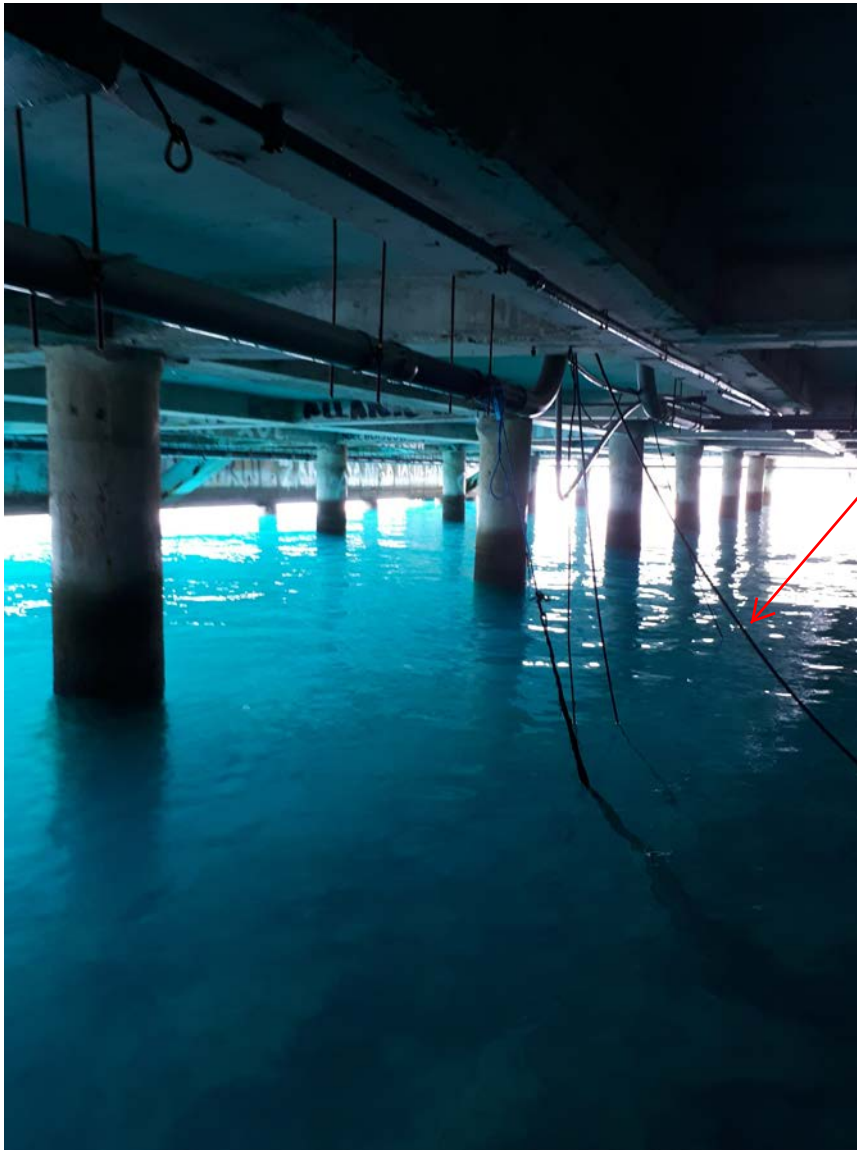
Remains of  
cathodic protection  
system
