# Baseline Conditions Report

## Bermuda and Climate Change: Impacts from Sea Level Rise and Changing Storm Activity

**Smith Warner International Limited**  
Unit 13, Seymour Park, 2 Seymour Avenue  
Kingston 10, JAMAICA

26 September 2022

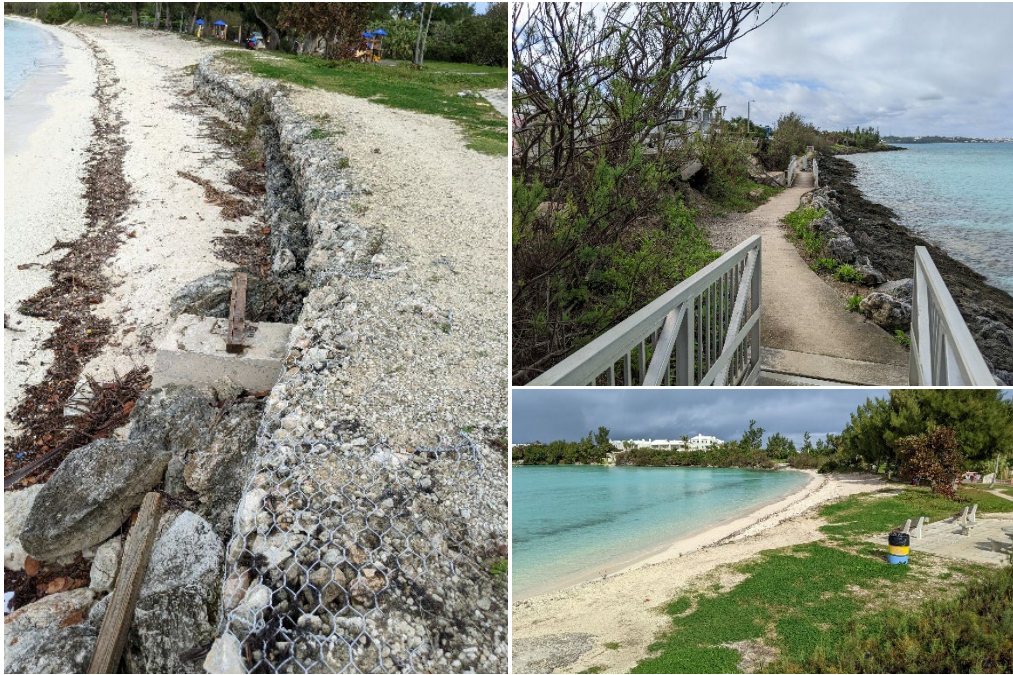
Figure 3.2 Shelley Bay Beach

The beach is protected in parts with rock-filled gabion baskets. The gabions are in good condition despite being over 10 years old. A rocky shoreline protects a footpath connected with aluminium bridges in places. The rocky shoreline is disjointed with the gaps allowing wave energy to penetrate the shoreline. Shoreward of the beach/footpath lies the main arterial road. There is evidence of recent (and imminent) failure of the roadway slipping seaward, repaired with a concrete seawall. Apparently two brush islands existed within the bay, which were cut for firewood.

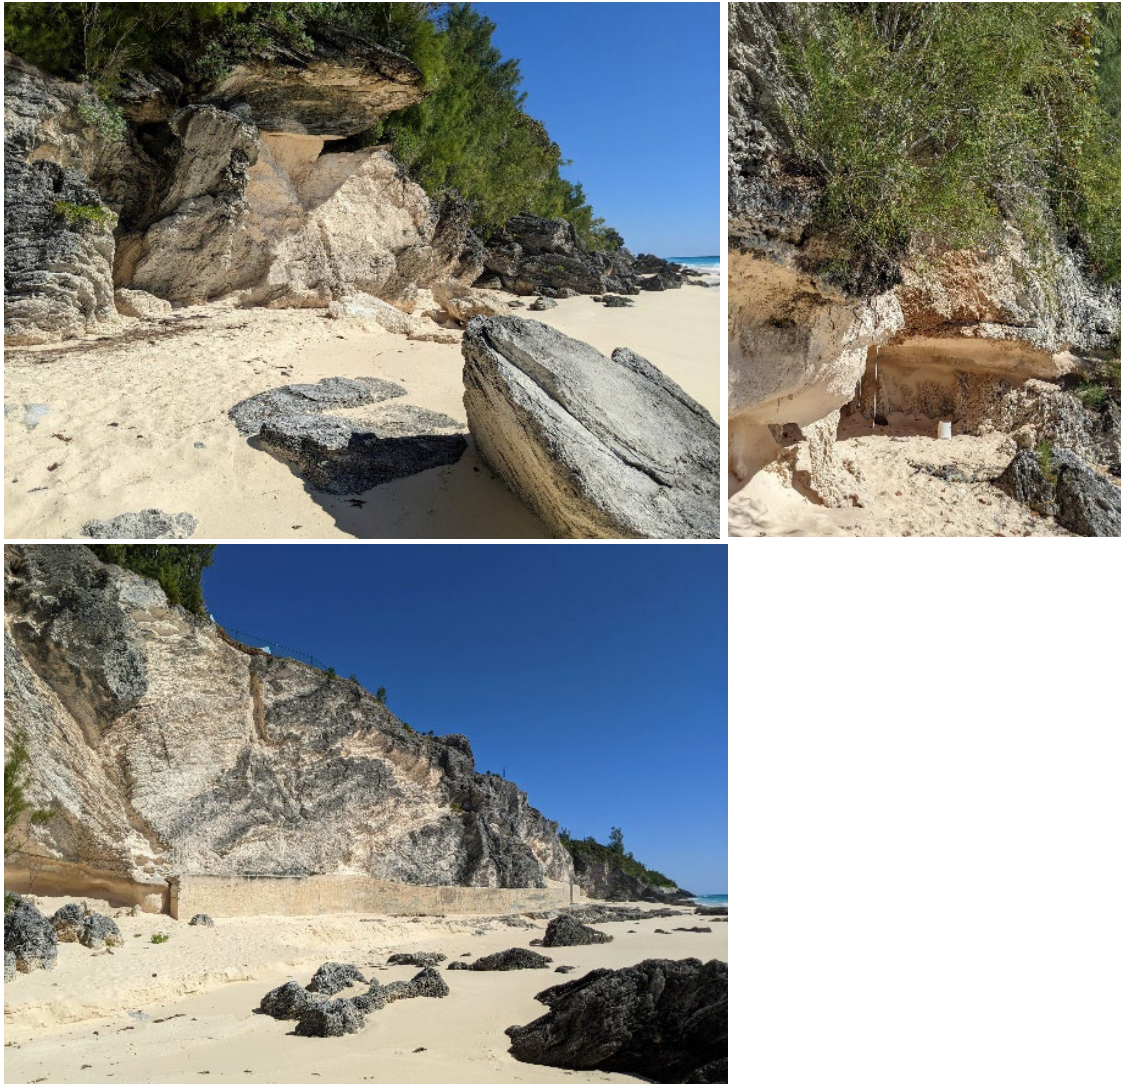
Figure 3.3 Marley Beach

A large coastal cliff failure has occurred under a new development of three apartment blocks. A concrete seawall was built at the toe of the cliff to protect from further erosion.

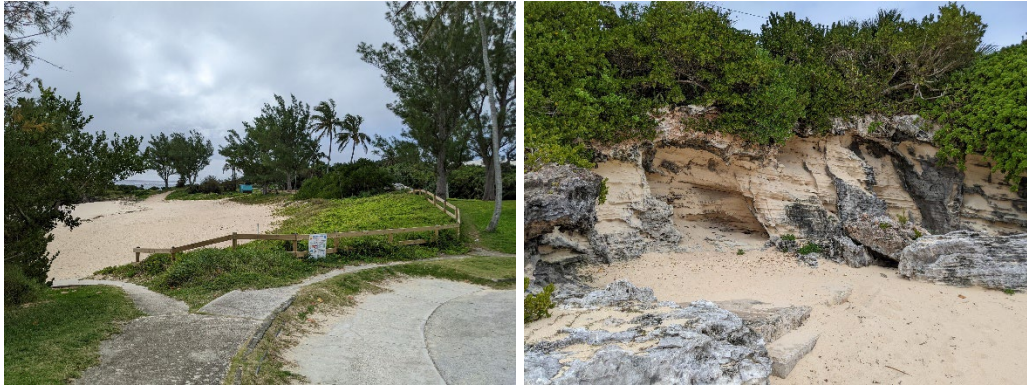
Figure 3.4 John Smith's Beach

John Smith Beach is a sandy beach formed within a crenulate bay. The beach itself appears quite healthy with a well-defined vegetated upper dune. However, there is evidence of undercutting of the sandstone rock in the cliff face, presumably caused by wave action during storm events.

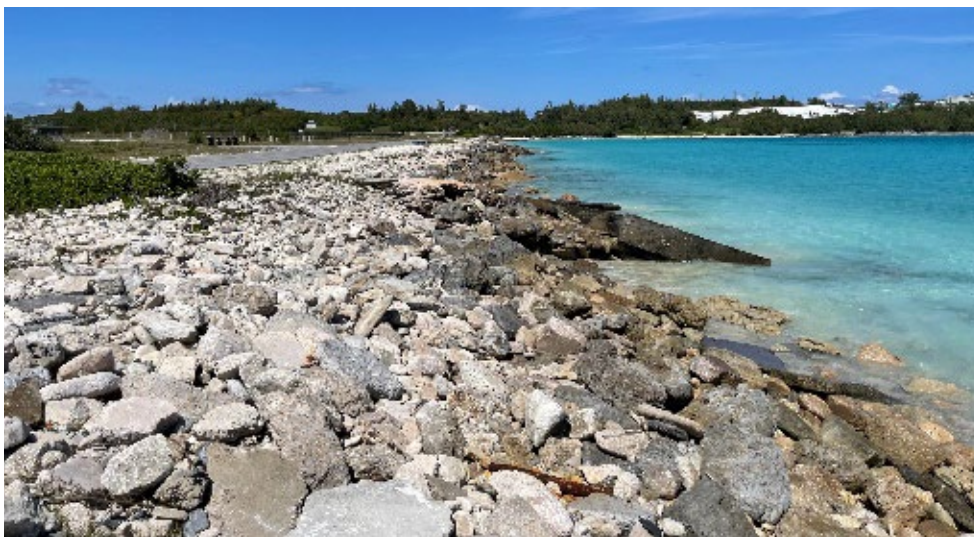
Figure 3.5 Annie's Bay

The eastern end of the airport runway terminates with a roadway that is protected by a low revetment. This gets covered with sand and debris during passing hurricanes and requires heavy machinery to clear the road.

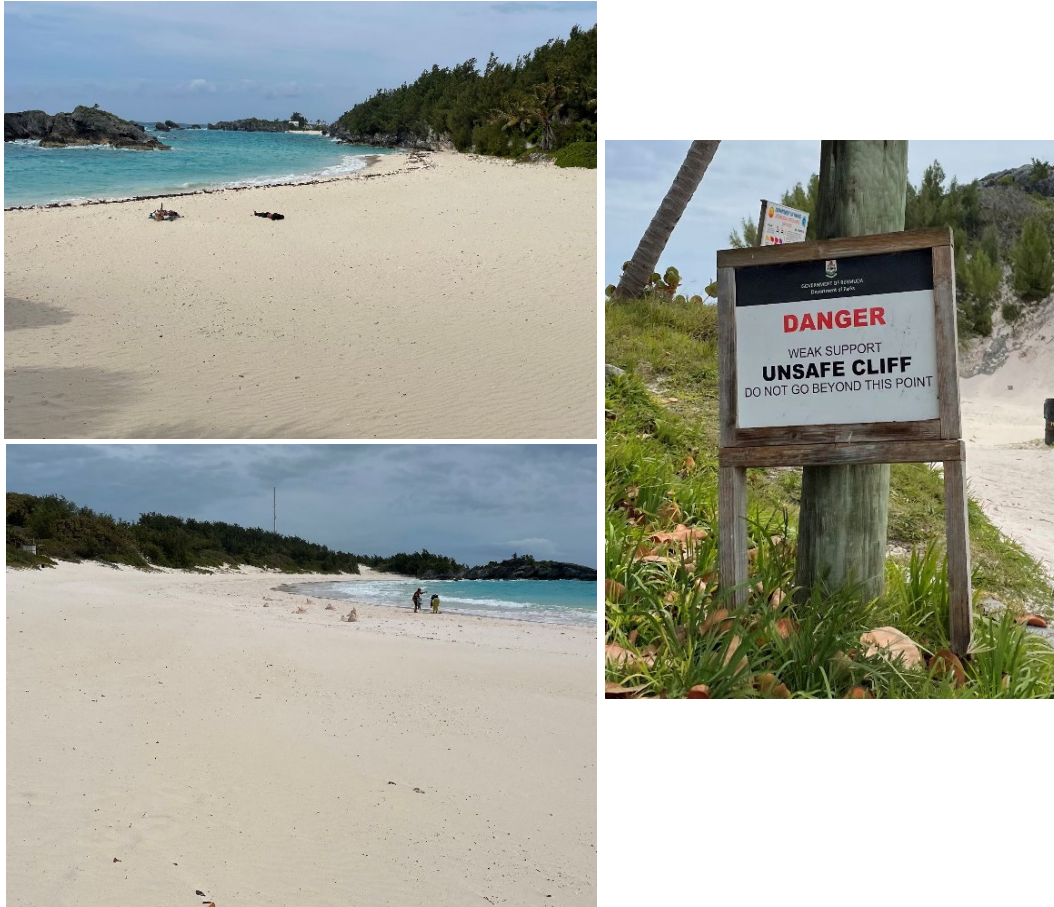
Figure 3.6 Horseshoe Bay

Horseshoe Bay has a wide crenulate shape beach. The beach is divided by a cliff headland that recently experienced cliff failure. The rock/reefs offshore offer significant protection to the sandy beach.

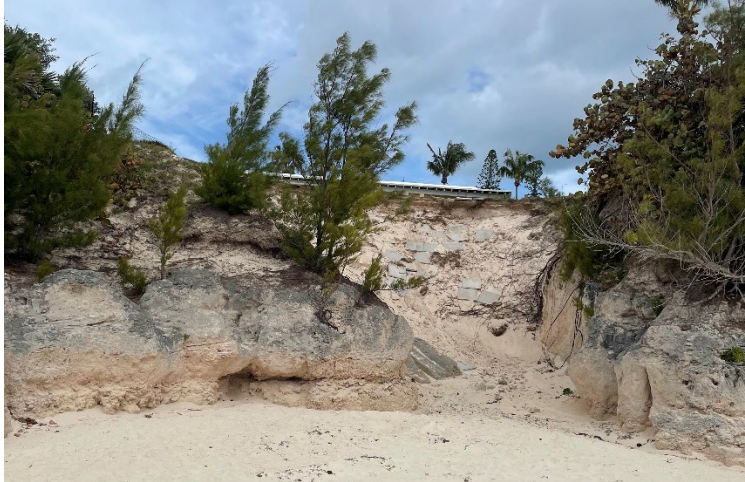
Figure 3.7 Grape Bay Beach

At the Grape Bay Beach, even though there's a wide beach area, the cliffs at the back of the beach show evidence of erosion: a walkway atop of the cliff recently collapsed.

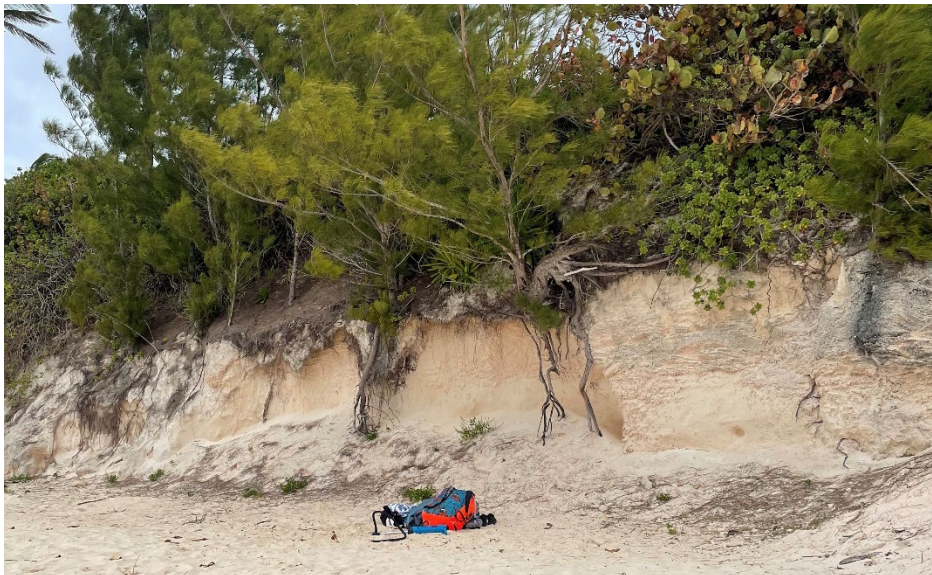
Figure 3.8 Elbow Beach

Similarly, at Elbow Beach there's evidently of cliff erosion.

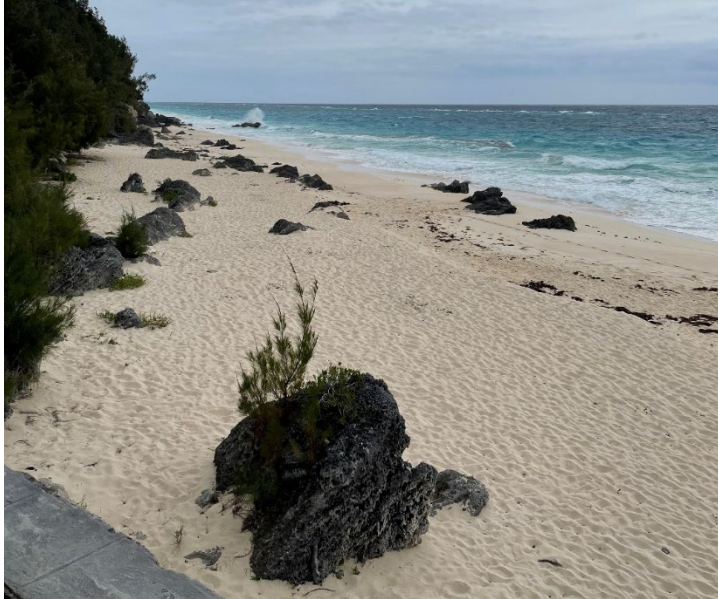
Figure 3.9 Southlands Beach

The Southlands beach is a small pocket beach. This beach has a significant number of rock outcrops, many of which have invasive Casuarina trees growing out of them. The casuarina trees out-compete or inhibit native vegetation and the roots embed themselves into the rocks, both of which ultimately lead to erosion of beaches and unstable rock formations.

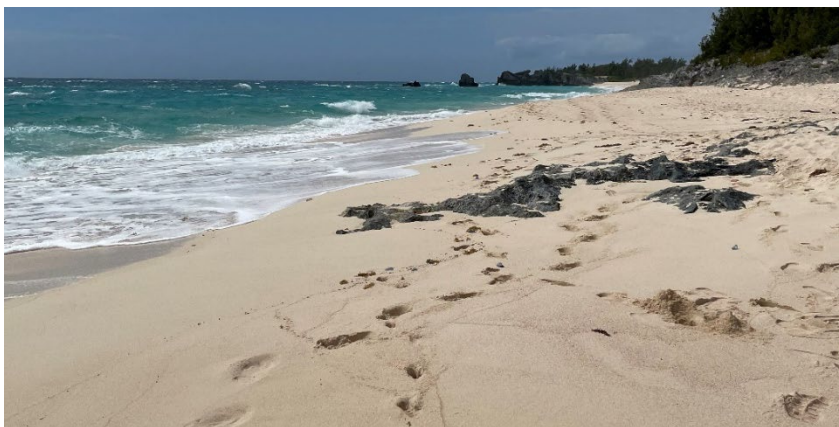
Figure 3.10 Warwick Long Bay

At the time of the visit, wave conditions at this beach were aggressive and significant wave run-up was observed. There is a high cliff at the back of the beach, with less erosion than other beaches visited.

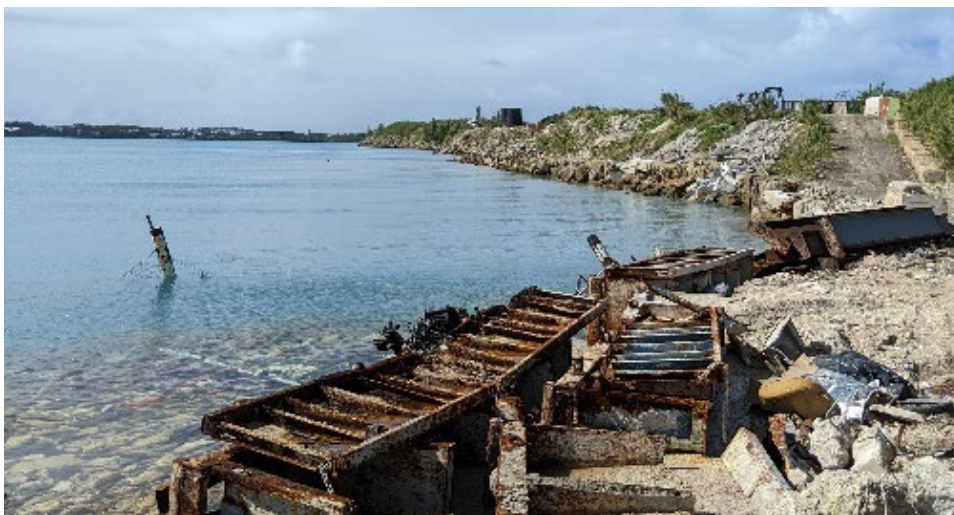
Figure 3.12 Landfill site

The Airport Waste Management Facility is licenced (under the Clean Air Act 1991) to receive ‘inert’ materials but including construction debris, drained road vehicles, tyres, white goods, non-recyclable e-waste, PVC and incinerator ash-concrete - as 1m<sup>3</sup> blocks or as capping pours. Wood waste, other organic waste and hazardous waste is prohibited. The site appears to be subject to ad-hoc reclamation, with fill being pushed into the shallow nearshore area.

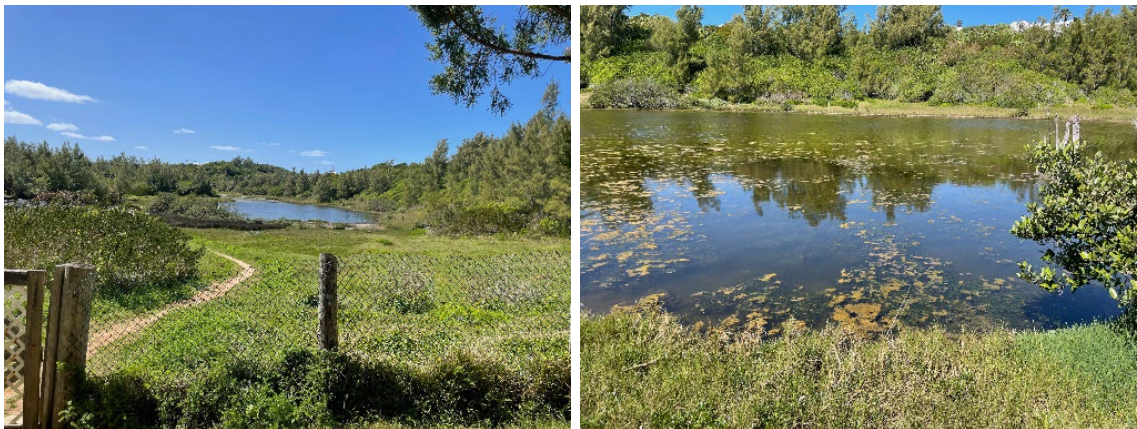
Figure 3.14 Spittal Pond

Rising sea levels will likely cause the pond to connect with the sea eventually. During high water events (e.g., mesoscale eddies) the connection to the sea is already evident. Other impacts of rising waters may result in the roots of Bermuda palm being exposed to seawater.

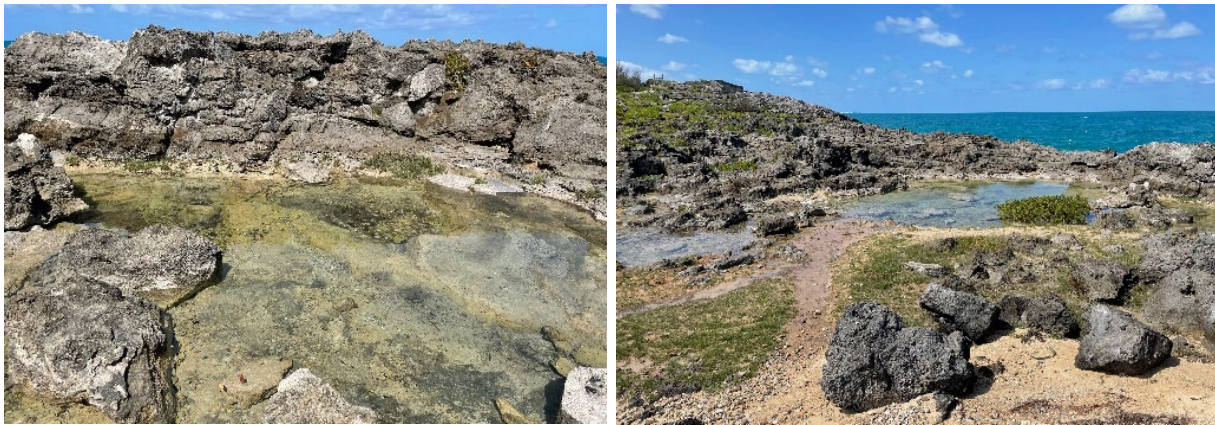
Rising mean sea levels have eroded the soil away from several salt marshes, leaving very few thriving salt marshes. The white line along the rocks in the images below (Figure 3.17) delineates areas that were recently filled with soil and supported vegetation, including the locally rare native plant Sea Lavender (*Limonium carolinianum*). Increased wave action and high water levels swept away the soil and vegetation. Coastal erosion and storm damage are the biggest threats to salt marsh habitats, and are likely to worsen due to climate change and the associated increase in sea level and hurricane activity. Coastal development has also been a threat and, without appropriate intervention, will continue to threaten any remaining pockets of salt marsh. The largest salt marsh in Bermuda is at the eastern end of Spittal Pond (bottom end of photo in Figure 3.18).

Figure 3.17 Former salt marsh

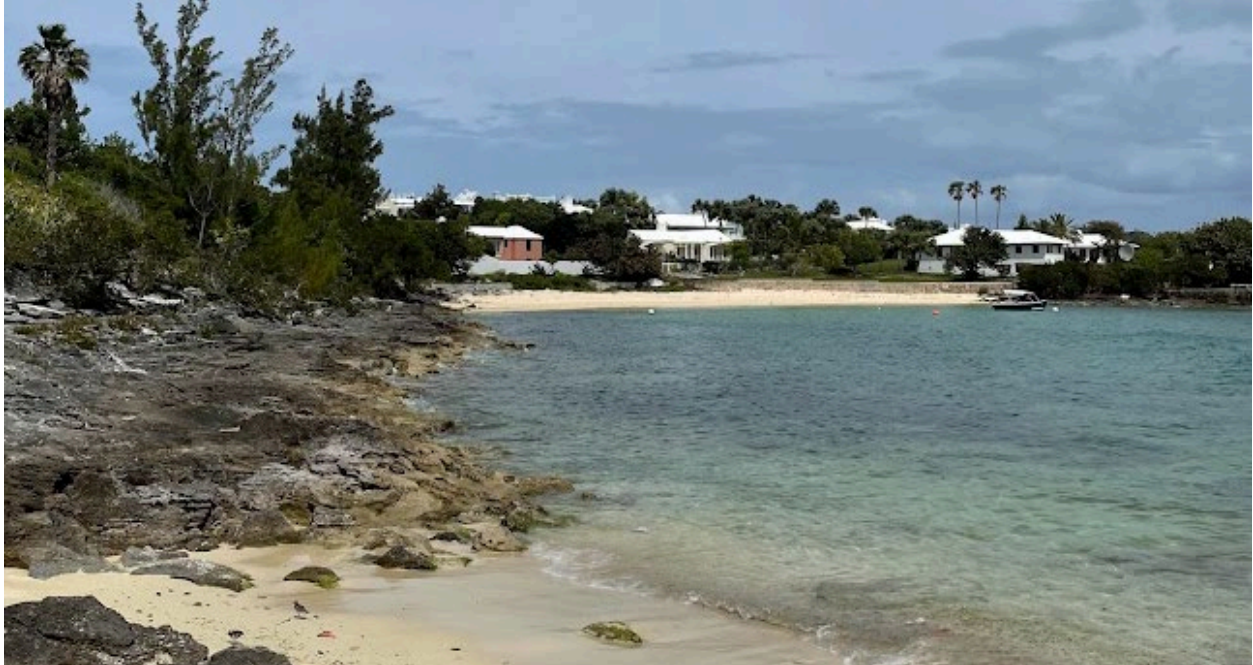
Figure 8.4 Example of low-lying rock shoreline in Devonshire

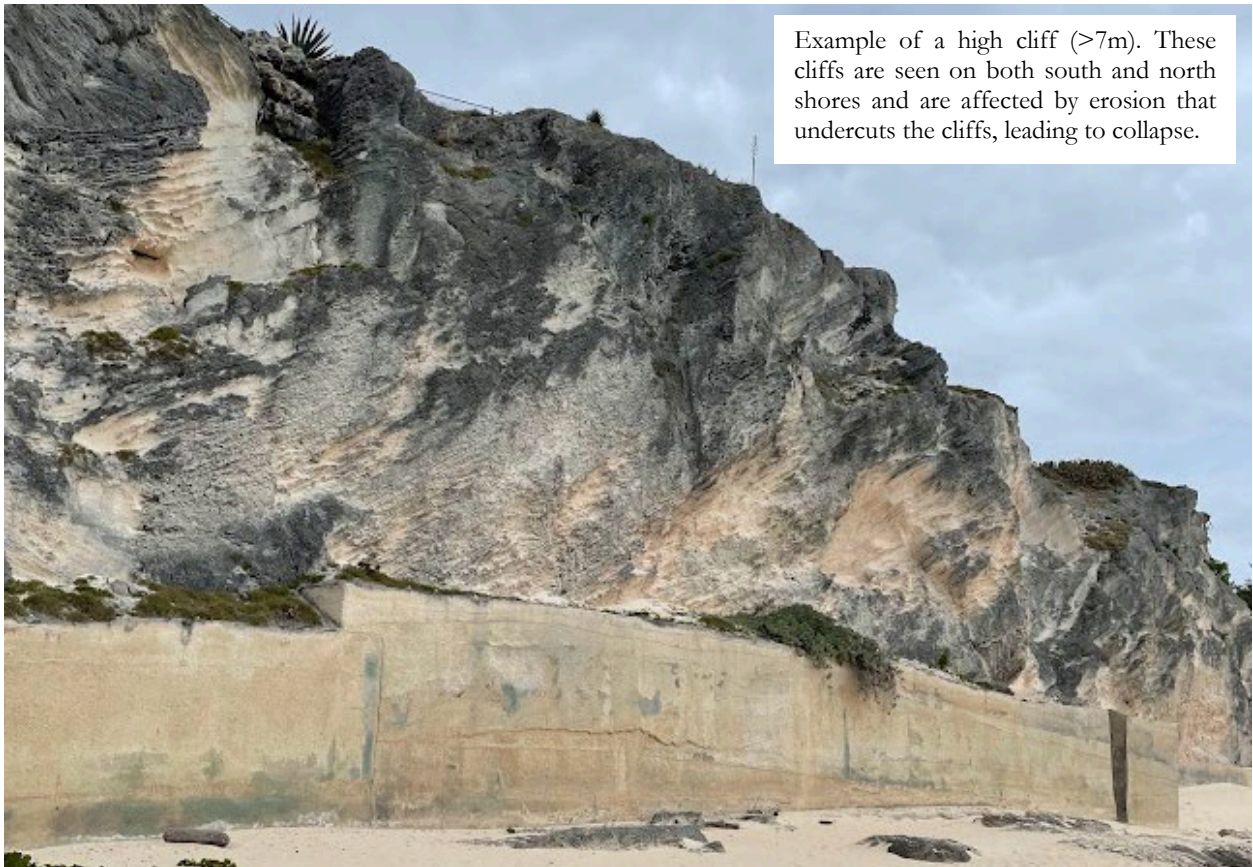
Figure 8.5 Example of high cliff in Southlands, Bermuda

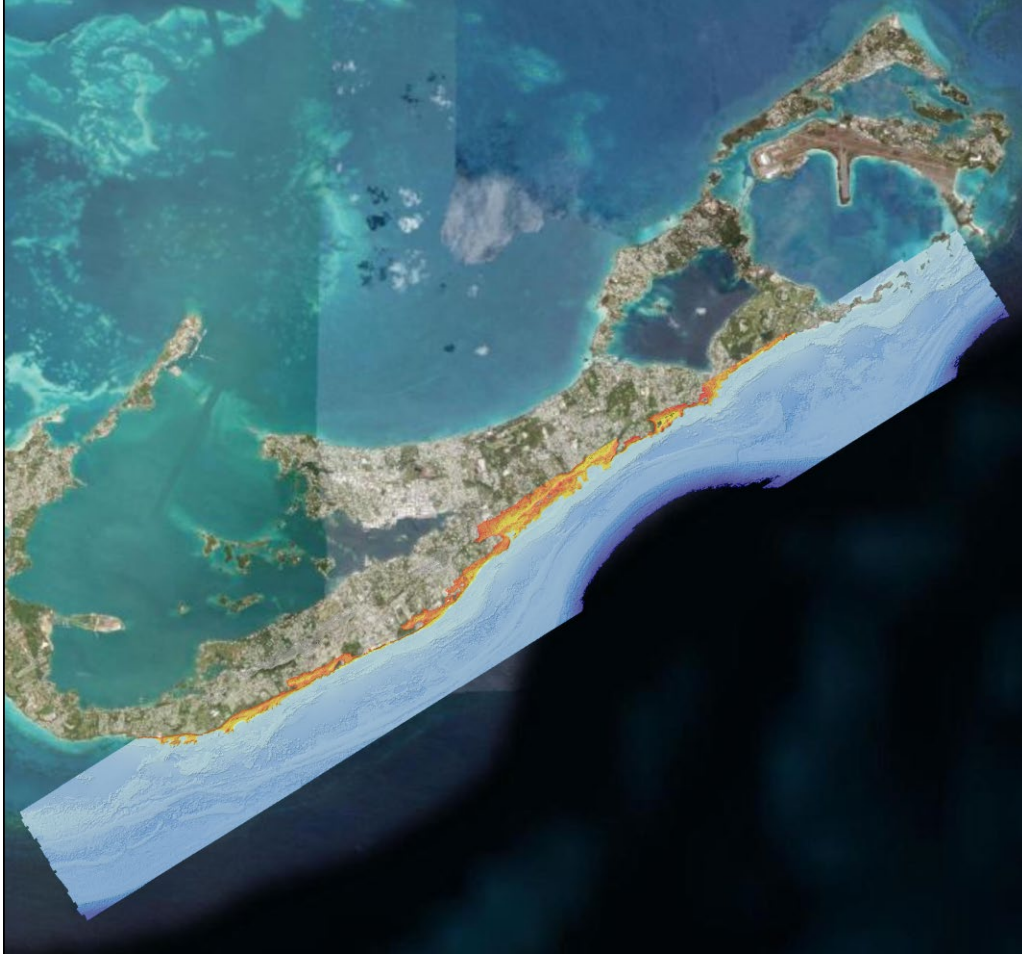
Airborne LiDAR surveys conducted in 2004 and 2019 provide an opportunity to quantitatively analyze coastal change, including cliff retreat, over this period. The 2004 LiDAR dataset is relatively sparse, with a density of about 0.06 points/m<sup>2</sup> (1 point per 17m<sup>2</sup>) and spans about 24km along the southern side of Bermuda and about 2.7km in the cross-shore direction. The dataset includes the offshore bathymetry to depths of about 60m (Figure 9.1). The point density is suitable to generate a 4m resolution elevation model and could be compared to the 2019 LiDAR data (Figure 9.2) to detect large scale cliff failure and retreat on the south site of Bermuda.

Figure 9.1 2004 lidar coverage of Bermuda; orange and reds are land area data coverage (i.e. the points above sea level) and light blues are bathymetric data coverage

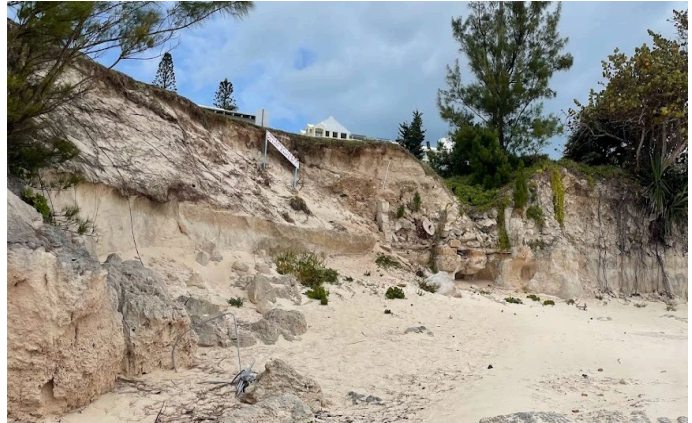
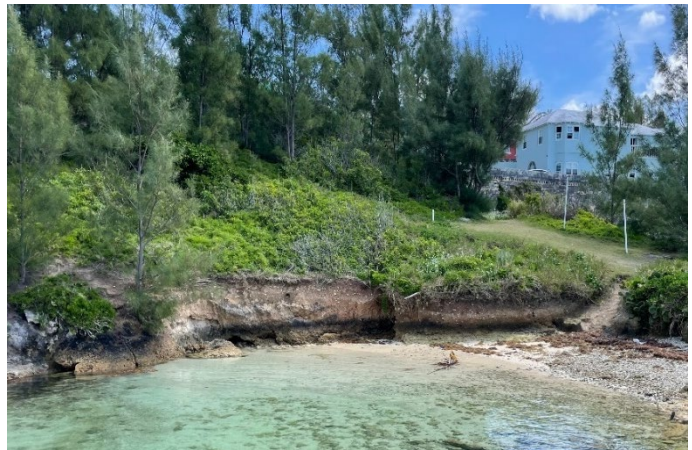
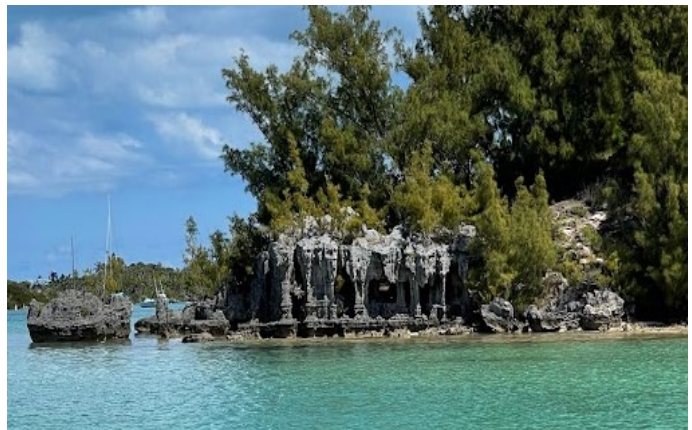
Figure 9.3 Three main types of weathering processes

**Physical Erosion** – This refers to the gradually movement of soil/sediments due to applied forces from waves (mainly), wind and gravitational forces, etc. that affect the shoreline. For example, as waves approach a shoreline there is an amount of energy that causes sediment to move from one point to another. This causes a shoreline to reshape to a new equilibrium based on the incident waves. Additionally, gravitational forces may cause the movement of sediment that leads to land slippages as shown in the photo at right.

**Biological Erosion** - Rocks can be impacted by plants and animals. Roots burrow into the rock's structure, weakening it until it breaks away. Plant roots can find their way into even the tiniest cracks in the rock. The cracks get bigger as the roots grow. Small pieces of rock break away as a result of this. The Casuarina trees located along the cliffs of Bermuda cause significant erosion because of their roots.

**Chemical Erosion** - Rainwater and seawater can be weakly acidic. Over time, a coastline made up of rocks such as limestone or chalk can become dissolved by the acid in the water. This causes the formation of fissures in the rocks, which weakens them thus making it easier for the other processes.

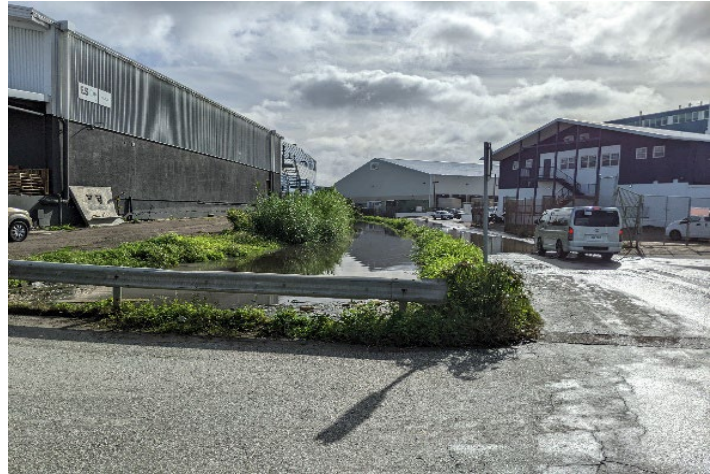
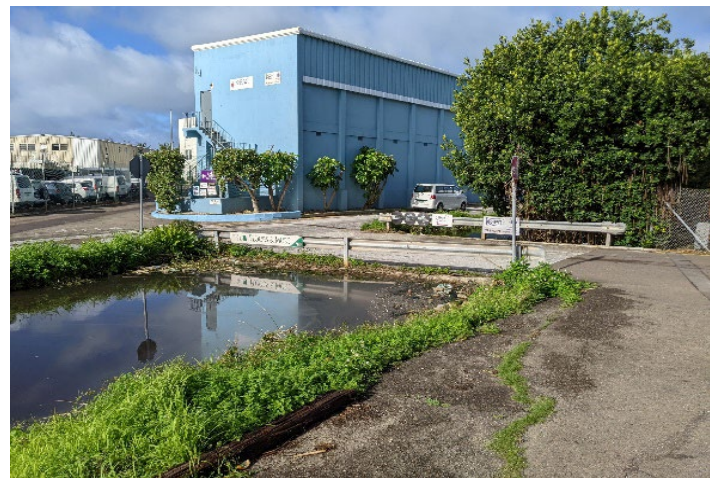
Figure 10.2 Pembroke Canal, Hamilton

- The visit was conducted at 9:30am, approximately 1 hour after high tide. Water level in the canal is at the level of the road, with some pooling of water onto the road in lower elevations.
- Sparse mangroves exist at the downstream side of the canal leading to the bay.

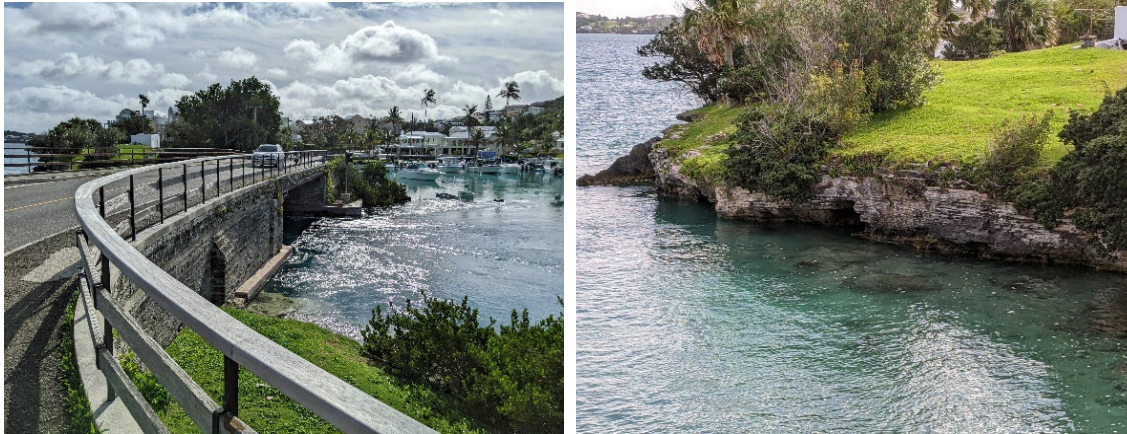
Figure 10.3 Flatts Bridge

The Flatts Bridge connects the North Shore Road to the airport and towns like St Georges. Though there are alternative routes, this is the main route used by drivers. The bridge goes over a noted tidal inlet with an aggressive tidal flow. There is evidence of bioerosion undercutting the banks, especially on the bay side.

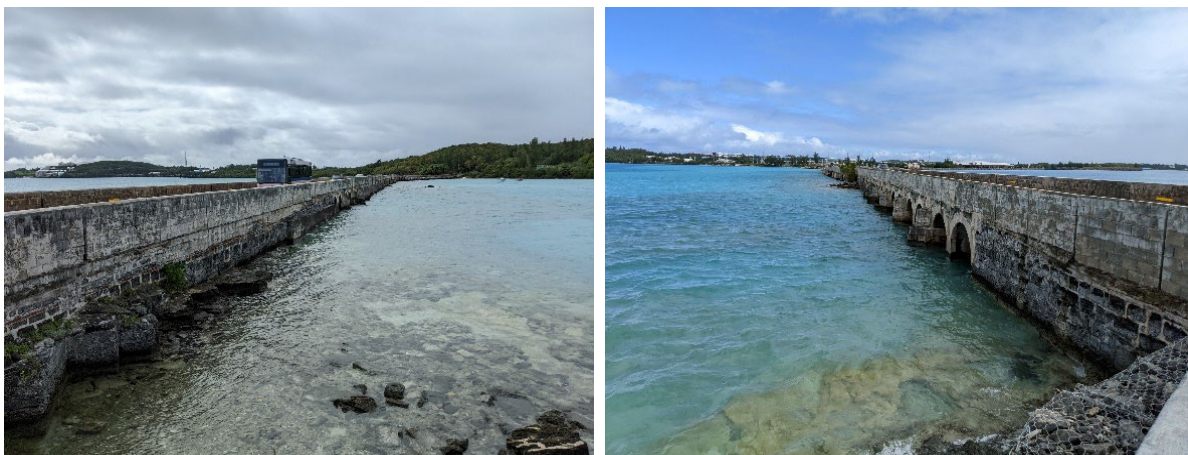
Figure 10.4 Causeway

The causeway connects the mainland of Bermuda to the airport and Banjo Island and is considered vital infrastructure for medical emergencies and air-related evacuations. It is approximately 150 years old and failed in parts during the last major hurricane. During subsequent repairs, a layby was built that included protection using gabion baskets. Due to its low-lying nature and fragile condition, the causeway is closed during severe storm events such as the passage of tropical storms. A proposal to replace the causeway with a pier structure was considered in 2010.

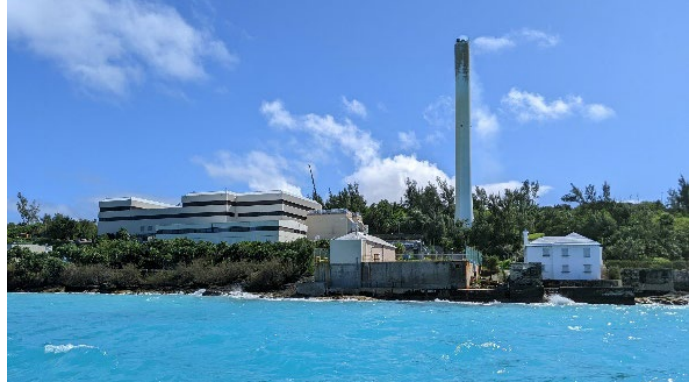
Figure 10.5 Desalination plant at Tyne's Bay

The infrastructure associated with the waste to energy plant and the desalination plant appears to be quite elevated.

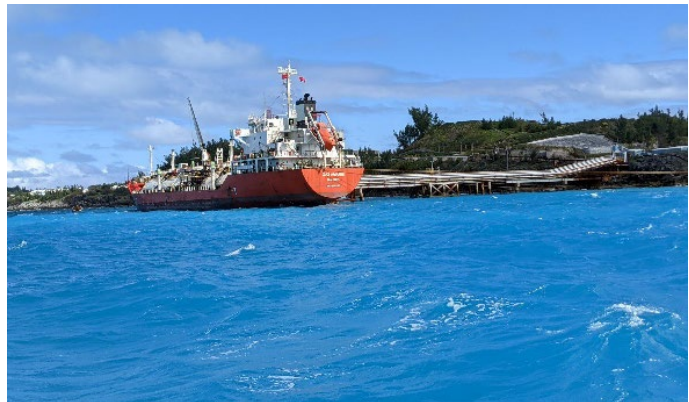
Figure 10.6 Sol Fuel Jetty

The fuel terminal appeared to be in good working condition. The infrastructure at the shoreline showed signs of corrosion from wave action.

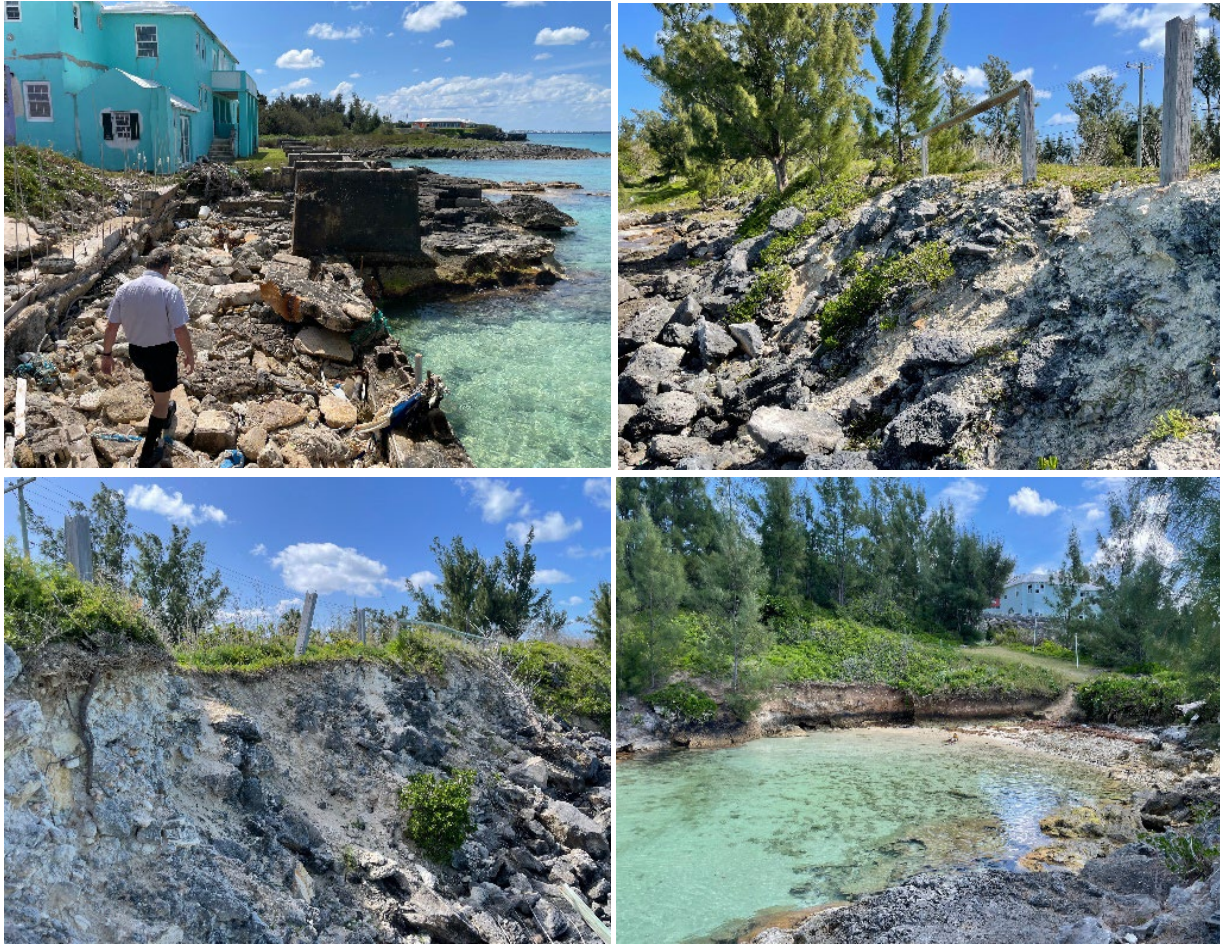
Figure 10.7 Railway Trail

Sections of the railway trail were inspected. Some areas showed signs of erosion, and others are exposed to potential wave damage. It was not clear where the Sol pipeline is located along all segments (awaiting mapping from Sol). At various points the trail is exposed to coastal erosion and wave damage. Periodic inspections by Sol have revealed pipeline corrosion, which leads to shoreline reinforcement and/or pipeline replacement.

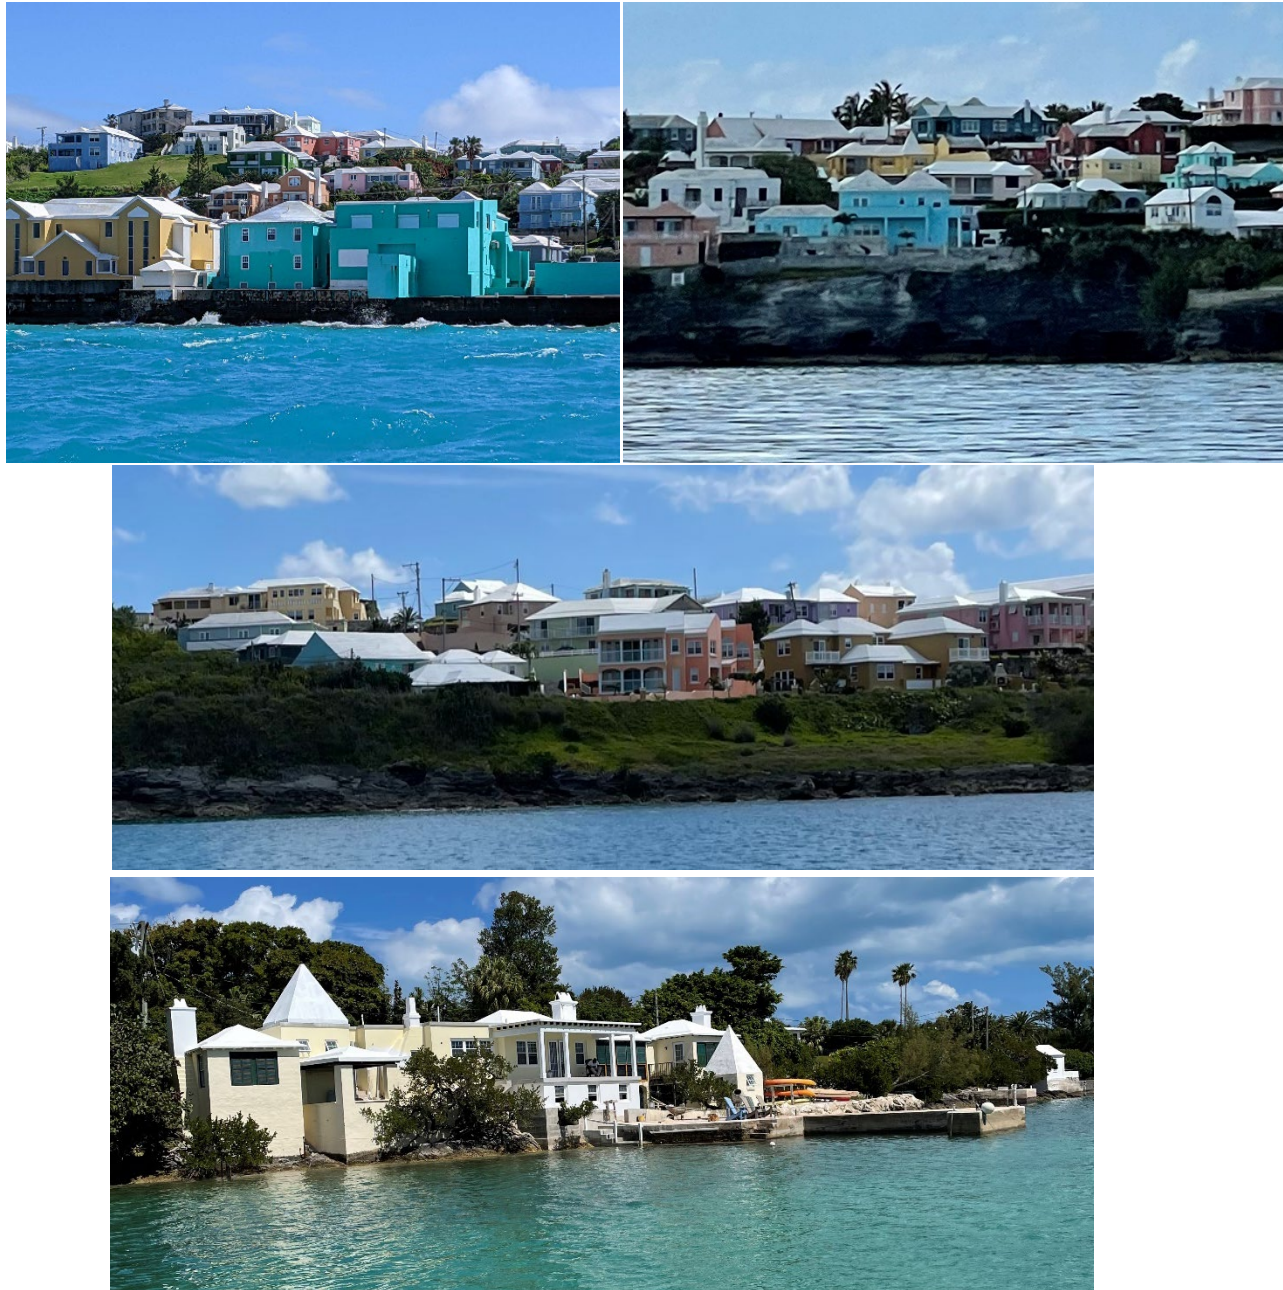
Figure 10.8 Residences along the North Shore

The condition along the North Shore varies. Some areas are on high ground with residences set back from the shoreline, while other areas are low-lying and require protection from the sea with seawalls. Some residences on the North Shore were subject to wave action on their protective seawalls. Other buildings are built directly on the shoreline and fitted with boat docks. However, with a changing wave climate and rising sea levels, the viability of these dwellings will be compromised.

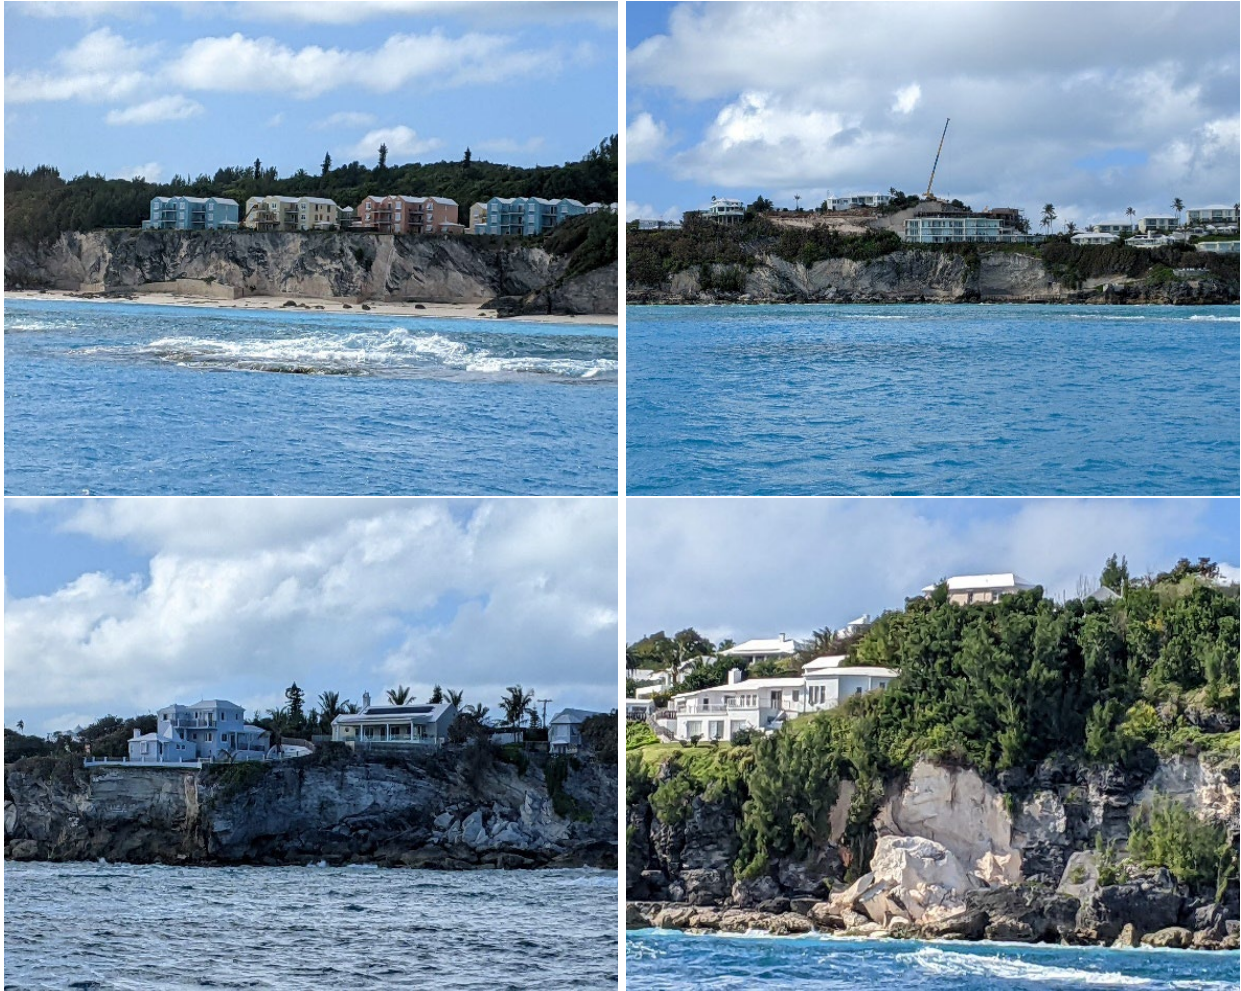
Figure 10.9 South Shore cliff failure

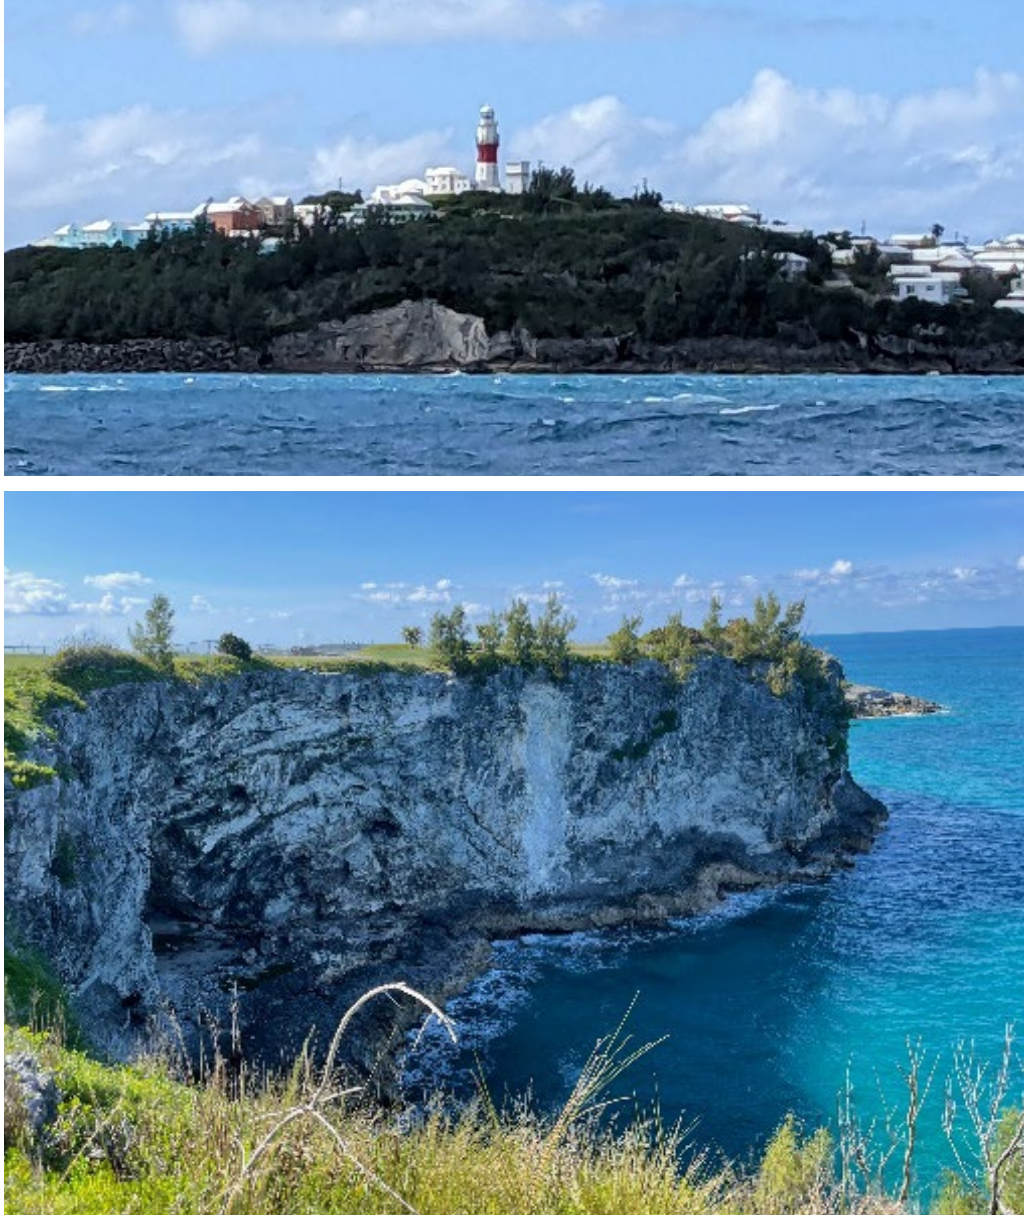
Figure 10.10 Cliff failure

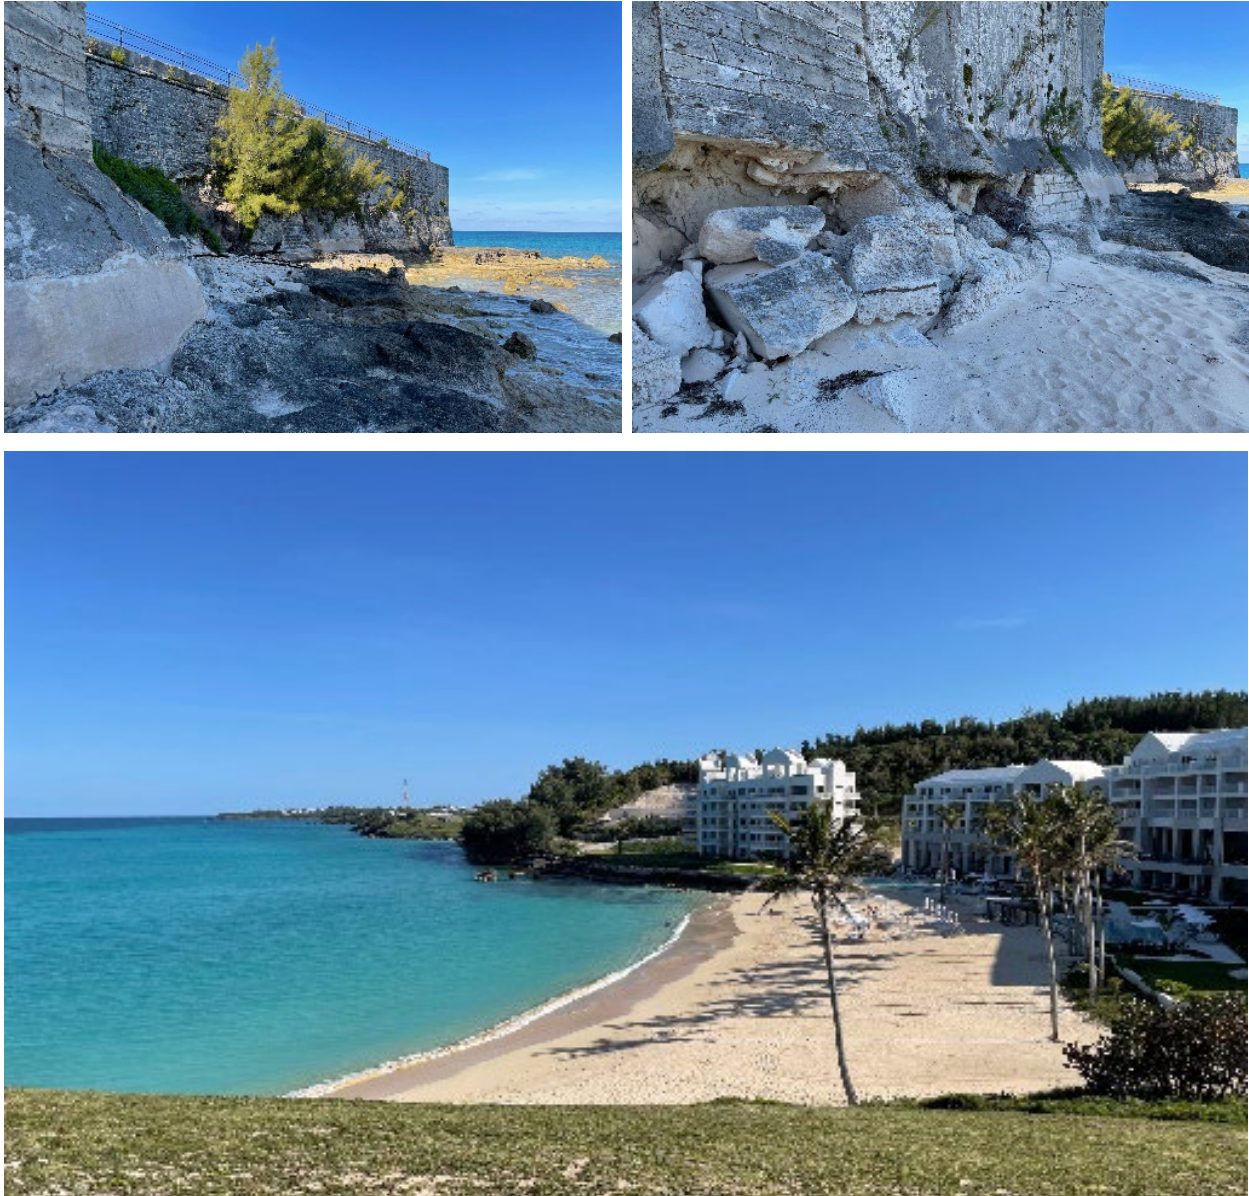
There was some erosion of the cliffs at the historic Fort St Catherine. A recently constructed St. Regis Hotel sits just to the south of these eroded walls at the back of a sandy beach.

Figure 10.11 Fort St Catherine's eroding seawalls (top) and the Residences at The St Regis (bottom)

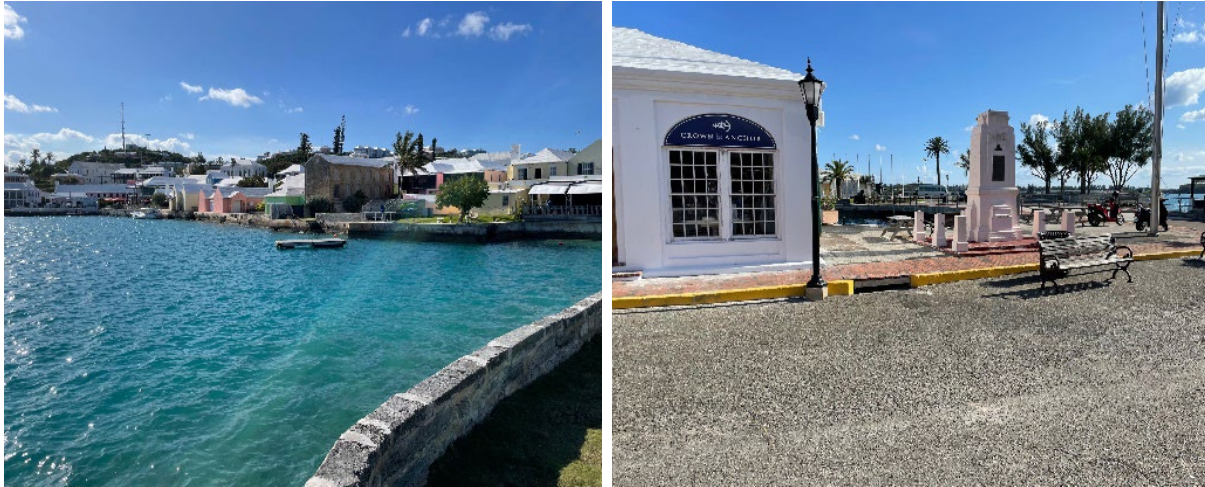
Figure 10.13 Town of St George

The town appears to be low-lying with streets and seawalls that are overtopped and flooded during storms. It is evident that drainage issues exacerbate this problem, again likely due to the low-lying nature of the area.
