# Baseline Conditions Report

## Bermuda and Climate Change: Impacts from Sea Level Rise and Changing Storm Activity

**Smith Warner International Limited**  
Unit 13, Seymour Park, 2 Seymour Avenue  
Kingston 10, JAMAICA

26 September 2022

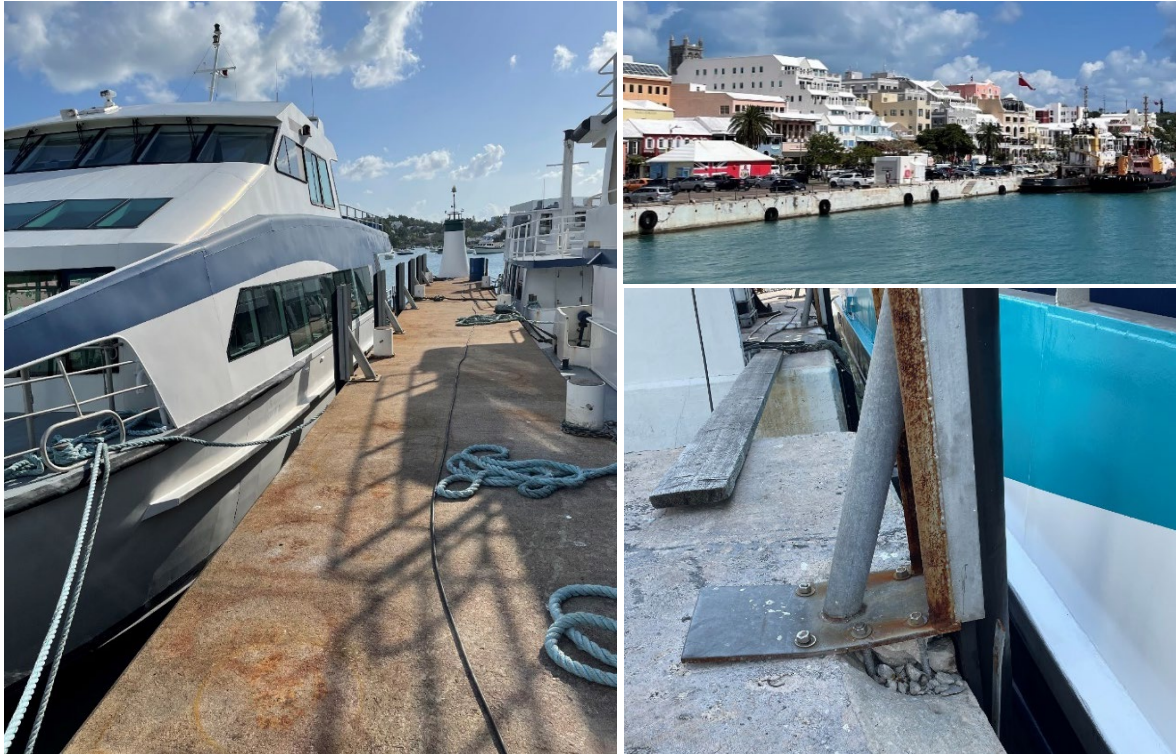
Figure 10.14 Ferry terminal

The Ferry terminal at Front Street appears to be too low for the changes in sea level and the fuel storage facility needs to be relocated. There is no storage for ferries. With more frequent extreme wave conditions expected, the current facility will require more storage.

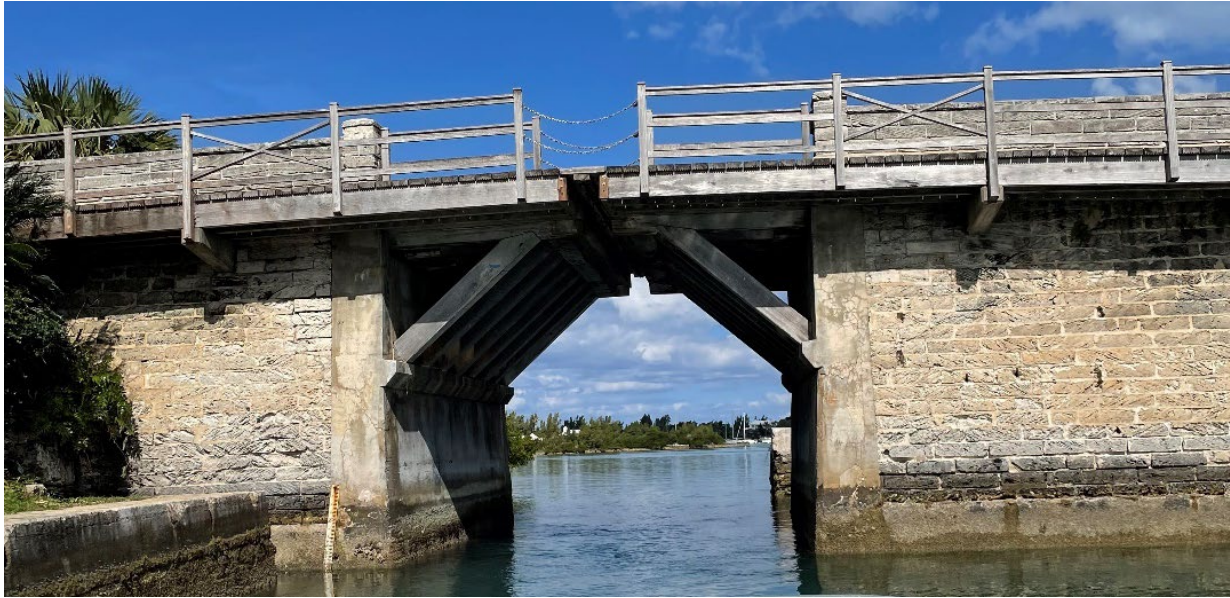
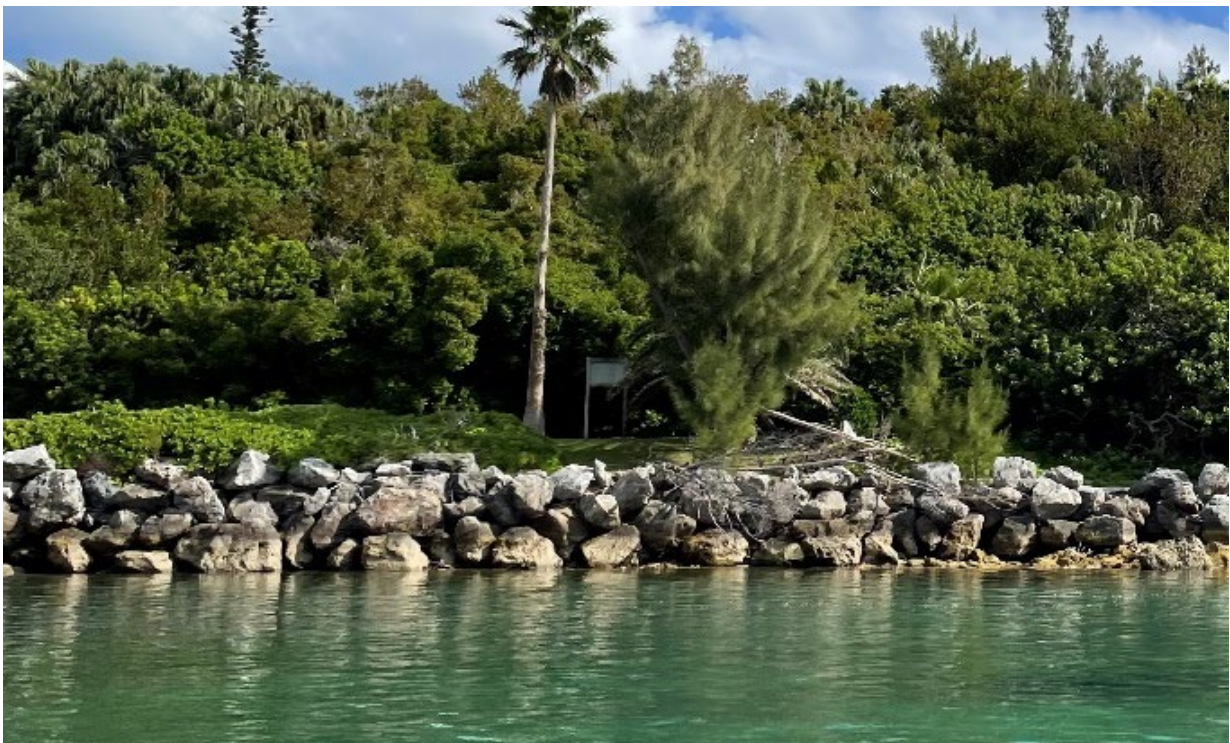
The Somerset bridge is the only connection to Sandys Parish. It is known as the smallest drawbridge on the island. The area is affected by fast currents as the water squeezes through the small area. Rock revetments were used for further protection from currents and boat loads.

Figure 10.15 Somerset bridge (top) and rock revetment adjacent to bridge (bottom)

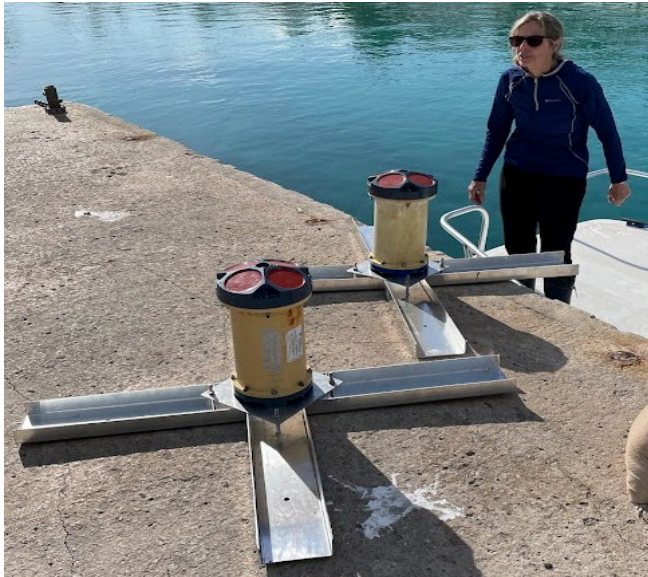
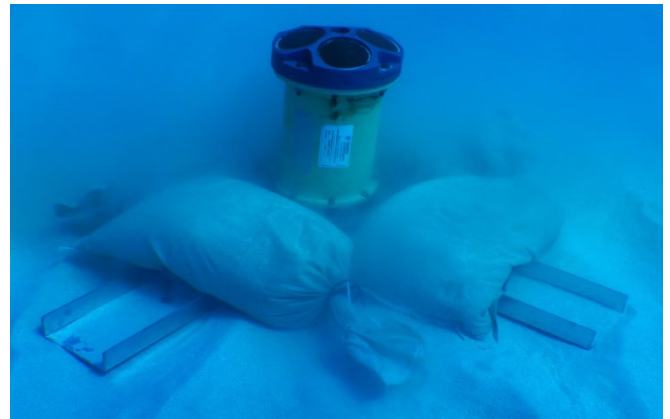
Figure 11.14 Deployed ADCPs

The offshore ADCPs were mounted in aluminium frames (Figure 11.14) and deployed on the seabed in water depths ranging from 14m to 16m. Sandbags were used to keep them anchored. Each ADCP instrument was set to record current speed and direction in nine vertical bins, each 2m thick. Readings were made every 30 minutes, along with the tide level and the water temperature at the seabed. In addition to the current measurements, the ADCP can determine wave characteristics. These readings were made every hour for the duration of the monitoring program. Recorded wave conditions are described later in this section.

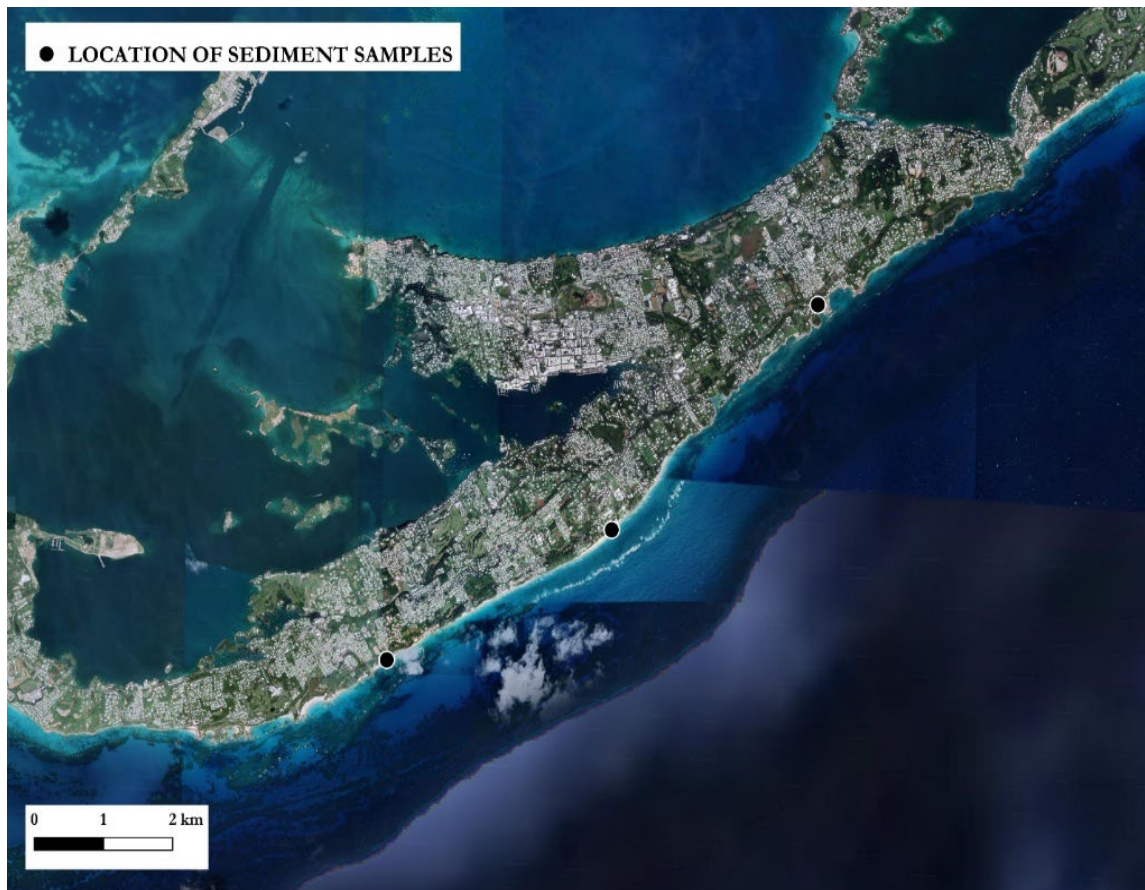
Figure 11.21 Locations of sediment sampling

Understanding the movement of sediment along the shoreline is important in understanding the long-term stability of the various beach areas. This insight will be garnered from historical mapping of the shoreline as well as from grain size analysis. Sediment samples were collected at the locations shown in Figure 11.21 and have been sent for dry sieve analysis. As at the writing of this report results were not yet available.

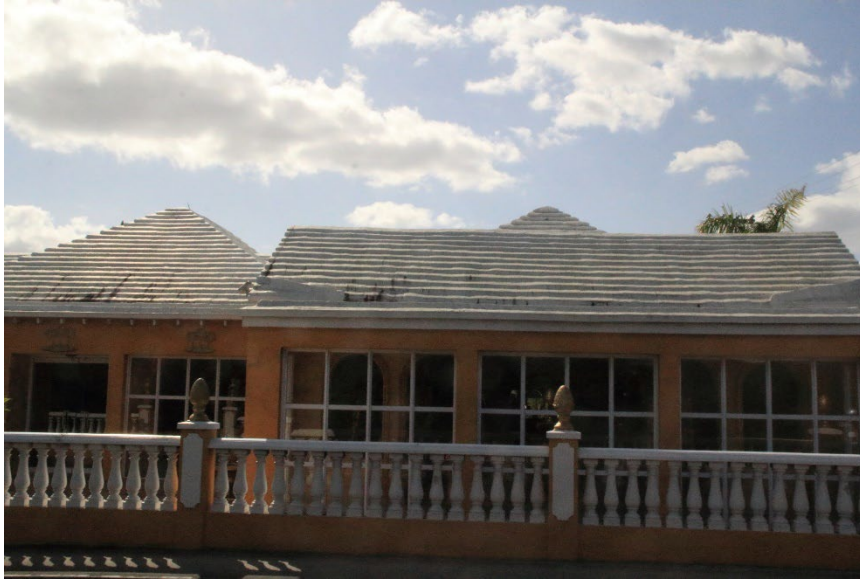
Limestone tile roof top with guides to channel rainwater to storage

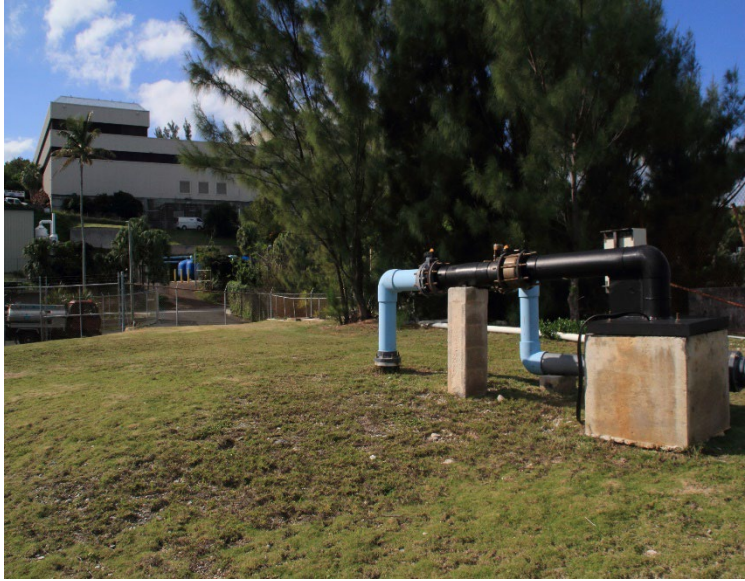
Seawater extraction well at Tynes Bay SWRO plant, SWRO plant and incinerator Plant in background, Incinerator is behind trees

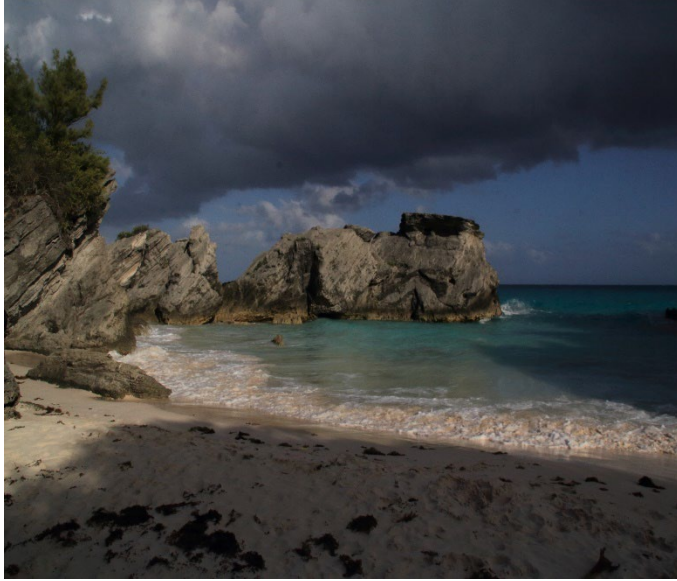
Rocky Bay Formation at Horseshoe Bay

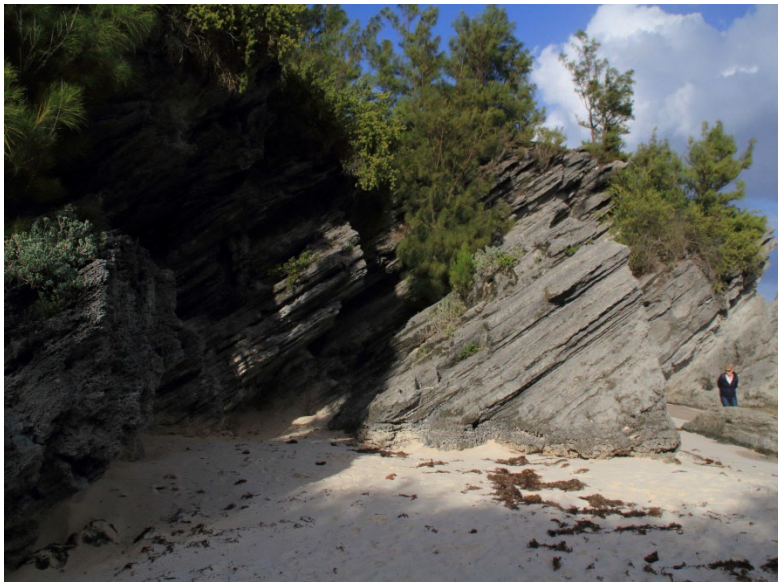
Rocky Bay Formation at Horseshoe Bay

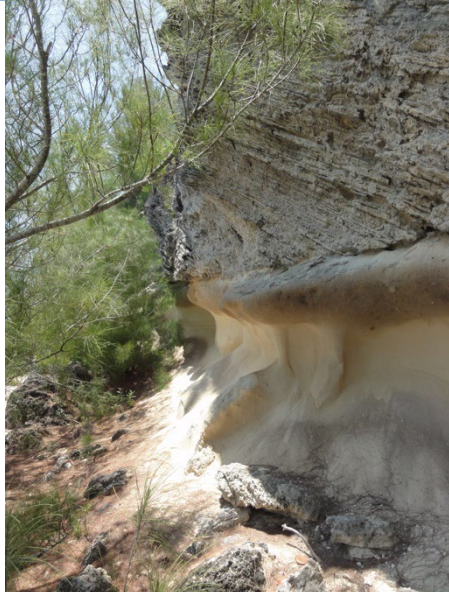
<p><b>Marley Beach</b>  <b>Bermudiana Beach</b>  <b>Surf Side Beach</b>  <b>Azura Bermuda Resort</b></p> <ul style="list-style-type: none"> <li>- 15:05 Accessed Marley beach at a small beach park, walked towards SW first</li> <li>- Observed large cave with freshly exposed limestone and roots hanging from ceiling</li> <li>- Observed a layer of soft material at the back of the beach below the limestone above, probably a paleosol</li> <li>- Collected 7 Schmidt hammer measurements of different types of material at this site (limestone in contact</li> </ul>

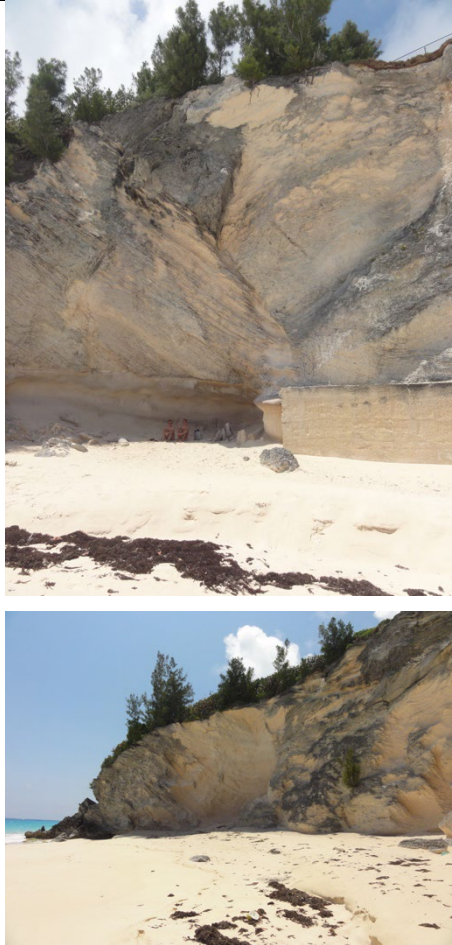
<p>with water, weathered, freshly exposed, paleosol, etc.)</p> <ul style="list-style-type: none"> <li>- Beach scarp observed</li> <li>- Walked NE to site below the Bermudian. Observed a low seawall at the base of the cliff below the development. To the SW of the seawall, a soft paleosol layer was observed similar to that observed at Marley Beach. Collected a Schmidt hammer measurement on this material.</li> <li>- Surveyor Jeffery Roach was conducting a high resolution total station survey of the cliff face and provided his business card.</li> <li>- Observed chunks of gray limestone crust on the sand below the cliff, and fresh cliff erosion south of the seawall.</li> <li>- Collected a Schmidt hammer measurement on shore platform fronting seawall.</li> <li>- Continued NE to Surf Side Beach, collected 3 Schmidt measurements at various locations.</li> <li>- Cliffs at SW side of Surf Side Beach NE of Bermudian are undercut and appear primed to fail.</li> <li>- Continued walking up the beach to the Azura Bermuda Resort. This area also has a low seawall at the base of the cliff possibly where the same soft paleosol layer is located. The upper cliffs also look primed to fail, with large vertical cracks.</li> <li>- Schmidt measurement on freshly exposed limestone at a recent failure did not register.</li> <li>- Collected one Schmidt measurement at the base of the cliff below the high tide line.</li> </ul>

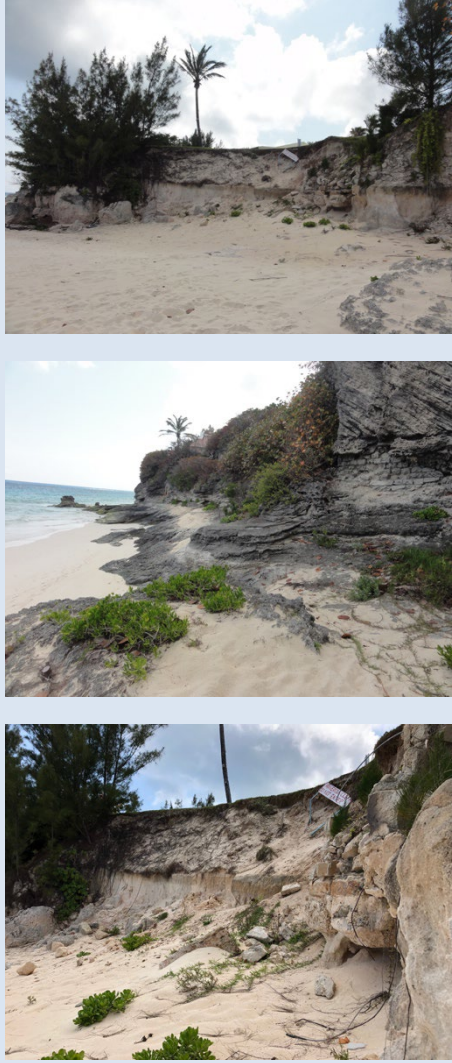
<p><b>Elbow Beach</b>  <b>Coral Beach</b></p> <ul style="list-style-type: none"> <li>- 16:00 Began at the Lido resort and walked SW along the beach</li> <li>- Just NE of a set of former access stairs, now destroyed, Schmidt hammer could not register hardness.</li> <li>- One Schmidt hammer measurement was collected about 2 feet above the sand on a low cliff at the back beach.</li> <li>- Beach is wide and sandy, with few to no limestone cliff blocks. Cliffs at the back of the beach are low and soft, and appear comprised of paleosol material. Schmidt hammer could not register hardness. This appear to be a vulnerable coastal location.</li> <li>- Further SW down the beach, limestone cliff material returns and the beach narrows. Walls are built into the limestone for resorts above. Sand height (water level to back beach) varies by about 10' in this area.</li> <li>- Collected 3 Schmidt measurements on limestone in this area, one of which was on a secondary deposit of calcium carbonate that formed a very hard crust on the limestone material.</li> </ul>

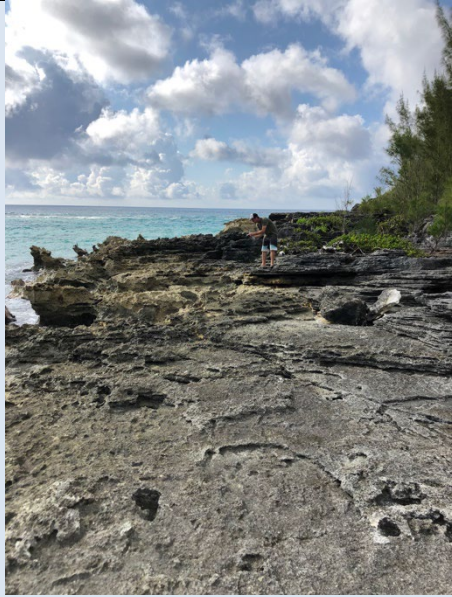
<p><b>Devonshire Bay Park</b></p> <ul style="list-style-type: none"> <li>- 8:55 Limestone here has nearly flat bedding, but slopes a little bit toward the water.</li> <li>- Collected 3 Schmidt hammer measurements</li> <li>- Observed apparent tree trunk (palm?) fossil traces in the limestone here</li> <li>- Erosion mechanisms observed at this site include wave undercutting, bioerosion by marine organisms such as chiton, rainwater dissolution, and casuarina root-wedging</li> <li>- The low lying rocks here suggest the area may be subject to overtopping during storms.</li> <li>- Bedding measurement</li> </ul>
9

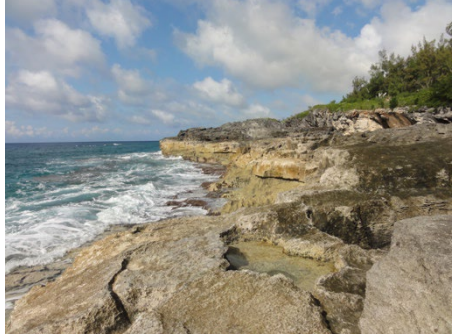
<p><b>Spittal Pond</b></p> <p>9:28 Visited Checkerboard rocks, collected Schmidt measurements on each of the layers of limestone (oldest, Checkerboard; middle, and youngest layer, above paleosol)</p>
10

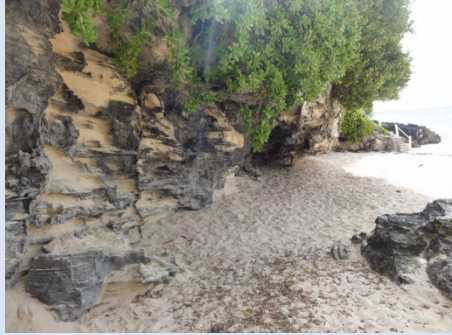
<p><b>John Smith Bay</b></p> <ul style="list-style-type: none"> <li>- 9:56 Low cliffs back this beach, with very weathered rocks on NE side of the bay</li> <li>- Cliffs are very undercut and soft at the back beach</li> <li>- Collected 3 Schmidt measurements on rocks at NE side of bay, and 1 at rocks on SW side of bay</li> <li>- Bedding measurement</li> </ul>

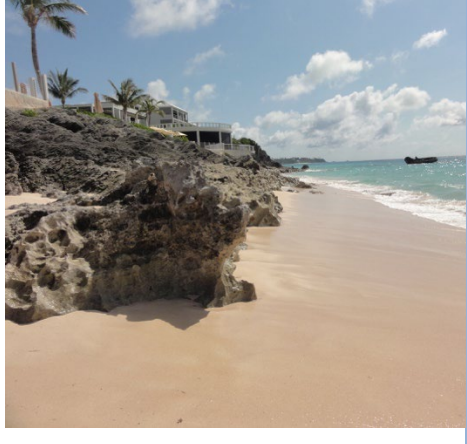
<p><b>Pink Beach West</b></p> <ul style="list-style-type: none"> <li>- 10:16 Cliffs are low and dip away from the water</li> <li>- Collected 1 Schmidt measurement on limestone just above the water</li> <li>- Bedding measurement</li> </ul>
12

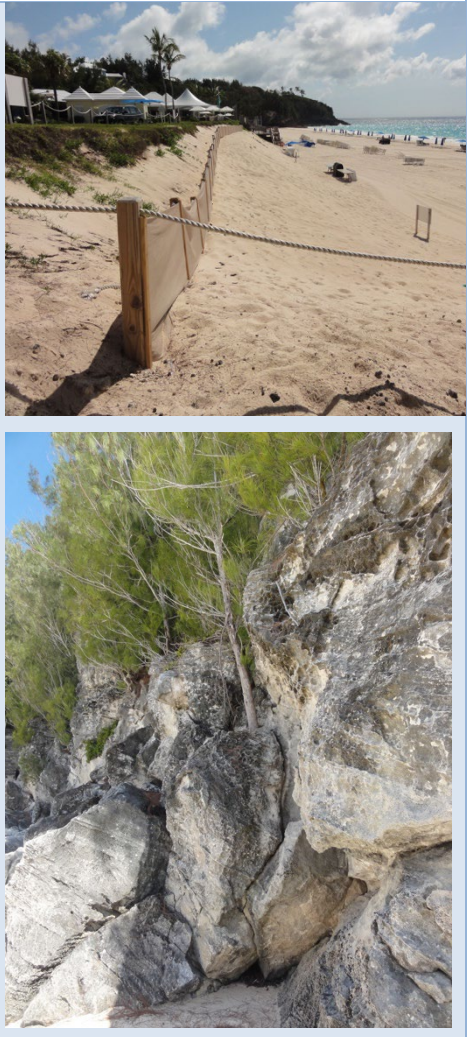
<p><b>Rosewood Beach</b></p> <ul style="list-style-type: none"> <li>- 10:37 Wide sandy beach with high limestone cliffs at each end</li> <li>- Back beach has signs saying “unstable cliff” but appears to be a dune, possibly an artificial dune to protect low cliffs?</li> <li>- Cliffs at NE side of beach are pretty jointed, with caves, and dip toward water, cliffs at SW dip away from water</li> <li>- Root wedging</li> <li>- Collected 3 Schmidt hammer measurements</li> </ul>

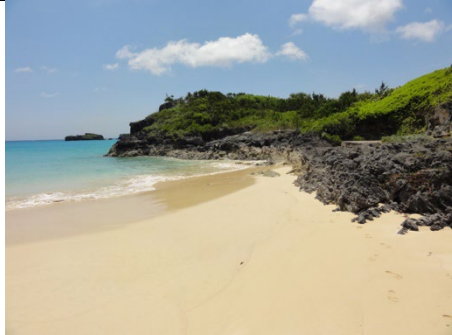
<p><b>Clearwater Beach</b>  <b>Long Bay Beach</b></p> <ul style="list-style-type: none"> <li>- 11:50 Collected 5 Schmidt hammer measurements from limestone material backing beaches around Cooper’s Island</li> <li>- Very little infrastructure here to be threatened by future erosion</li> </ul>
14

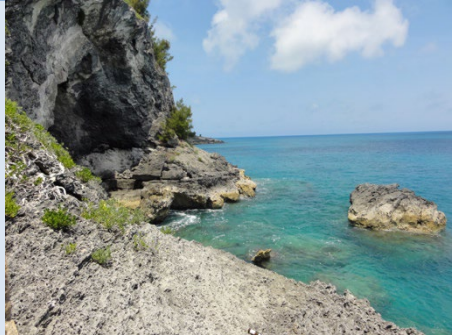
<p><b>St. David’s Head</b></p> <ul style="list-style-type: none"> <li>- 12:52 Huge vertical and very undercut cliffs with caves below the battery</li> <li>- Collected one Schmidt measurement on limestone about 20’ above the water at the base of stairs leading down from the top of the headland</li> </ul>
15

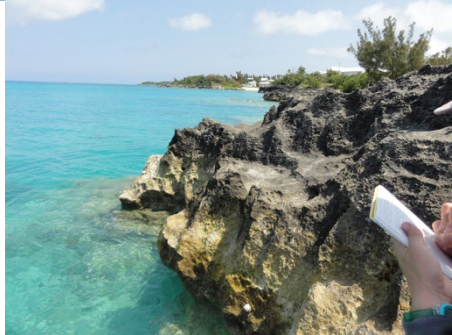
<p><b>Just north of Building Bay Beach</b></p> <ul style="list-style-type: none"> <li>- 15:00 Rock very solid, not fractured, but appears weathered by rain and bioerosion from marine organisms at the water’s edge. Very little layering apparent in rock.</li> <li>- Collected one Schmidt measurement at the top of an undercut, about 3’ above the water.</li> </ul>

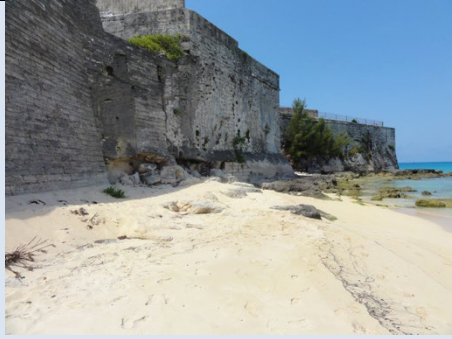
<p><b>St. Catherine’s Beach</b></p> <ul style="list-style-type: none"> <li>- 15:14 Stairs to the beach north of the fort damaged and closed, no access to beach</li> <li>- Observed sea stacks in water and vertical cliffs around this beach, from top of damaged stairs.</li> <li>- Accessed beach on south side of fort near St. Regis. Damage to fort walls apparent along bottom of external walls. Soft paleosol layer visible.</li> </ul>

<ul style="list-style-type: none"> <li>- Beach has shells, coral, and bits of tiny volcanic cobble washed up, contrasting with other beaches visited so far, that did not have material washed up on sand.</li> <li>- Collected one Schmidt hammer measurement on the shore platform, which was quite broken up</li> </ul>
17

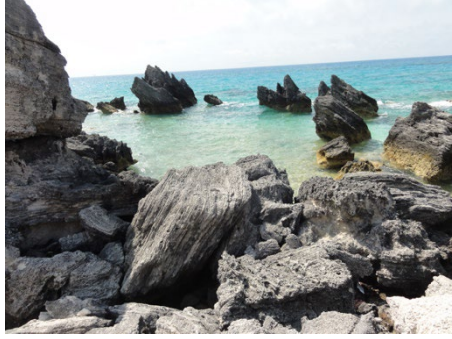
<p><b>Tobacco Bay</b></p> <ul style="list-style-type: none"> <li>- 15:37 Observed quite thick paleosol, limestone very broken up</li> <li>- Collected 3 Schmidt hammer measurements, one about 1 foot above waterline, one about 3 feet above water on gray weathered limestone, and one above 15 feet above water on freshly exposed limestone</li> </ul>
18

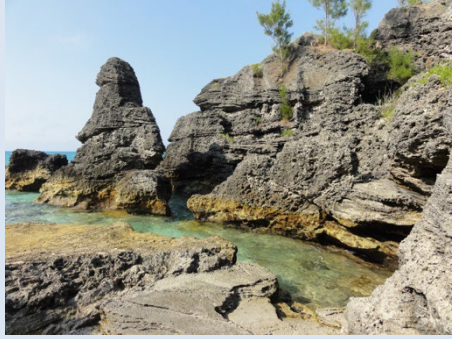
<p><b>Railway Trail near Callen Glen Dr.</b></p> <ul style="list-style-type: none"> <li>- 16:52 Small coves with stairs cut into limestone/poured with concrete to access water</li> <li>- Collected 3 Schmidt hammer measurements from limestone near water and on top of shore platform</li> </ul>

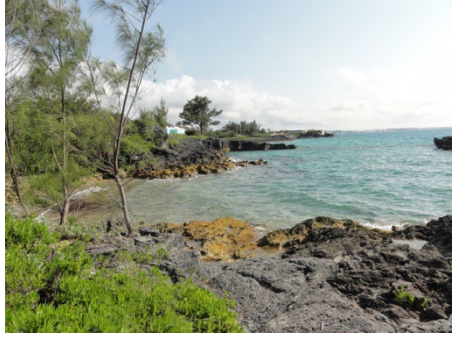
<p><b>Railway Trail near Lynwood Dr.</b></p> <ul style="list-style-type: none"> <li>- 17:00 Low cliffs and wide shore platform in this area</li> <li>- Collected 3 Schmidt measurements, at waterline, about 1.5 feet above, and 5 feet above waterline</li> <li>- Observed water flowing out of apparent underground tunnels – possibly water from Harrington Sound draining to ocean</li> </ul>
<p>Site visit conducted via land 21 May 2022</p>

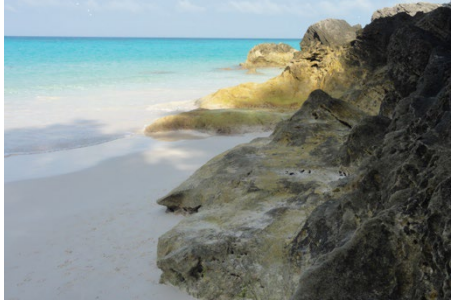
<p><b>West Whale Bay Park</b></p> <ul style="list-style-type: none"> <li>- 8:51 Small pocket beach, limestone bedding dips away from the water</li> <li>- Abundant casuarina at the west side of beach</li> <li>- Collected 2 Schmidt hammer measurements, one on yellow limestone in contact with water and one on gray limestone about 3 feet above water</li> <li>- Bedding measurement</li> </ul>
21

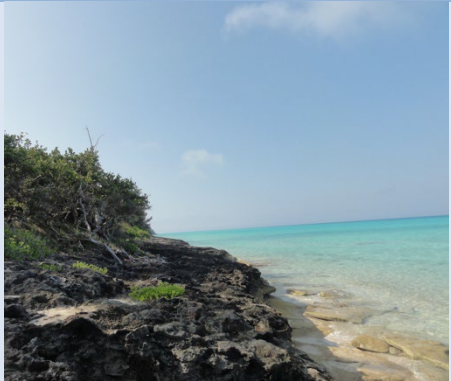
<p><b>Hog Bay Park</b></p> <ul style="list-style-type: none"> <li>- 9:27 Very little/no sand, “beach” is instead comprised of flat slabs of beach rock</li> <li>- Block detachment observed and photographed</li> <li>- Coastline setting appears relatively uniform for some distance along the coast in this area – beach rock and no sand at the coast, sand is offshore underwater instead</li> <li>- Collected 2 Schmidt measurements, one on clean beach rock and one on gray weathered limestone not in contact with water</li> <li>- Bedding measurement</li> </ul>

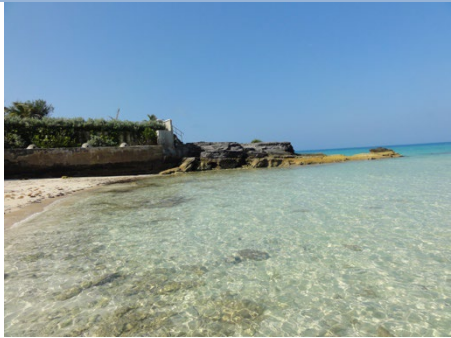
<p><b>Pocket Beach at 8 West Side Rd</b></p> <ul style="list-style-type: none"> <li>- 9:54 Collected one Schmidt measurement on bioeroded limestone above one foot above water surface</li> <li>- Cliffs low, bedding approx. horizontal</li> <li>- Paleosol exposed at north side of pocket beach, limestone is undercut/arched/full of caves where the paleosol is eroded</li> </ul>

Representative Photos	Observations
		<ul style="list-style-type: none"> <li>- Paleosol is not visible at S side of beach, where entire cliff has been engineered/covered by a seawall</li> </ul>
23

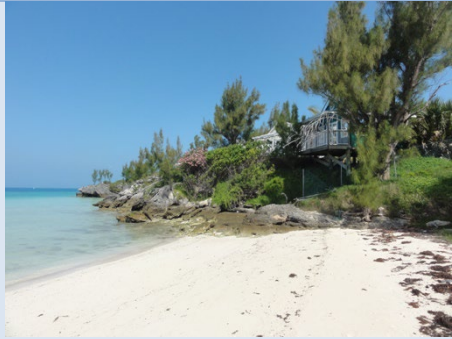
<p><b>Daniels Head</b></p> <ul style="list-style-type: none"> <li>- 10:07 Abandoned resort, beach on N side of headland blocked by a fence.</li> <li>- Accessed beach on S side of headland, collected 1 Schmidt measurement on gray limestone about 1 foot above water.</li> <li>- Water was a bit cloudy; first experience of water that was not perfectly clear</li> <li>- Coral and shells were washed up on beach.</li> </ul>
24

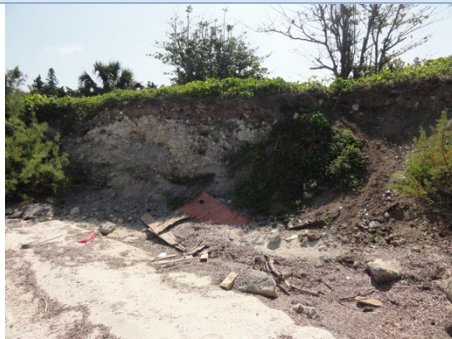
<p><b>Long Bay Beach</b></p> <ul style="list-style-type: none"> <li>- 10:20 Murky water, coarse sand with sargassum washed up, rubbish</li> <li>- Very low cliffs observed at ends of long beach, and chunks of beach rock at the north end of the beach. Collected one Schmidt measurement on yellow limestone with algae.</li> <li>- “Cliffs” behind beach appear to be comprised of old trash</li> <li>- Seawalls occur at the south end of the beach</li> </ul>

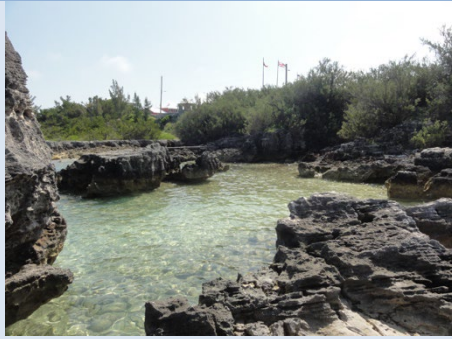
<p><b>Dockyard Beach</b></p> <ul style="list-style-type: none"> <li>- 10:44 Rock is fractured, layered, has some arches and areas with beach rock.</li> <li>- Paleosol layer observed at the back beach; observation of these paleosol layers/pockets suggests that beaches may form where paleosol layers are near sea level</li> <li>- Collected 3 Schmidt measurements including one on weathered portion of</li> </ul>

Representative Photos	Observations
		<p>paleosol; freshly weathered paleosol area did not register with Schmidt hammer</p> <ul style="list-style-type: none"> <li>- Bedding measurement</li> </ul>
26

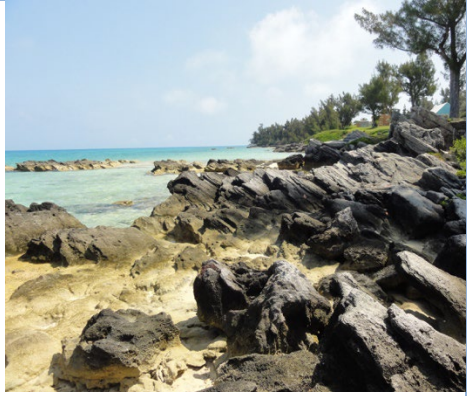
<p><b>Theo's Cove</b></p> <ul style="list-style-type: none"> <li>- 11:09 Low limestone cliffs with several small pocket beaches and a low hill at the back beach</li> <li>- Collected Schmidt hammer measurement on (marine) bioeroded limestone about foot above water.</li> <li>- Bedding measurement</li> </ul>
27

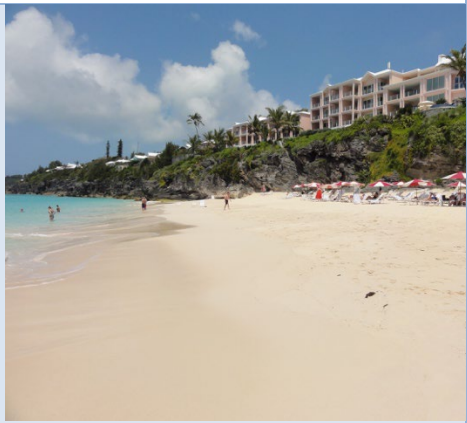
<p><b>Reefs Resort Beach</b></p> <ul style="list-style-type: none"> <li>- 12:05 Collected 1 Schmidt measurement at base of gray limestone ~4 feet above water</li> <li>- Paleosol observed at back beach at lower part of cliff</li> <li>- Bedding measurement</li> </ul>

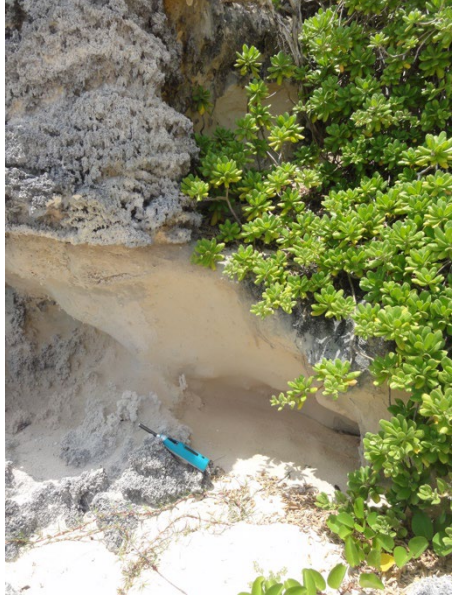
<p><b>Church Bay Beach</b></p> <ul style="list-style-type: none"> <li>- 13:17 Variable bedding, limestone layers change a lot and contain paleosols</li> <li>- Thick paleosol at the back beach</li> <li>- One Schmidt measurement on limestone, one on paleosol at the top of the back beach just above the sand (~10 feet above water level)</li> </ul>
29

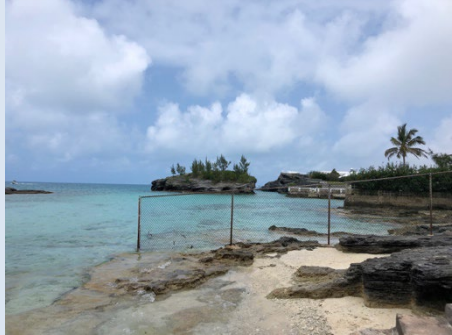
<p><b>Spanish Point Park</b></p> <ul style="list-style-type: none"> <li>- 14:48 Limestone bedded thinly, and approximately horizontal</li> <li>- Very little sand accumulated in embayments</li> <li>- Rocks offshore contain arches and sea caves</li> <li>- Variable rock hardness appears to be causing complex erosion patterns</li> <li>- Collected 2 Schmidt measurements on gray limestone, one about 1 foot above and one about 3 feet above water; additional measurement on yellow limestone at water level was too soft to register.</li> </ul>

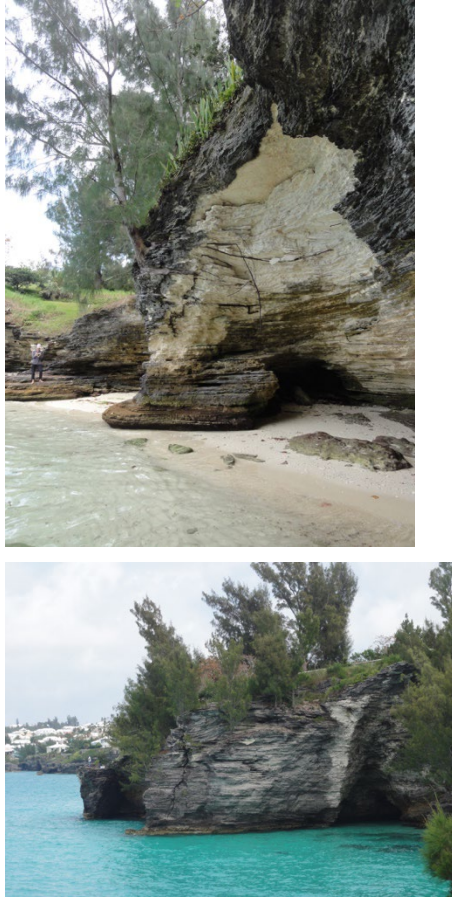
<p><b>Clarence Cove</b>  <b>Admiralty House Park</b></p> <ul style="list-style-type: none"> <li>- 15:30 Big cliffs with caves facing N, pocket beach (Clarence cove) w/seawall along north side of beach behind these large cliffs.</li> <li>- Cliffs inside the cove are undercut and full of caves. Bedding is approximately horizontal and thin, looks like a stack of cards with weathered material between each “card”. Flat beach rock pieces observed underwater in cove.</li> <li>- Evidence of recent cliff failures</li> <li>- Very erodible</li> <li>- Schmidt did not register on many rocks, collected one measurement on freshly exposed limestone about 2 feet above water.</li> <li>- Top of limestone not pitted/sharp here, as in other locations</li> </ul>
31

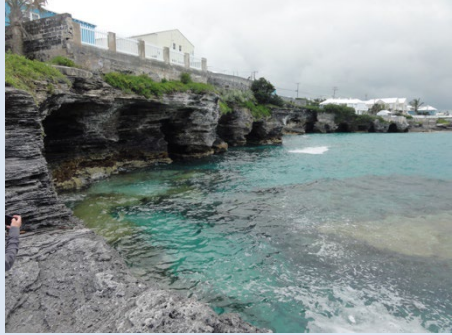
<p><b>Ducking Stool Park</b></p> <ul style="list-style-type: none"> <li>- 15:54 Very large undercut caves beneath park</li> <li>- Bedding ~horizontal, lots of pitting/sharp parts on top surfaces. Lots of holes in limestone exposed to air.</li> <li>- Fresh failures evident</li> <li>- Collected Schmidt measurement on yellow limestone about 1 foot above water</li> </ul>

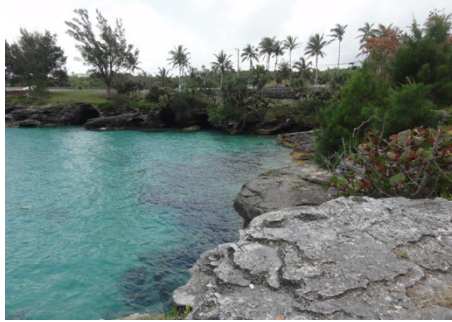
<p><b>Robinson Bay Park</b></p> <ul style="list-style-type: none"> <li>- 16:15 Friable layers of limestone and caves like other locations along this stretch of coast, but cliffs lower overall</li> <li>- Schmidt measurement on limestone about 2 feet above water</li> <li>- Bedding measurement</li> </ul>
33

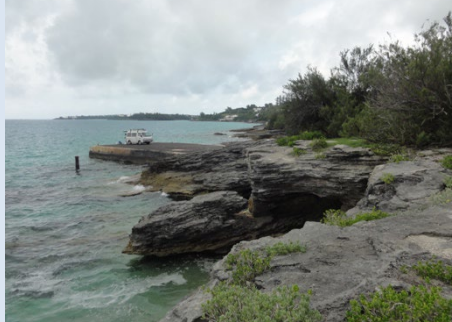
<p><b>Penfurst Park</b></p> <ul style="list-style-type: none"> <li>- 16:29 Schmidt measurement on yellow limestone ~1 foot above water, on spot cleared of algae by marine life</li> <li>- Schmidt hammer did not register on rocks higher up – sounded hollow</li> </ul>
<p><b>Site visit by kayak 22 May 2022</b></p>		
		<p><b>Harrington Sound</b></p> <ul style="list-style-type: none"> <li>-Southern half of Harrington Sound visually inspected</li> <li>-Almost fully enclosed interior water body with a few islands. Strong currents at Flatts Village</li> <li>-Many plunging cliffs with undercutting and some seacaves</li> <li>-No photos taken</li> </ul>

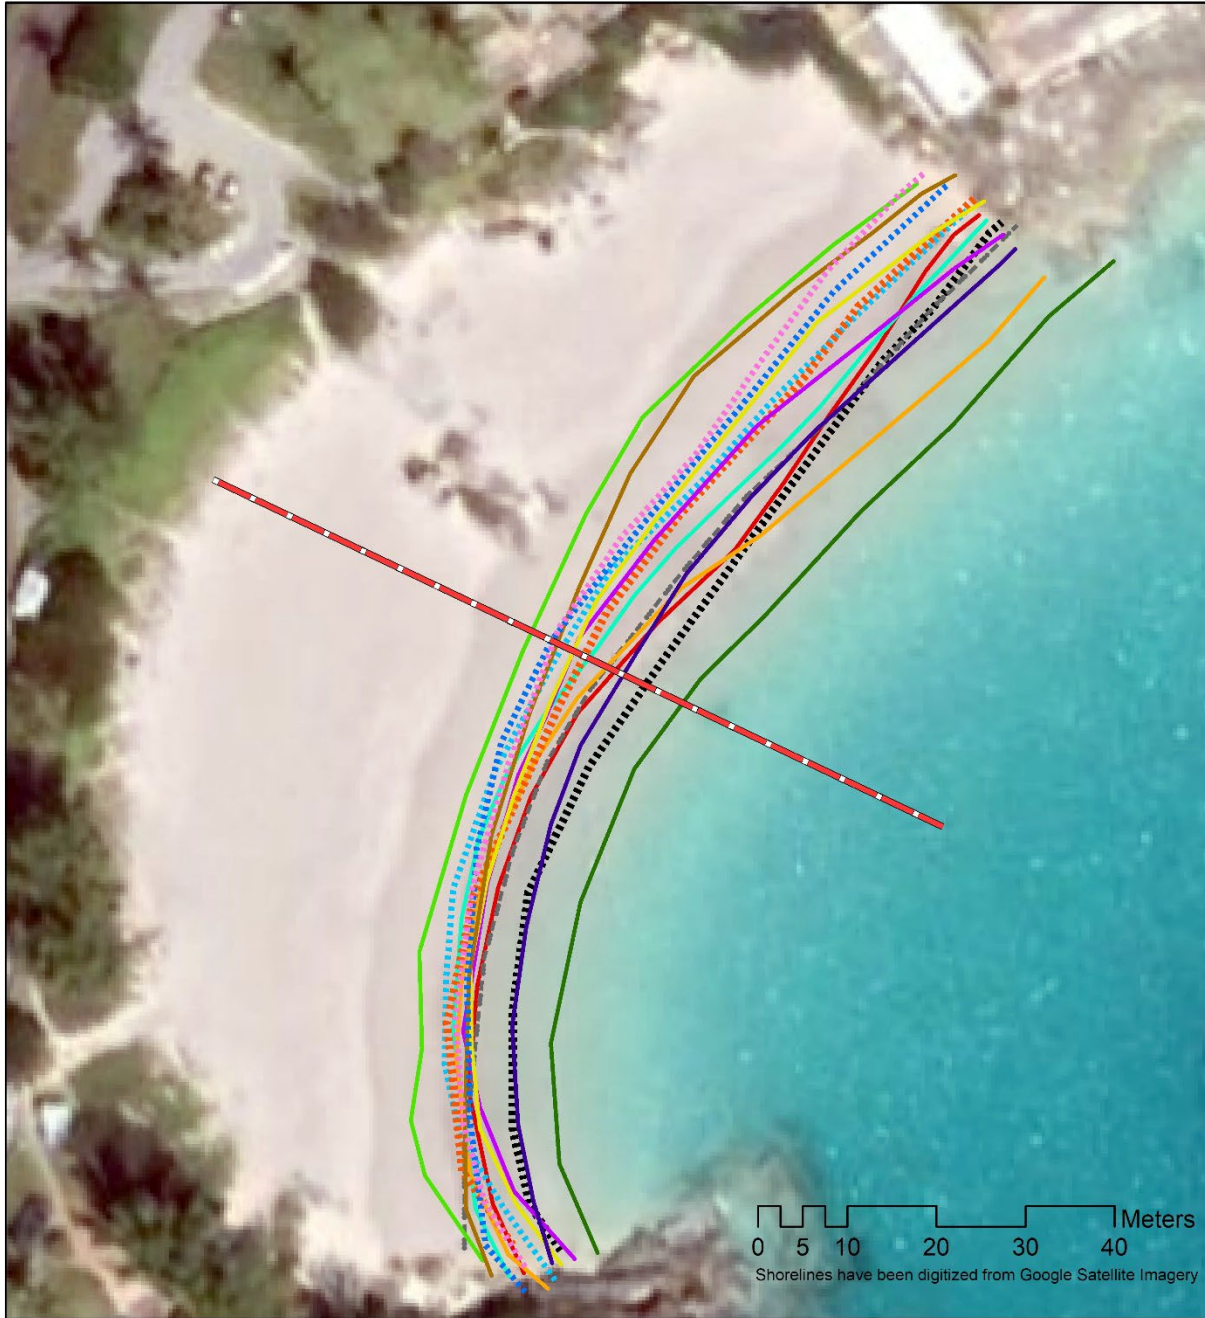
Bermuda - John Smith's Bay Shoreline Change

JOHN SMITH'S BAY	
		<b>PROFILE 1</b>	
<b>Date of Image Capture</b>	<b>Time Change</b>	<b>Distance</b>	<b>Erosion Rate</b>
	<b>(years)</b>	<b>(m)</b>	<b>(m/yr)</b>
9/15/2005		52.308	
11/6/2006	1.141683778	42.507	-8.584688849
5/12/2008	1.514031485	44.048	1.017812387
9/21/2010	2.360027379	42.706	-0.568637471
3/24/2011	0.503764545	45.168	4.887203804
8/20/2012	1.409993155	43.038	-1.510645631
3/15/2013	0.566735113	39.726	-5.844
3/10/2014	0.985626283	44.799	5.14698125
12/30/2015	1.80698152	45.263	0.256781818
8/10/2016	0.613278576	43.529	-2.827426339
8/18/2017	1.021218344	48.896	5.255487265
6/3/2018	0.791238877	46.8	-2.649010381
8/6/2019	1.174537988	49.073	1.935229021
5/3/2020	0.741957563	58.662	12.92391974
4/5/2021	0.922655715	53.868	-5.19587092
3/1/2022	0.90349076	50.032	-4.245754545
<b>Weighted Rate of Erosion/accretion (m)</b>			<b>-0.138297954</b>

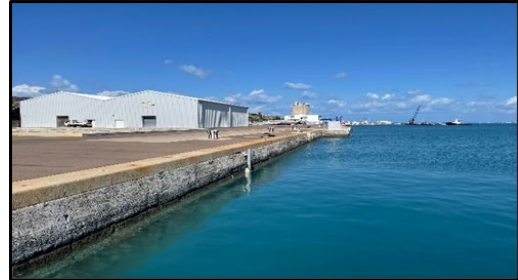
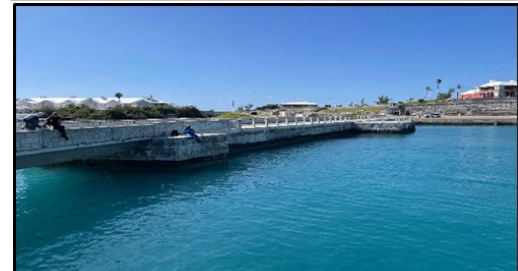
**Location: Dockyard**

Structure Class:	<b>Cruise Pier and Wharf</b>
Material:	<b>Concrete/Steel Sheet Piling/Stone Blocks</b>
Condition:	<b>3 (Fair)</b>
Coordinates (UTM 20):	<b>327255 m (Easting) 3577940 m (Northing)</b>

- Docks on sheet piling, with mooring dolphins
- Small drydock/ramp for hauling Marine and Ports ferries
- Storage areas including warehouses and a cement silo

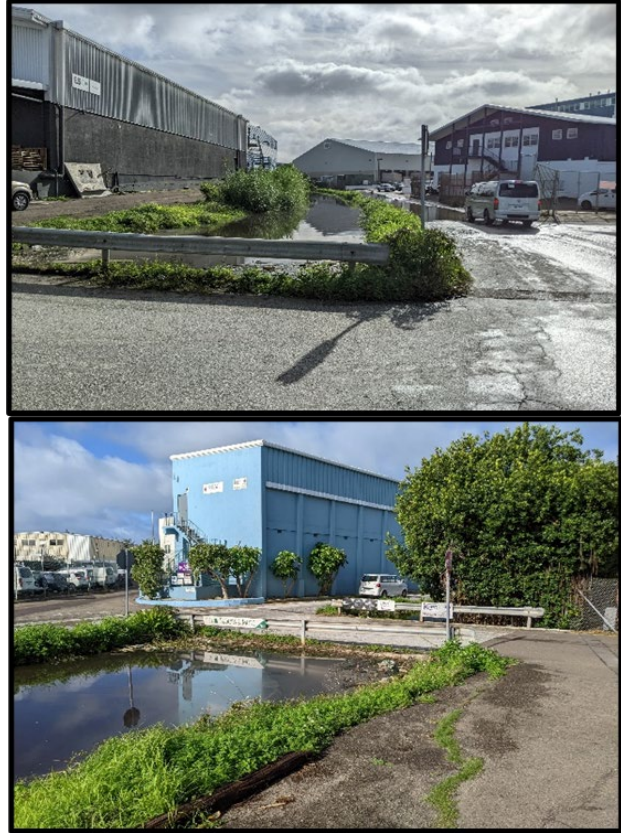
## Location: **Pembroke Canal, Hamilton**

Structure Class:	<b>Drainage Canal</b>
Material:	<b>Reinforced Concrete</b>
Condition:	<b>3 (Fair)</b>
Coordinates (UTM 20):	<b>330521 m (Easting) 3575181 m (Northing)</b>

- Major drainage conduit for a commercial section of Hamilton
- Subject to frequent flooding, with spillover into the adjacent roadways
- Sparse mangrove stand at the outflow end of the drain

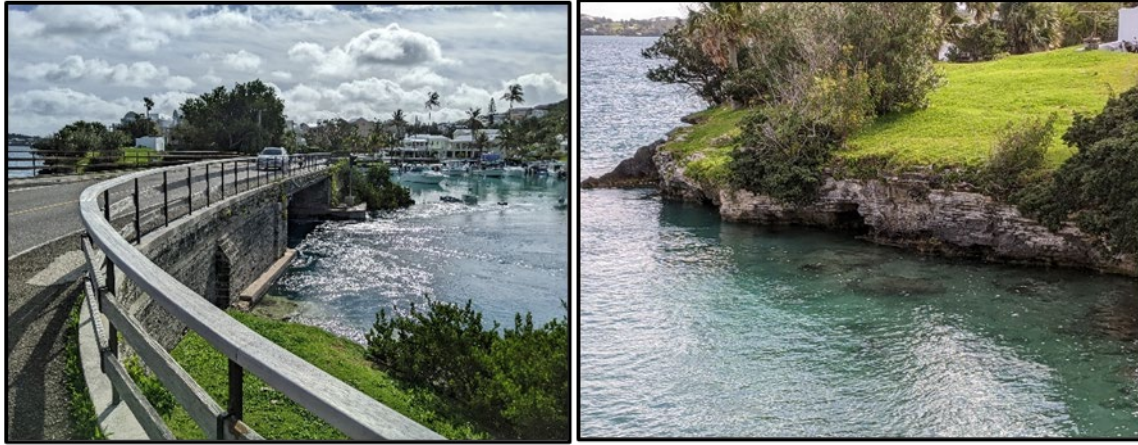
## Location: Flatts Bridge

Structure Class:	<b>Road Bridge</b>
Material:	<b>Reinforced Concrete</b>
Condition:	<b>2 (Good)</b>
Coordinates (UTM 20):	<b>336543 m (Easting) 3577564 m (Northing)</b>

- Connects Norths Shore Road to the airport and to towns such as St Georges
- Main route used frequently by many drivers
- Bridge spans a tidal inlet that exhibits very strong tidal flow velocities
- Evidence of bioerosion undercutting the banks, particularly on the bay side

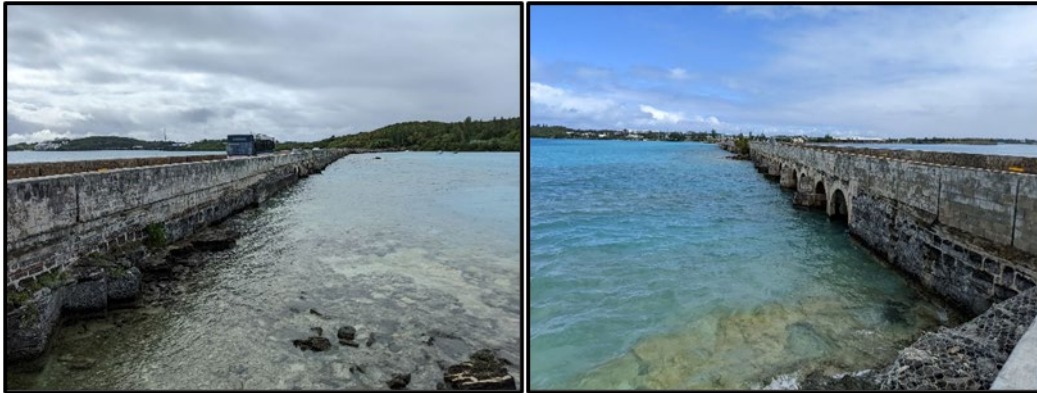
## Location: Causeway

Structure Class:	<b>Road Bridge</b>
Material:	<b>Cut stone blocks</b>
Condition:	<b>3 (Fair)</b>
Coordinates (UTM 20):	<b>339251 m (Easting)</b> <b>3581023 m (Northing)</b>

- Connects Mainland of Bermuda to the airport and Banjo Island
- Vital infrastructure for tourism/business, medical emergencies, air-related evacuations
- Structure is  $\approx$  150 years old, and partially failed in last major hurricane
- In subsequent repairs, a layby was built that included gabion basket protection
- Due to its low-lying nature, the causeway is closed during severe storm events

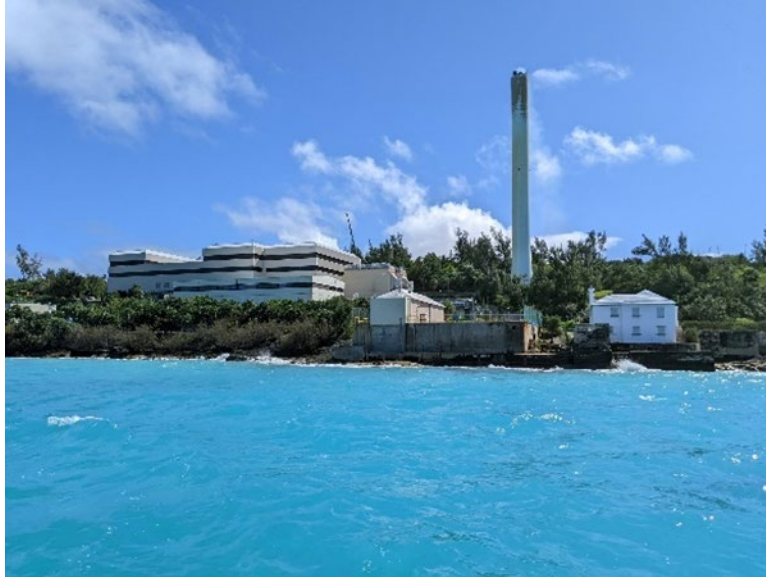
## Location: Tyne's Bay SWRO Plant

Structure Class:	<b>Utility – Water Supply Plant</b>
Material:	<b>Reinforced Concrete Block</b>
Condition:	<b>1 (Very Good)</b>
Coordinates (UTM 20):	<b>333793 m (Easting) 3576003 m (Northing)</b>

- Currently largest desalination plant for Bermuda ( 750K Imperial Gallons per Day)
- Infrastructure elements are significantly elevated above Mean Sea Level
- Reduced risk from storm surge at present-day sea levels

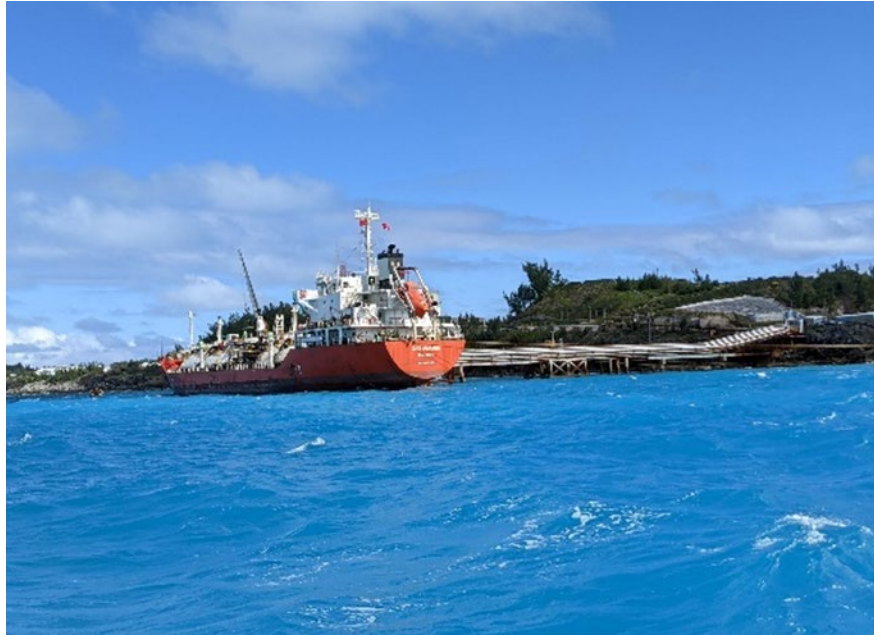
## Location: Sol Fuel Terminal

Structure Class:	Utility – Fuel Terminal
Material:	Reinforced Concrete Block
Condition:	2 (Good)
Coordinates (UTM 20):	339965 m (Easting) 3583105 m (Northing)

- Main fuel receptor terminal for Bermuda
- Infrastructure appears to be in generally good condition
- Infrastructure at the shoreline (jetty, conveyor belt, etc.) shows signs of corrosion
