# Baseline Conditions Report

## Bermuda and Climate Change: Impacts from Sea Level Rise and Changing Storm Activity

**Smith Warner International Limited**  
Unit 13, Seymour Park, 2 Seymour Avenue  
Kingston 10, JAMAICA

26 September 2022

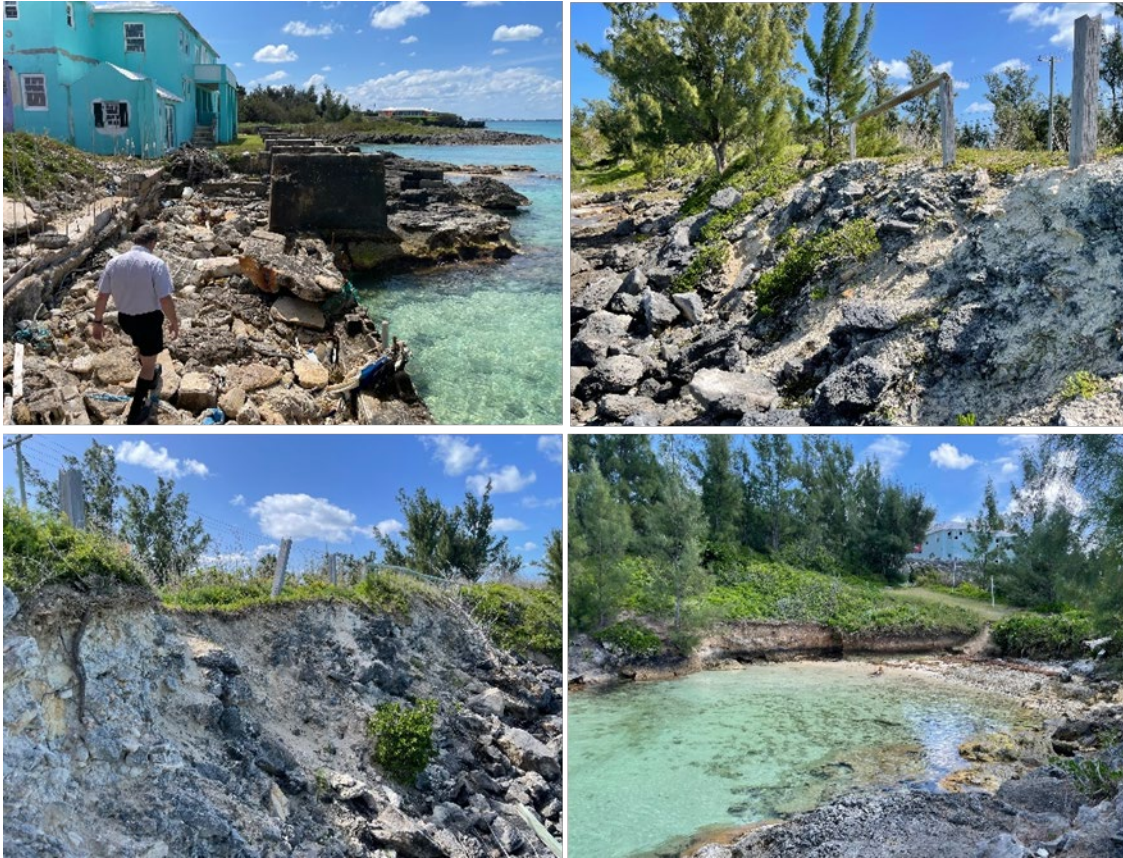
## Location: Railway Trail

Structure Class:	<b>Cultural/Historical – Walking Trail</b>
Material:	<b>Natural Ground</b>
Condition:	<b>3 (Fair with signs of deterioration)</b>
Coordinates (UTM 20):	<b>338570 m (Easting) 3581519 m (Northing)</b>

- Some sections of trail show signs of erosion and exposure to potential wave damage
- The Sol pipeline is located along some sections of the trail
- Periodic inspection by Sol have revealed pipeline corrosion, which has led to shoreline reinforcement and/or pipeline replacement

- Pipeline dates from 1972 and is inspected every 5 years using an internal instrument that evaluates wall thickness to detect corrosion. Results from these surveys are used to guide repairs and replacement programs.

- The pipeline is owned by Sol, but is on government lands. Much of the route follows the Railway Trail, a public footpath along the north coast.
- Past work has been done to stabilize eroding sections of the footpath where the pipeline is at risk from erosion or storm damage. Sol carries out this work to protect their asset, with permission/knowledge of government. Repairs are frequently done when problems arise, and studies or engineering designs are not typically done. Contractors suggest solutions to pressing problems, due to time and access constraints.

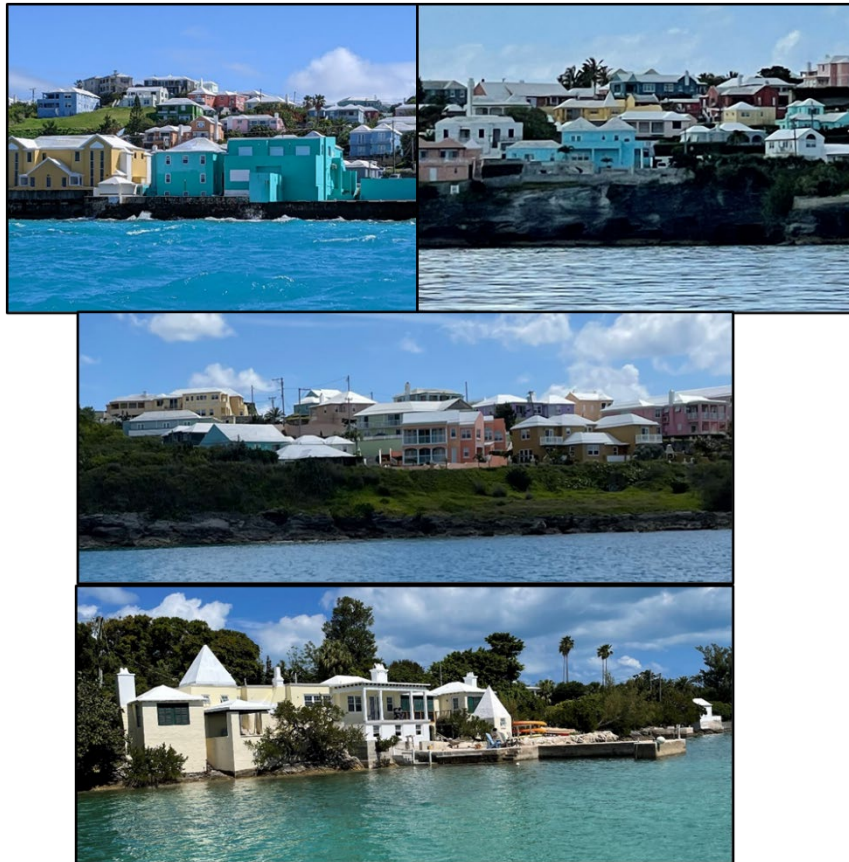
**Location: North Shore Residences**

Structure Class:	<b>Residential Housing</b>
Material:	<b>Concrete Block,</b>
Condition:	<b>2 (Good)</b>
Coordinates (UTM 20):	<b>m (Easting) m (Northing)</b>

- Conditions along the north shore vary
- Some areas are on high ground and well set back from the sea, while others are low lying and require protection by seawalls
- Some buildings are located directly on the shoreline and accommodate small craft vessels which dock against the seawalls. With sea level rise, the long term viability of these residences and their functionality will be compromised.

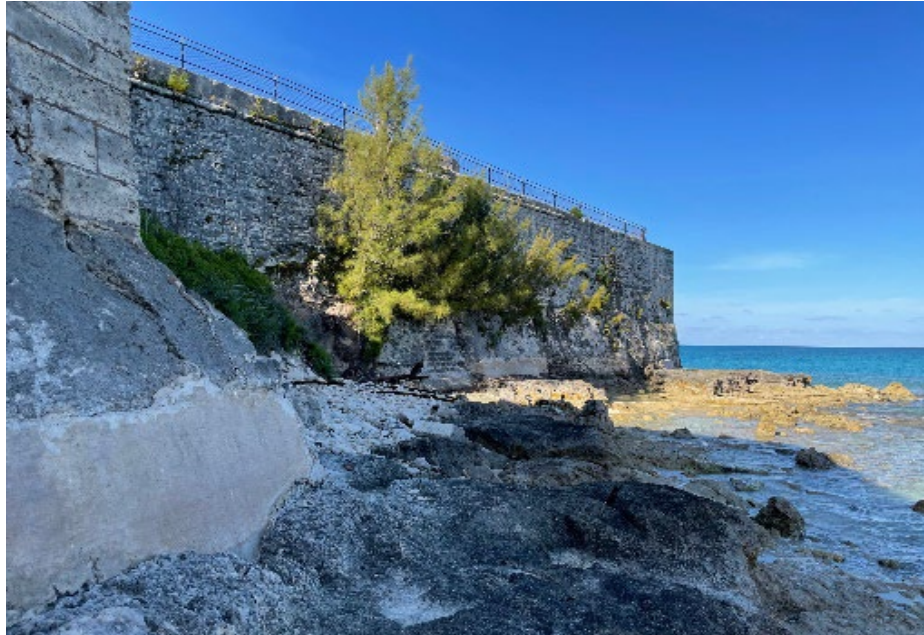
## Location: Fort St Catherine

Structure Class:	<b>Seawall</b>
Material:	Concrete
Condition:	<b>3 (Fair)</b>
Coordinates (UTM 20):	<b>342485.17 (Easting)</b> <b>3584977.62 (Northing)</b>

- Concrete wall with a foundation in sand rock.
- Vertical segments of the wall intact.

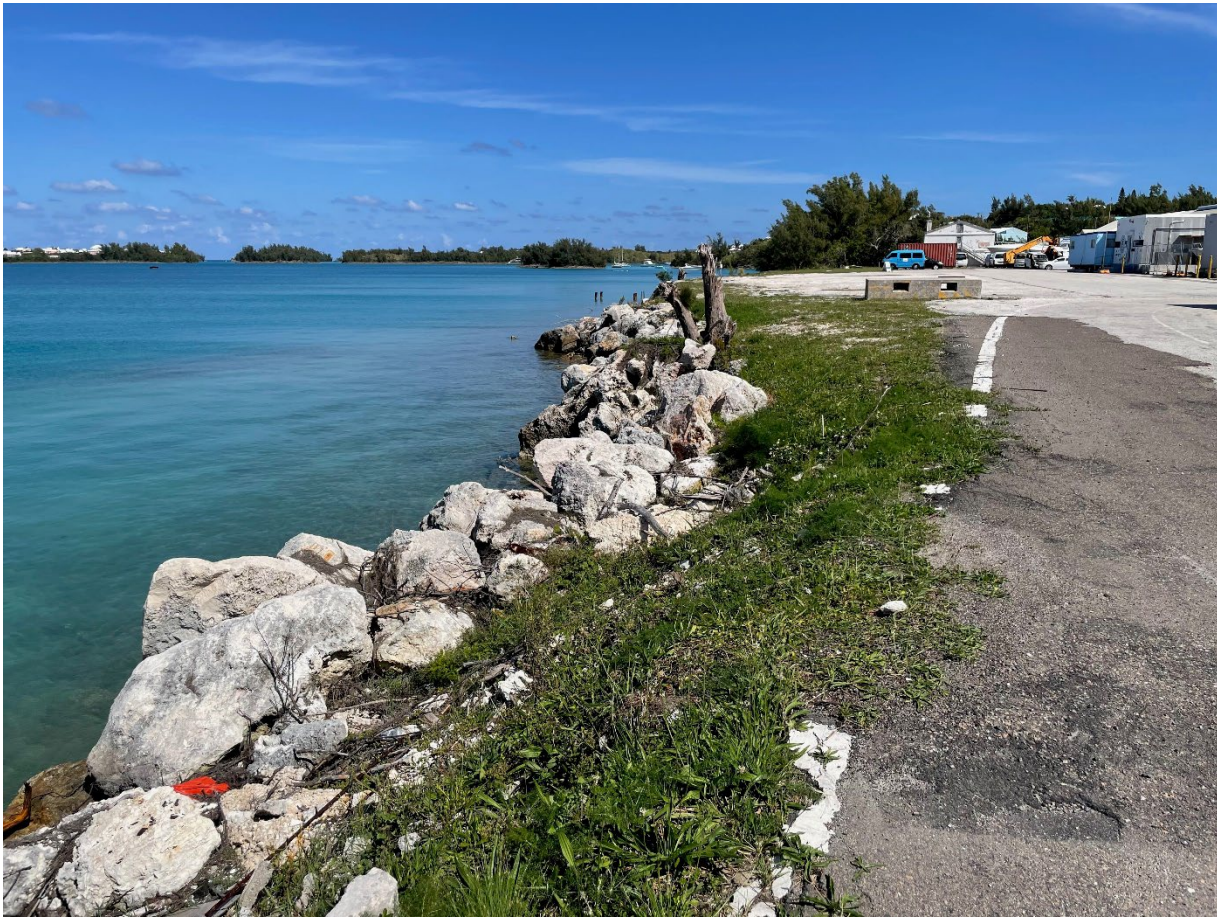
## Location: Dock at Bermuda Land Development Company (BLDC)

Structure Class:	<b>Rubble Mound Revetment</b>
Material:	Boulders
Condition:	<b>4 (Poor)</b>
Coordinates (UTM 16):	<b>341881.53 (Easting)</b> <b>3582790.23 (Northing)</b>

- Several displaced stones
- Needs to be repacked.

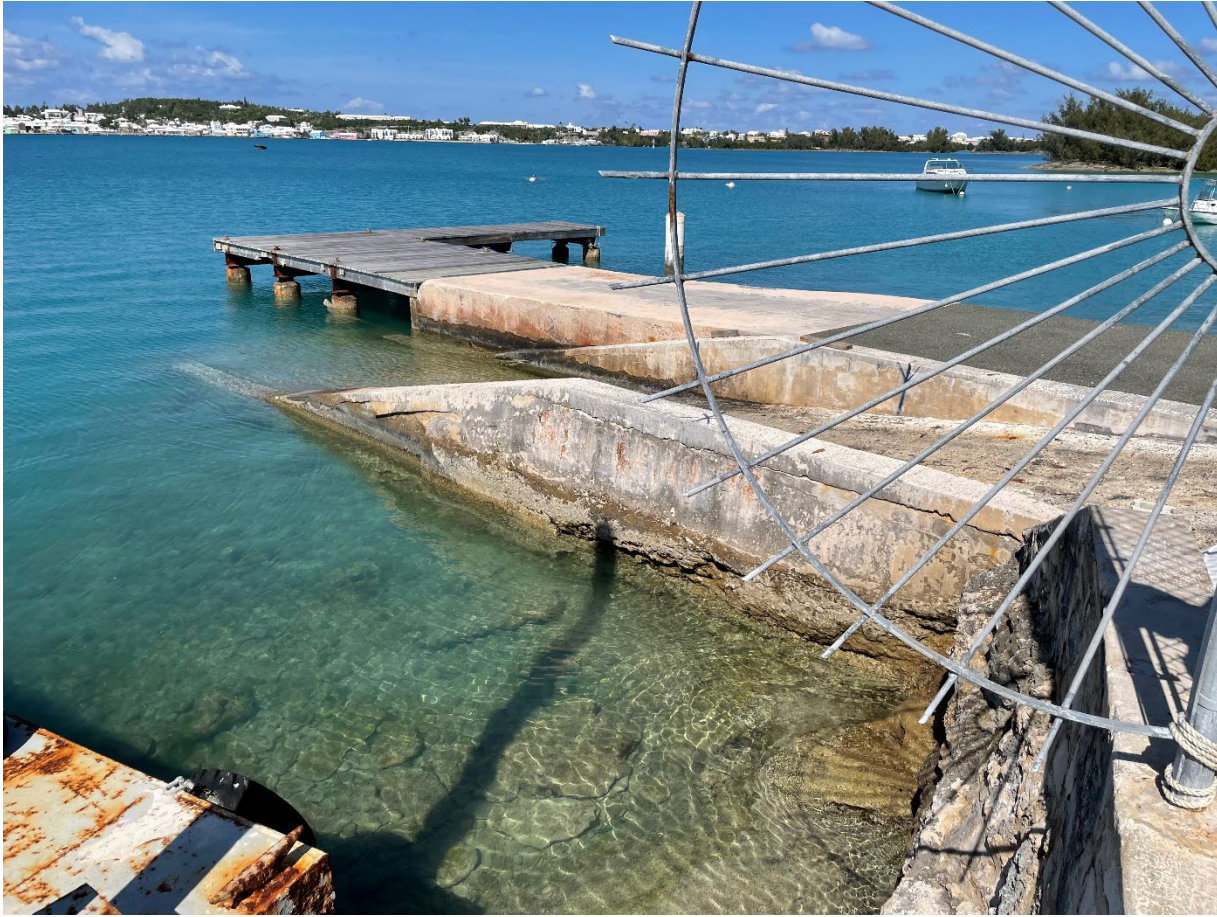
## Location: Dock at Bermuda Land Development Company (BLDC)

Structure Class:	<b>Boat Dock and Ramp</b>
Material:	Boulders
Condition:	<b>2 (Good)</b>
Coordinates (UTM 16):	<b>342209.81 (Easting)</b> <b>3582718.54 (Northing)</b>

- Evidence of scraping at the foundation of structures.
- Piles are intact, with no evidence of failure.

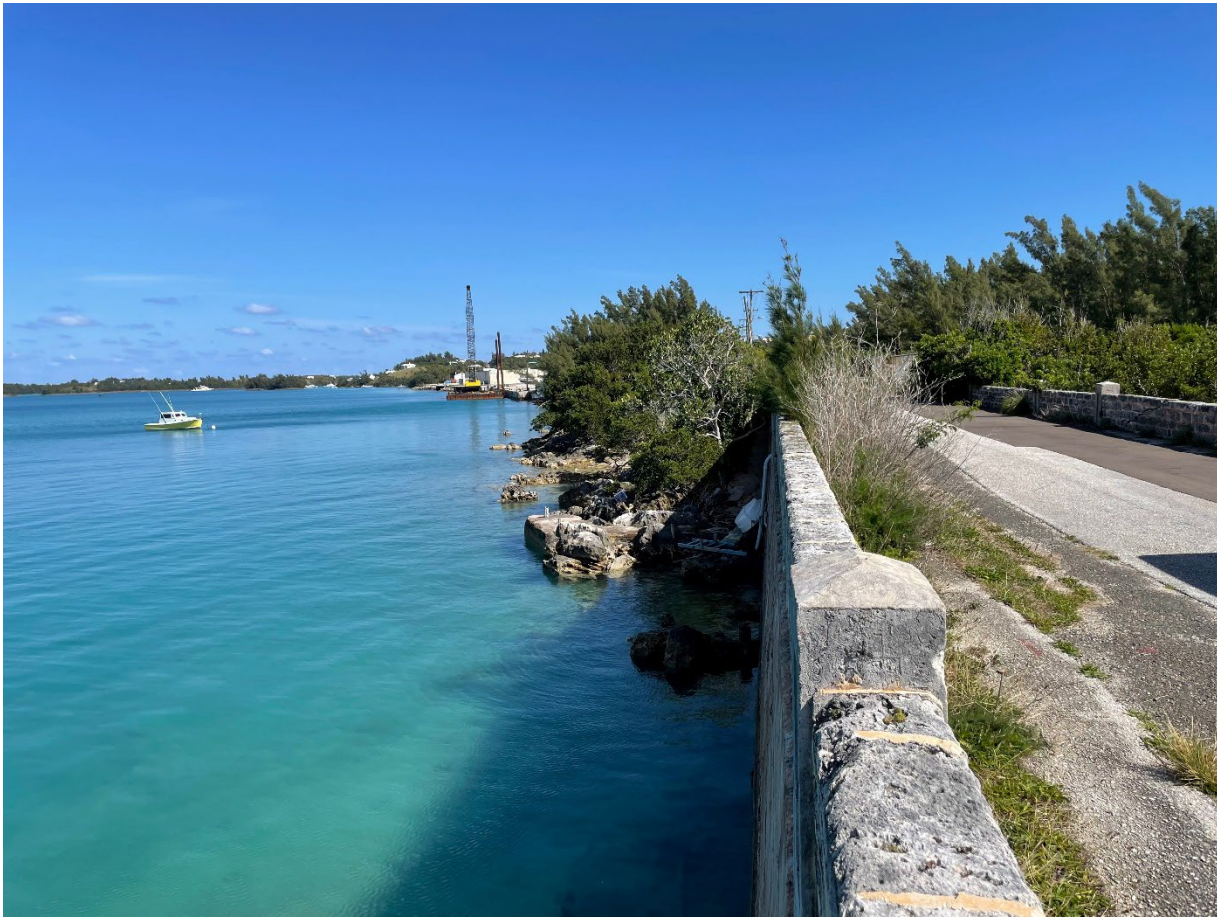
**Location: Dock at Bermuda Land Development Company (BLDC)**

Structure Class:	<b>Bridge</b>
Material:	Concrete
Condition:	<b>4 (Poor)</b>
Coordinates (UTM 16):	<b>341365.43 (Easting)</b> <b>3582887.07 (Northing)</b>

- Derelict bridge.

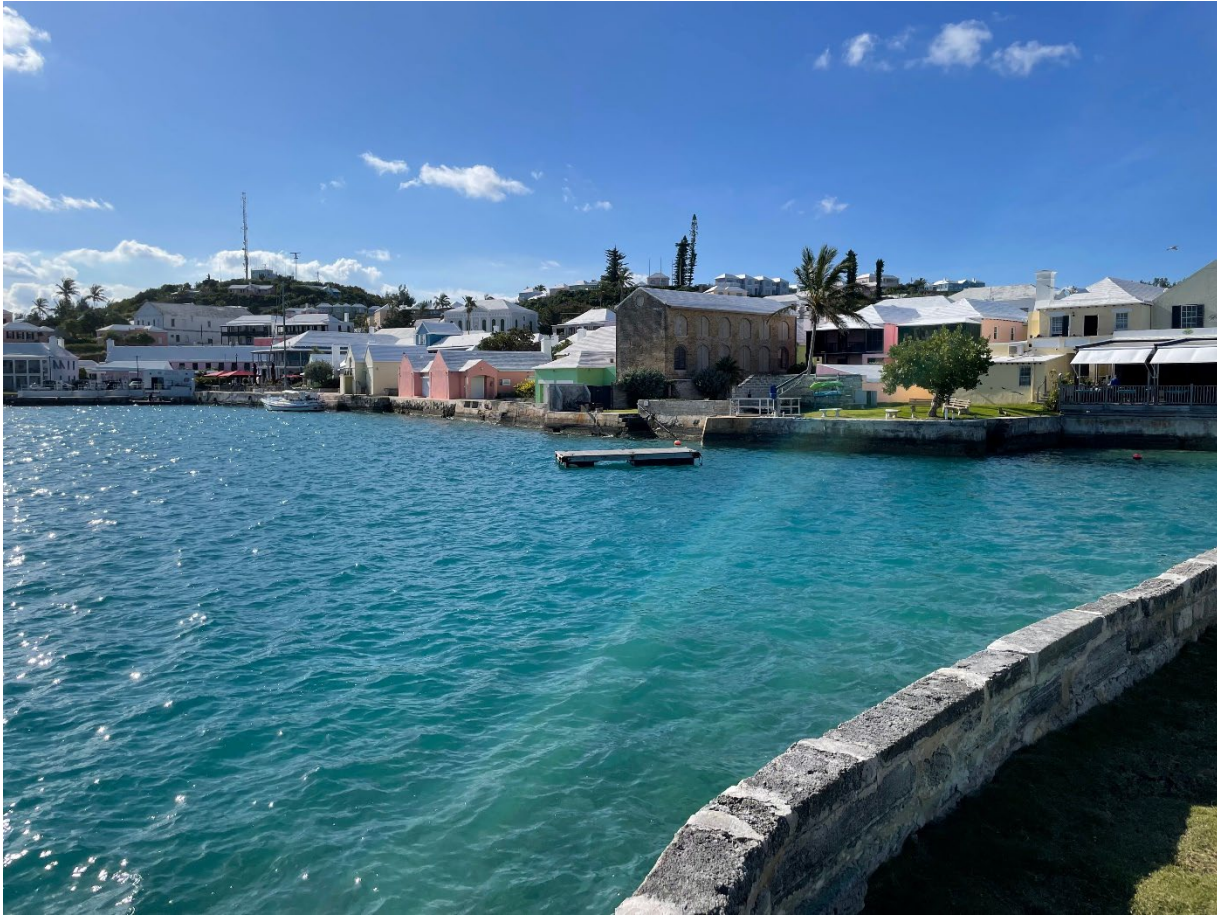
## Location: **Sea Defence, Town of St George's**

Structure Class:	<b>Seawall</b>
Material:	Concrete
Condition:	<b>2 (Good)</b>
Coordinates (UTM 16):	<b>342123.53 (Easting)</b> <b>3583817.77 (Northing)</b>

- Low elevation wall used for retaining land for residential and commercial properties.

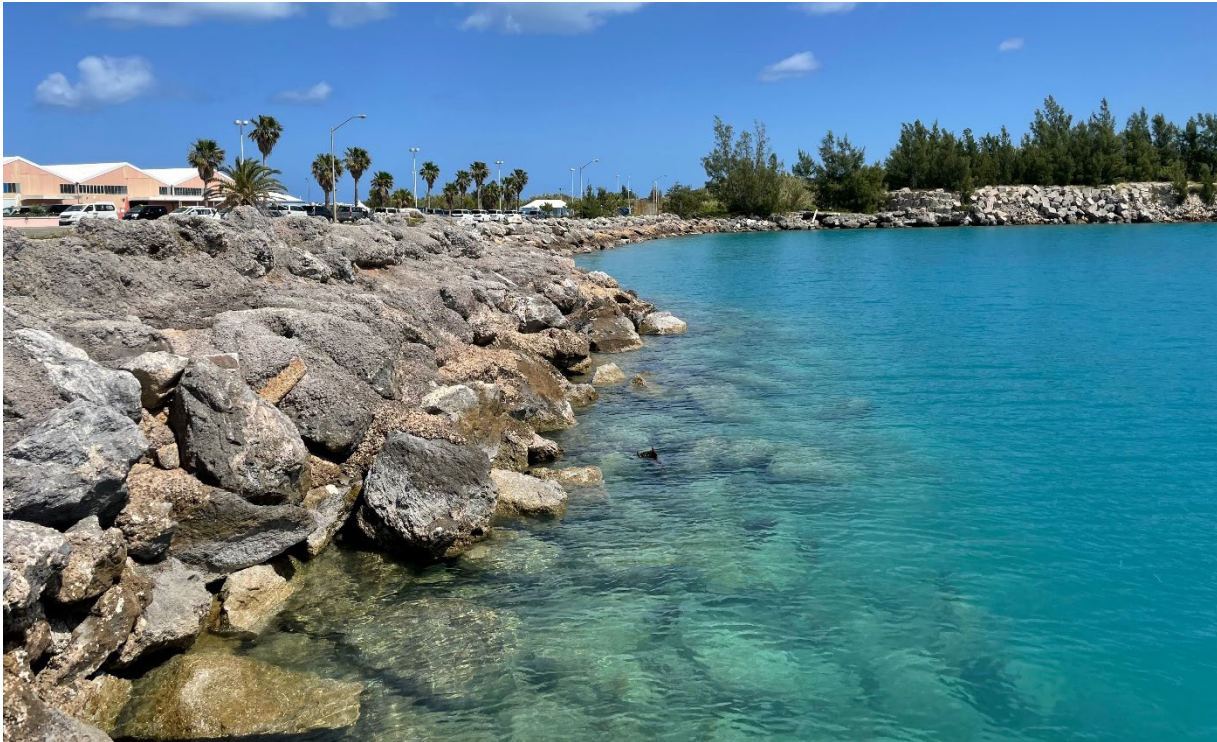
## Location: **Sea Defence, Airport**

Structure Class:	<b>Revetment</b>
Material:	Concrete Units and Boulders
Condition:	<b>2 (Good)</b>
Coordinates (UTM 16):	<b>339979.45 (Easting)</b> <b>3581544.96 (Northing)</b>

- Rubble structure held together by concrete grout which reduces the permeability of the structures.
- The elevation of the structure is set about 2m above sea level.

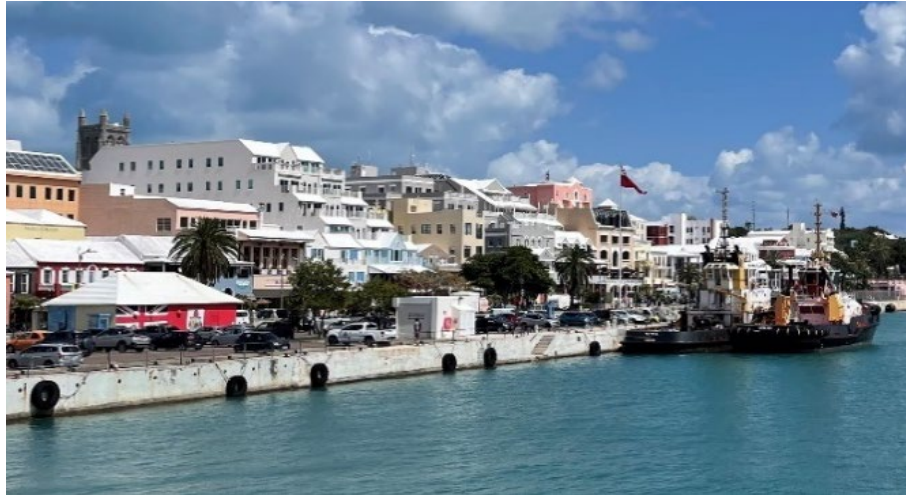
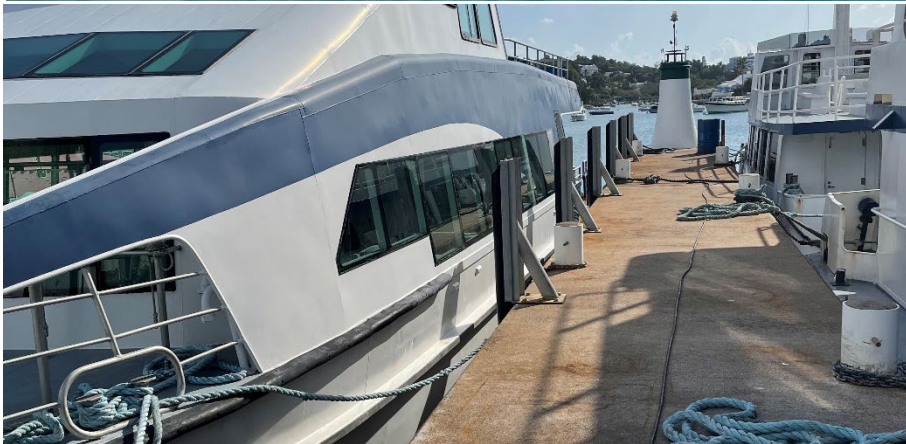
## Location: **Front Street (Ferry Terminal)**

Structure Class:	<b>Seawall and Floating Dock</b>
Material:	Concrete
Condition:	<b>2 (Good)</b>
Coordinates (UTM 16):	<b>332667.79 (Easting)</b> <b>3574299.94 (Northing)</b>

- Concrete seawall that is used as the cruise berths.
- The dock is relatively low and can likely be flooded under storm events.
- A few of the fenders along the berths have failed used to repeated collisions.

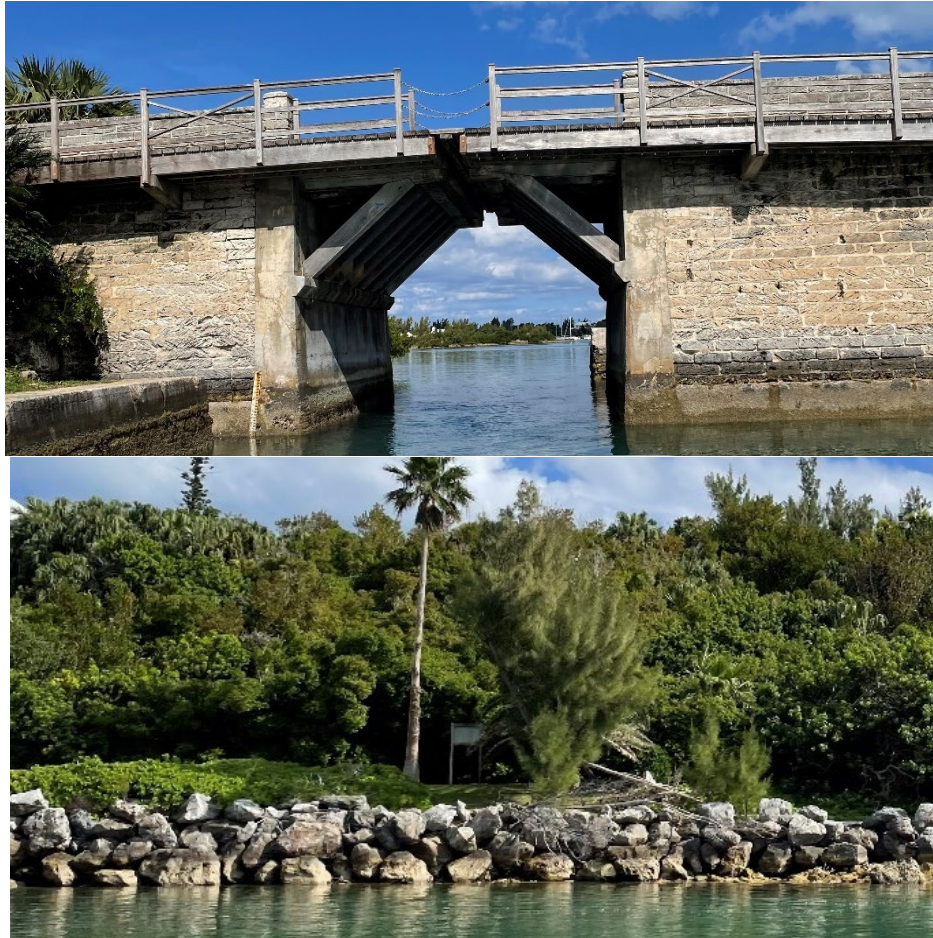
## Location: Somerset Bridge

Structure Class:	<b>Bridge</b>
Material:	Concrete
Condition:	<b>3 (Fair)</b>
Coordinates (UTM 16):	<b>323316.01 (Easting)</b> <b>3572828.95 (Northing)</b>
