Reference: BLG26058

**Shore Cliff Inspection
Grand Atlantic Development
South Shore Road
Warwick, Bermuda**

The above site was visited on October 20, 2011 to make a visual examination of the shore cliff and confirm that the remedial measures have been carried out in accordance with our report dated October 29, 2009.

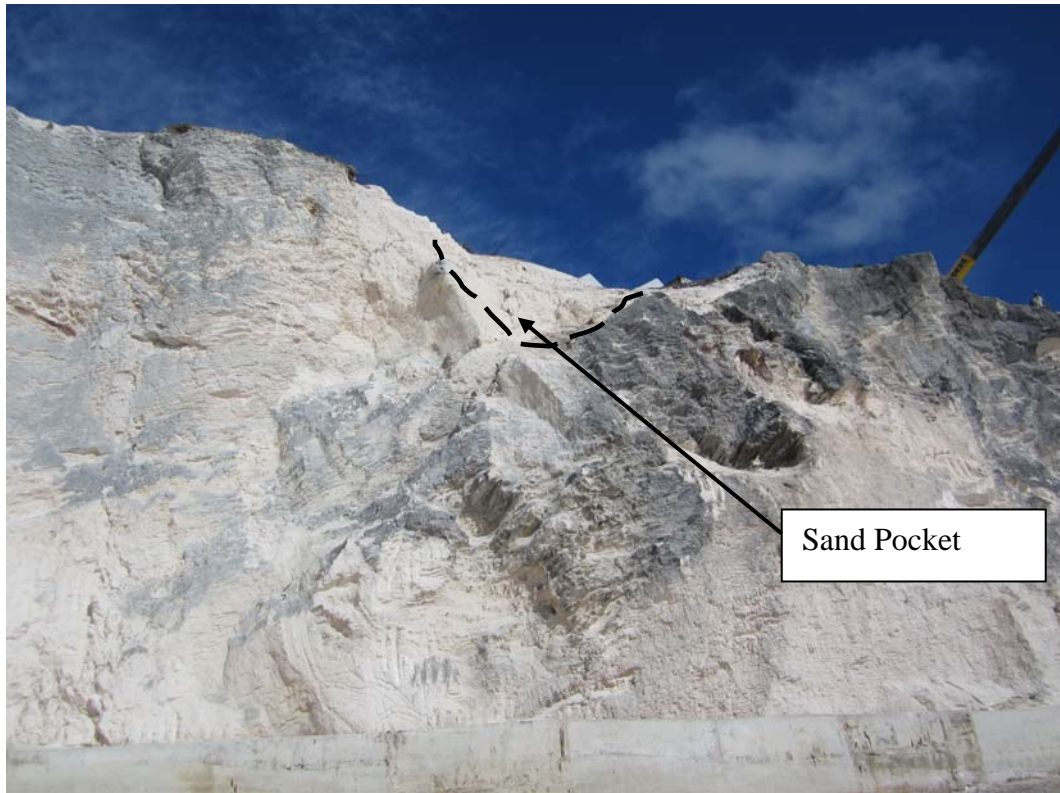
Photo 6: Sand Pocket at Top of Cliff

One large sand pocket is present at the top of the cliff as shown on Photo 5. It is understood that this will be benched and that a retaining wall will be constructed at this location.
